**AMENDMENT TO SUPPLEMENTAL PHASE II
ENVIRONMENTAL SITE ASSESSMENT**

Dagostino Rose Farm
Oak Street Extension
Exeter, New Hampshire
NHDES Site #201203003

September 30, 2016

**Subject: Amendment to Supplemental Phase II Environmental Site Assessment
Dagostino Rose Farm, NHDES #201203003
Oak Street Extension, Exeter, New Hampshire**

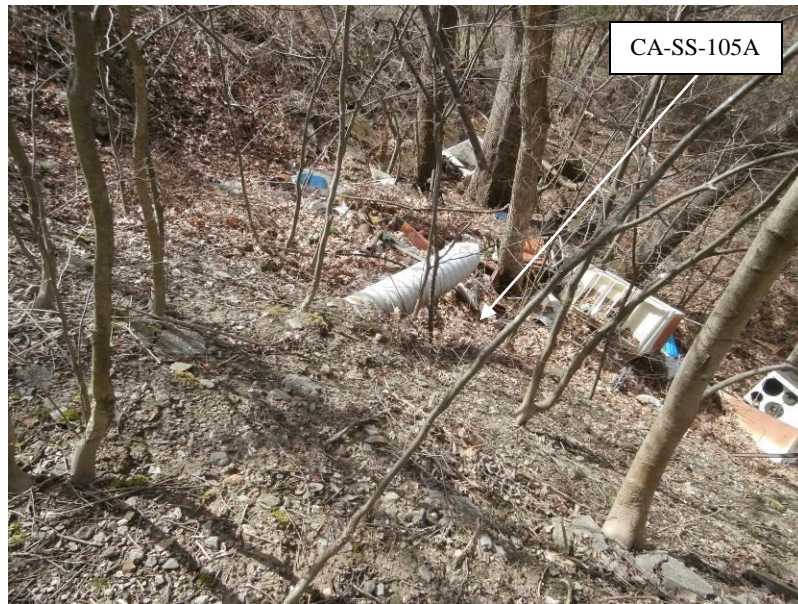
On September 23, 2016, Credere visited the Site to further investigate the culvert that was identified behind the Packing House (see **Figure 2**). Digsmart of Maine (Digsmart) met Credere at the Site to perform electronic location of the culvert and any possible connected drain structures. Digsmart used an electronic transmitter and receiver, a metal detector, and ground-penetrating radar (GPR) to attempt to locate the culvert and pipe (**Photographs 1 and 2**). Based on Digsmart's interpretation, it appeared the culvert went beneath the Packing House and stopped.

Concurrently with attempting to locate the culvert/pipe, one soil sample, CA-SS-105A (**Photograph 1**), was collected using hand tools from directly beneath the culvert/pipe discharge and former sample location CA-SS-105 previously collected from the material within the culvert. The sample was submitted for laboratory analysis of 4'-4'-DDT and total lead at Absolute Resource Associates (ARA) of Portsmouth, New Hampshire. Where the source of the culvert could not be located, Credere no other soil samples were warranted at this time.

1. Location of culvert to west of Packing House.

excavated to determine its source, and if any appreciable source material is observed (e.g., sediment in a drain structure), the material be sampled for laboratory analysis of 4'-4'-DDT and lead to ascertain if higher concentrations of these contaminants may be present in a specific source location. In addition, where 4'-4'-DDT has been detected in other areas of the Site, it is recommended that any other drainage structures identified within the former greenhouse area during redevelopment also be assessed for the presence of potential pesticide containing materials.

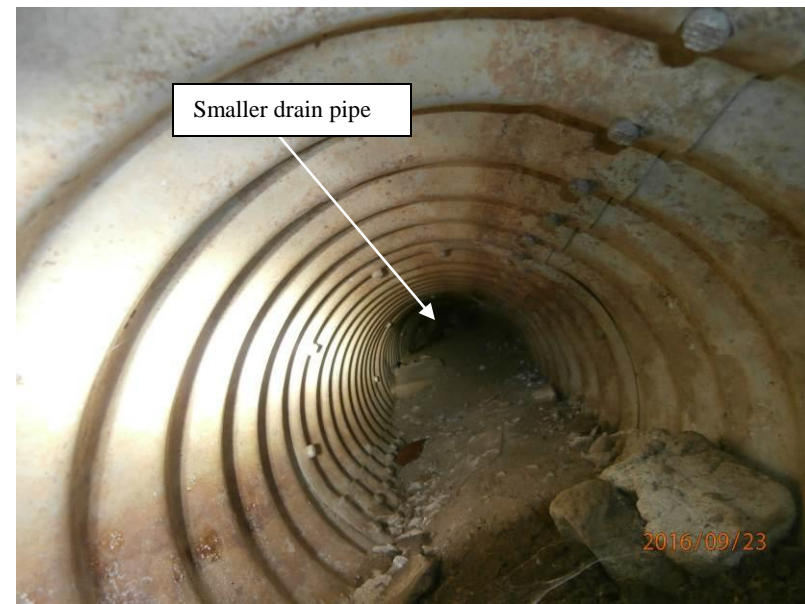
Upon further inspection of the interior of the culvert, it appeared the culvert had been placed into the slope to protect a 4 to 6-inch suspected cast iron drain pipe so that additional fill could be placed on the slope and the pipe could still drain. The soil within the culvert appeared to have eroded from the separation between the drain pipe and culvert. Due to the dilapidated state of the Packing House and the amount of debris on the floor (i.e., the roof/ceiling is caving in), the

2. View of interior of culvert. Note smaller diameter pipe inside.
