**CERTIFICATE OF STORAGE TANK SYSTEM TESTING**

Work Order #543863	Client Information	Location #NH0018	
Date: Mon Sep 30th, 2019 Reason: Compliance	Cross America Partners, LP (Tammy Hessler) Invoice # 753058 Permit# P.O.# Green050045	Cross America Partners, LP BP Service Station 4 Amherst Street Milford, NH 03055 County: Hillsborough State ID: 0113095	
Testing was conducted in accordance with all applicable portions of Federal, NFPA, and local regulations.			
Vapor Recovery - Stage I / Stage II			
Test		Result	
Pressure Decay		Pass	
Pressure Decay		Pass	
Cathodic Protection: Tanks			
Equip #	Grade	Test	Result
8	Diesel	CP: Tanks	Pass
Miscellaneous Inspections			
Test		Result	
CP: Continuity (Fixed Reference Cell)		Completed	
Secondary Containment			
Equip #	Grade	Test	Result
1	Regular	Spill Bucket: Dry Break	Pass
1	Regular	Spill Bucket	Pass
2	Diesel	Spill Bucket	Pass
Additional Costs			
MISCELLANEOUS FIELD SERVICES: Additional Pressure Decay Test

Facility/Agency Copy
Site #NH0018 / WO #543863
Mon Sep 30th, 2019

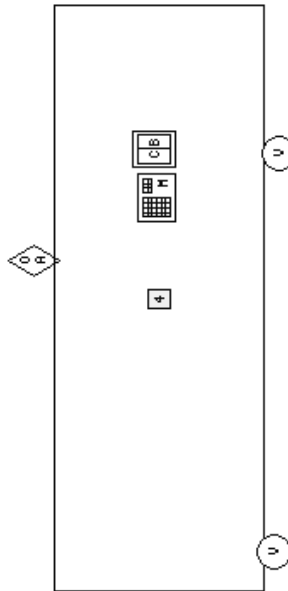
Site Diagram Labels

- 1: Tank - T-3 Diesel 6K
- 2: Tank - T-1 Regular 10K
- 3: Road - Amherst St.
- 4: Block - Garage
- 5: Dispenser - 1/2
- 6: Dispenser - 3/4 Diesel
- 7: Dispenser - Out of Service premium dispneser. tank removed
