## 0111910 Somersworth One Stop II - Hydrostatic Sump Testing

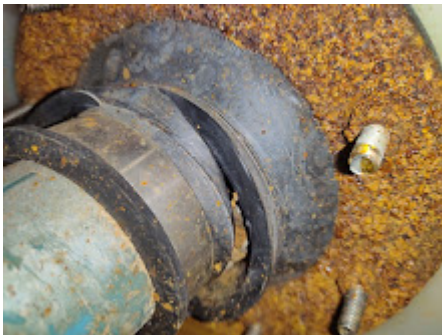
**Dispenser 1-2 Sump (2).JPG**  
122K

Dispenser 1-2 Sump - VISUAL FAIL - Secondary layer of piping on the super line is split wide open and a potential for catastrophic failure of primary line, that section of piping needs to be replaced before being put back into operation.. Secondary boots are also hardened and some fused onto piping and could not be moved into proper position to be able to seal up secondary piping to be able to do hydrostatic test., See attached pic.
