Re: UST Piping Closure Report  
Dick's General Store  
717 Route 4  
Danbury, New Hampshire 03230  
UST Facility No.: 0112726

# UNDERGROUND STORAGE TANK PIPING CLOSURE REPORT

**Dick's General Store**  
717 Route 4  
Danbury, New Hampshire 03230  
UST Facility No.: 0112726

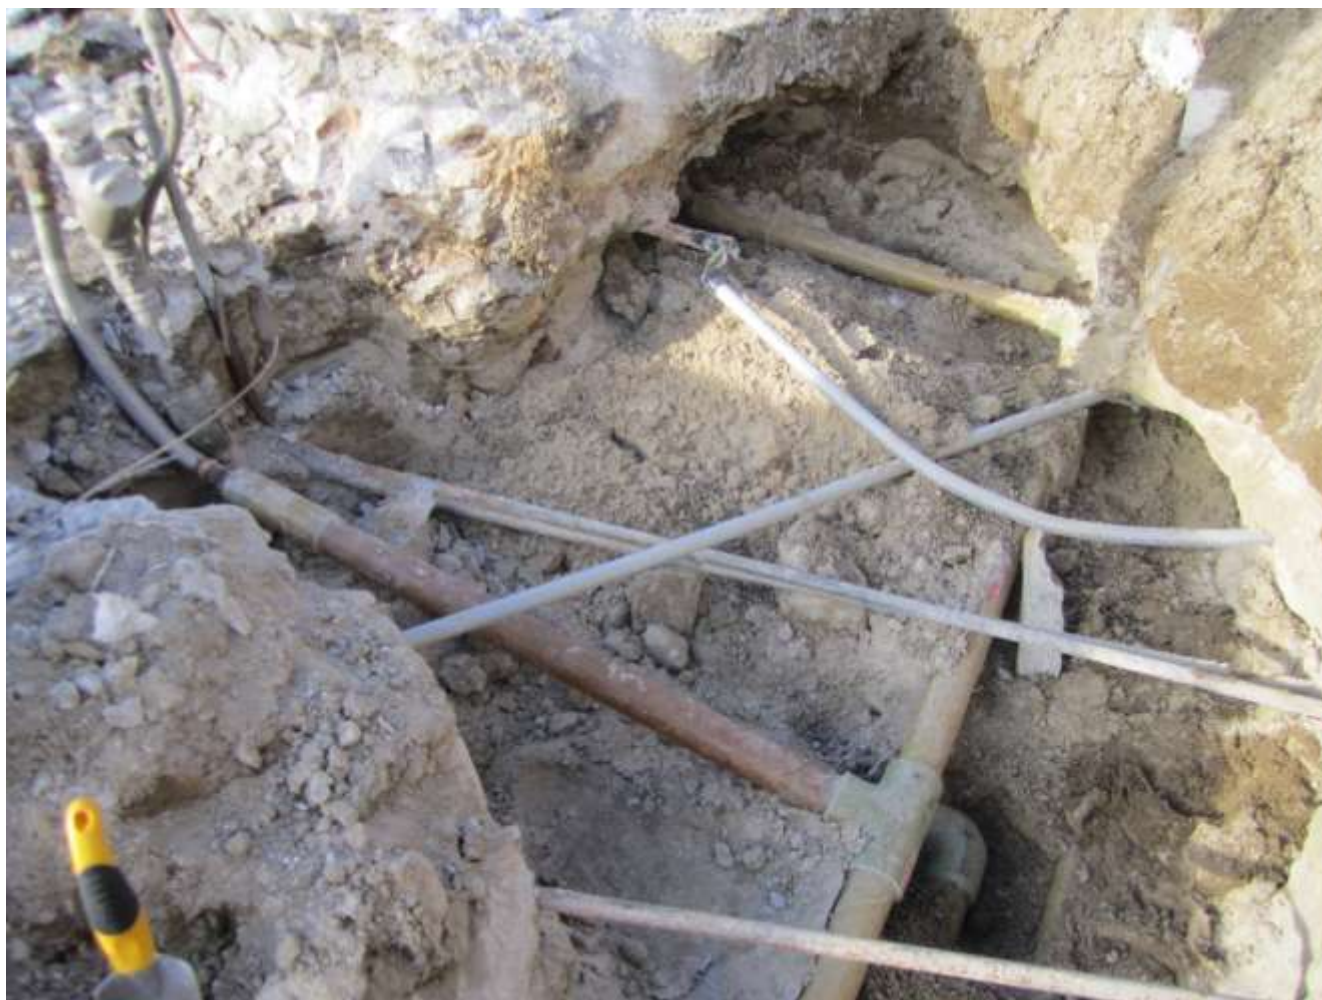
PHOTO #1

PIPING TRENCH AT DISPENSERS

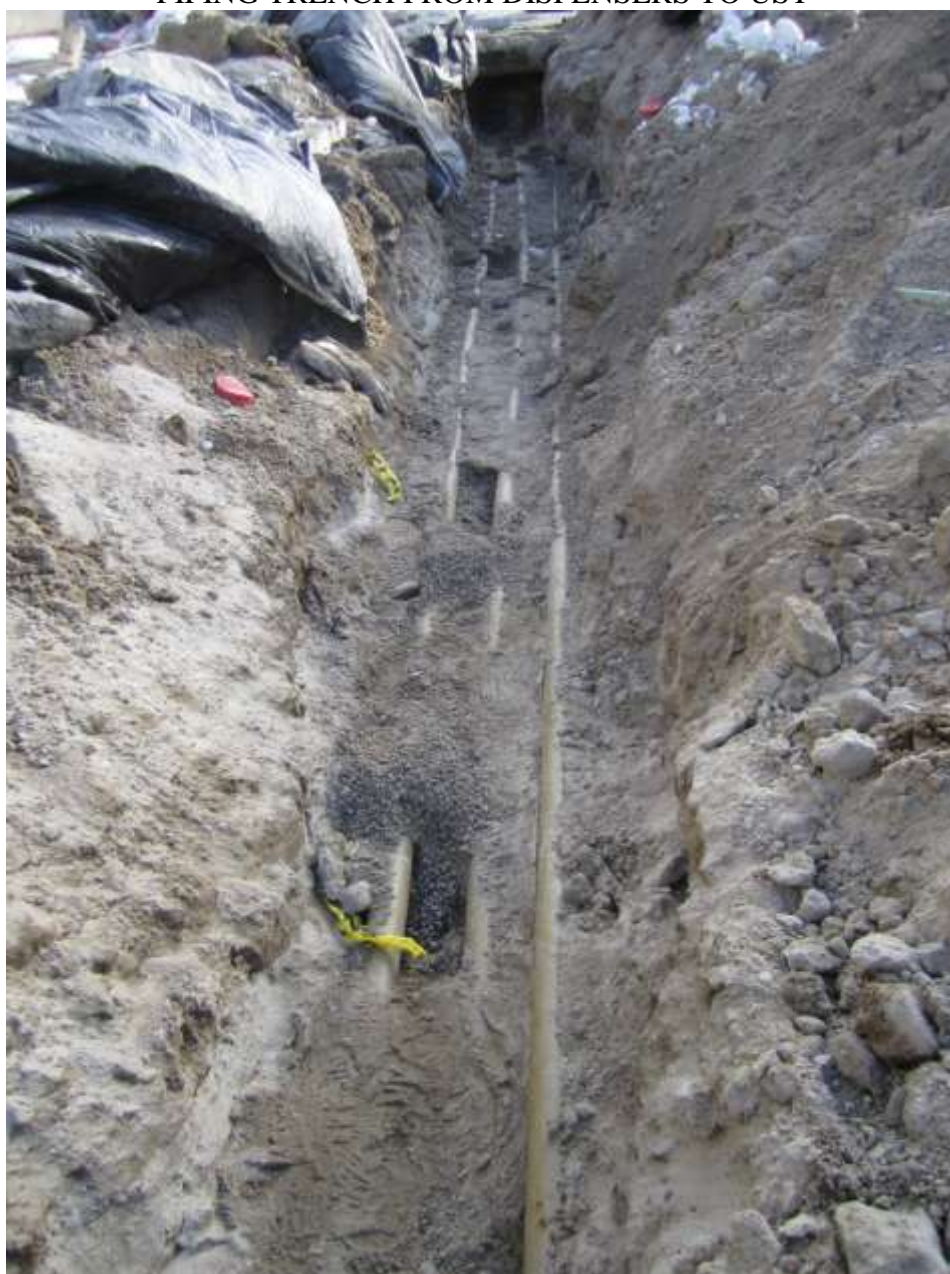
One (1) composite soil sample (CS-1) was obtained from 5 locations along the bottom of the piping trench that was exposed on January 2, 2019 and one (1) composite soil sample (CS-2) was obtained from three locations along the bottom of the piping trench over the UST that was approximately 10-feet long.

PHOTO #2  
PIPING TRENCH FROM DISPENSERS TO UST

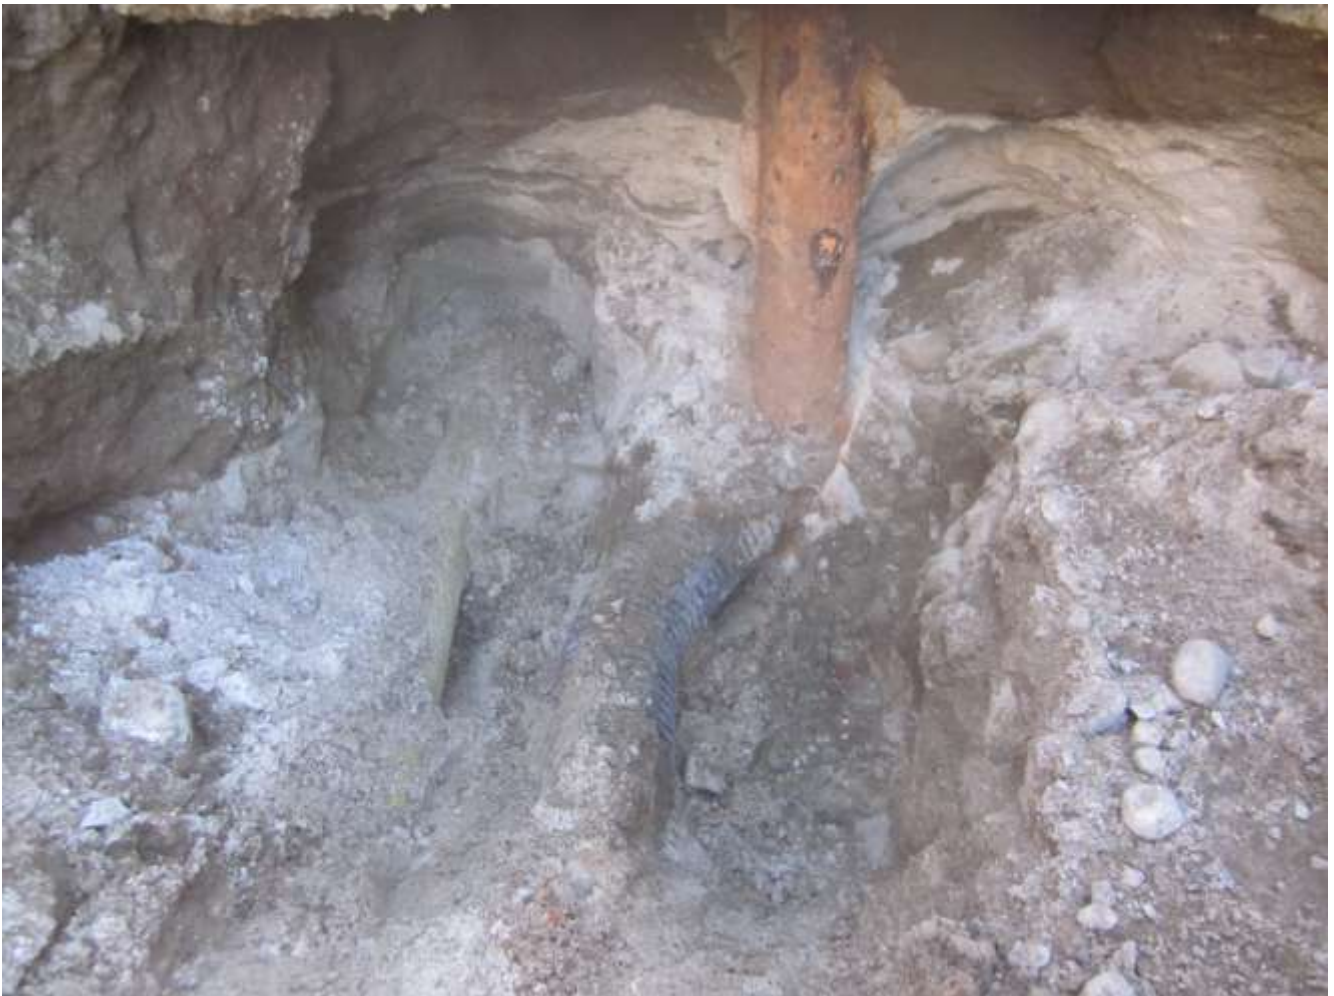
The UST system piping that was closed by removal consisted of single-wall fiberglass non-pressure/suction piping with no containment at the dispensers nor tanks. The piping was observed to be in excellent condition with no deterioration. The facility is serviced with an on-site well. There are no known groundwater monitoring wells on the property. The closed UST piping was installed between the UST and the dispensers.

PHOTO #3  
PIPING AT UST

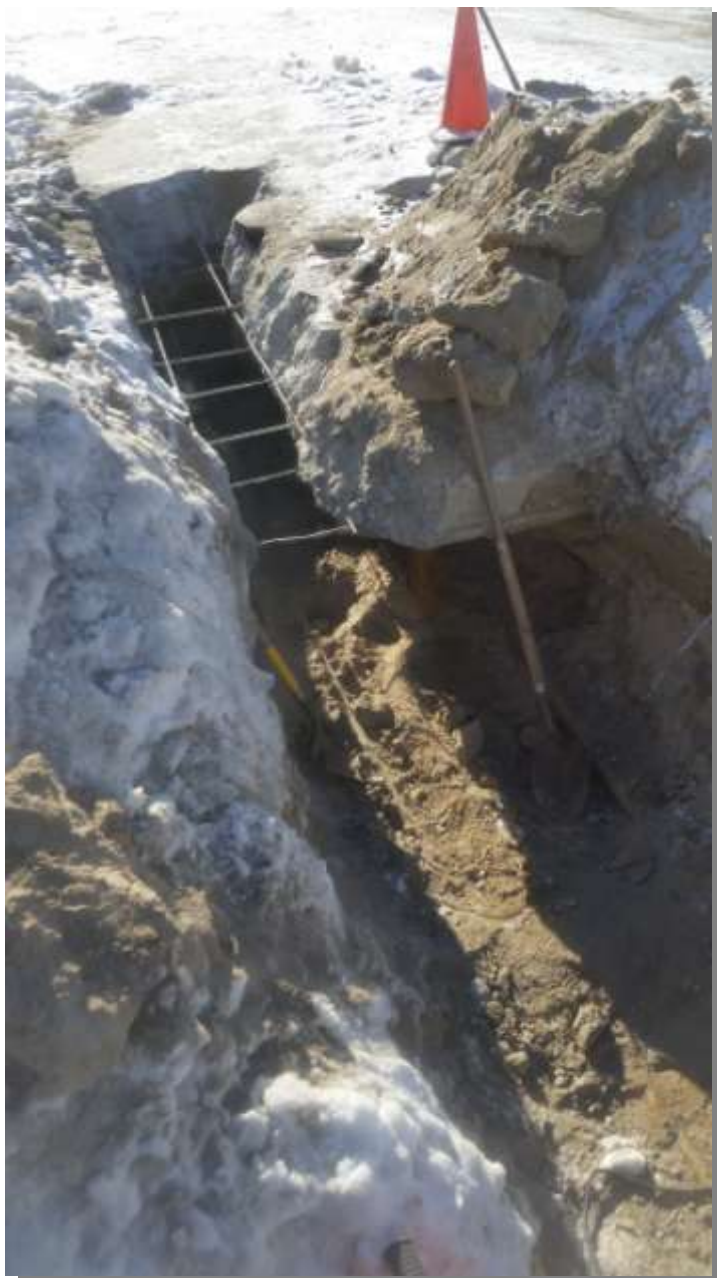
The closure activities were performed by Doug Colby of Danbury, New Hampshire on January 2, 2019 and January 17, 2019. The certified UST closure individual on-site was Doug Colby with ICC exp. 1/3/20. The owner representative is also Doug Colby of Dick's General Store. The NHDES representatives were Eric Johnson and Chris Wood and Mark Antonia of Antonia Design LLC performed the field screening of soils and confirmatory soil sample collection. Piping from the dispensers to the compartmentalized UST was evaluated on January 2, 2019 and piping that extended across the top of the UST was evaluated on January 17, 2019.

PHOTO #4  
PIPING ALONG TOP OF UST

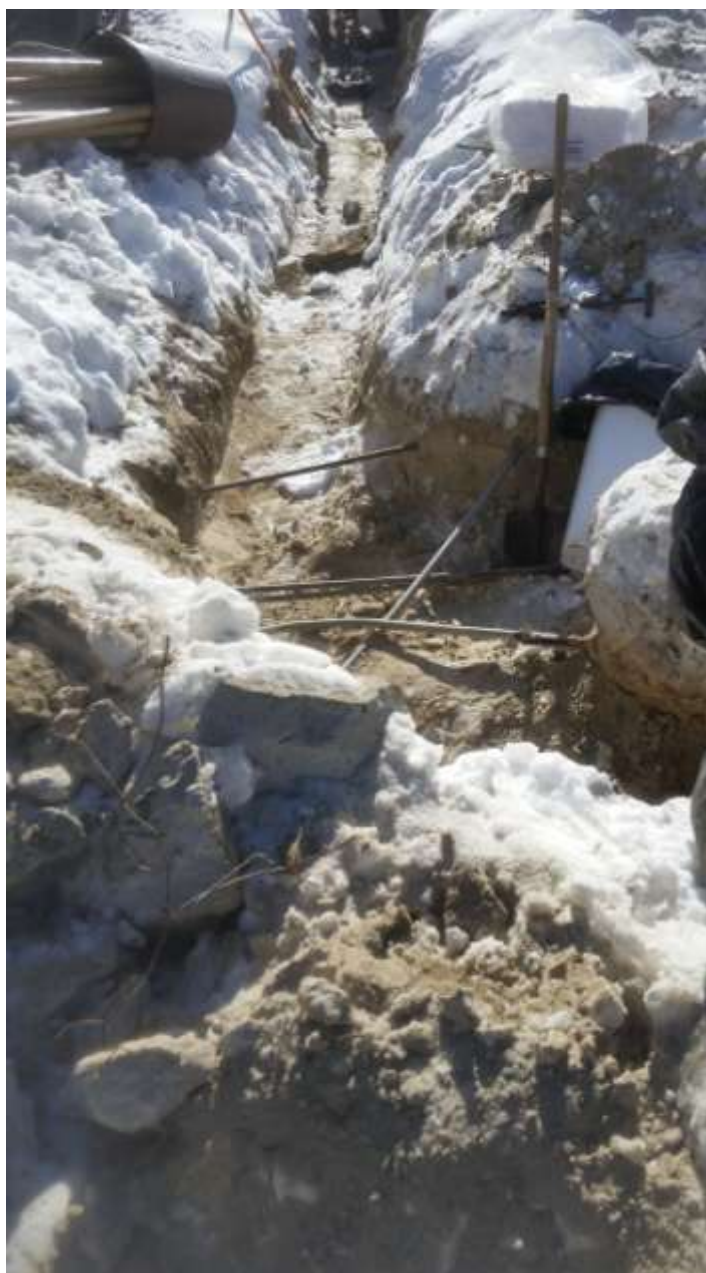
Physical observations were recorded in the field. The backfill material surrounding the UST piping consisted of medium sand, due to the limited extent of excavation the native material adjacent to the UST piping was not clearly observed but expected to be mostly of sandy soils. There were no areas of stained or darkened soil. Groundwater was not encountered from the limited exploration for removing the UST piping. There were no odors of petroleum in the air or excavated soil.

PHOTO #5  
PIPING TRENCH WITH PIPING REMOVED

Based on the field observations, condition of the piping, field screening of soils and the results of analytical testing of the composite soil samples it is believed that no contamination is present at the facility.
