**UST and BURIED FUEL SUPPLY PIPING  
SYSTEM CLOSURE & ASSESSMENT REPORT**

**KINGSBURY CORPORATION  
80 LAUREL STREET  
KEENE, NH 03431**

**NHDES Site #199102028  
UST Facility #0110849**

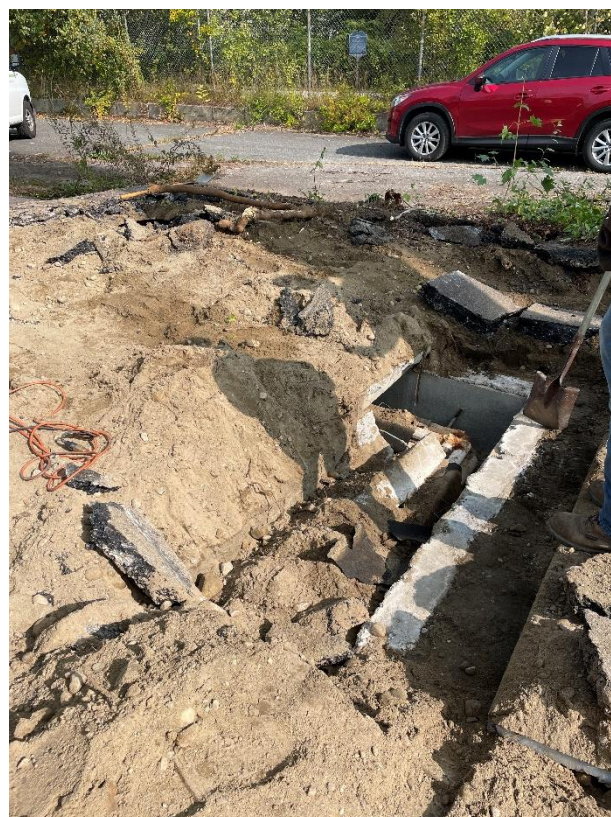
Photo 4: Buried UST fuel supply and vent piping exposed within a concrete secondary containment trench on the west end of Tank #6, view looking north.

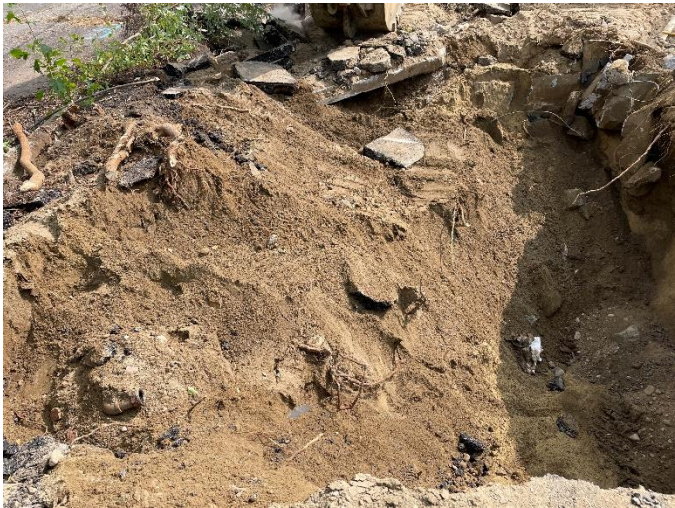
Photo 12: Loose, unconsolidated fine- to medium-grained sand exposed along sidewalls of UST excavation with evidence of buried debris indicative of urban fill.

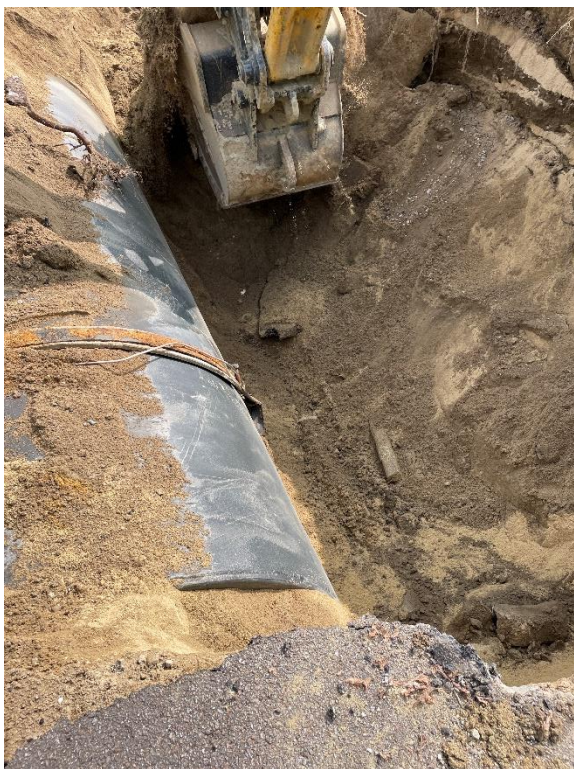
Photo 14: Southwest sidewall of Tank #6; loose sand to approximately 9-feet bgs.

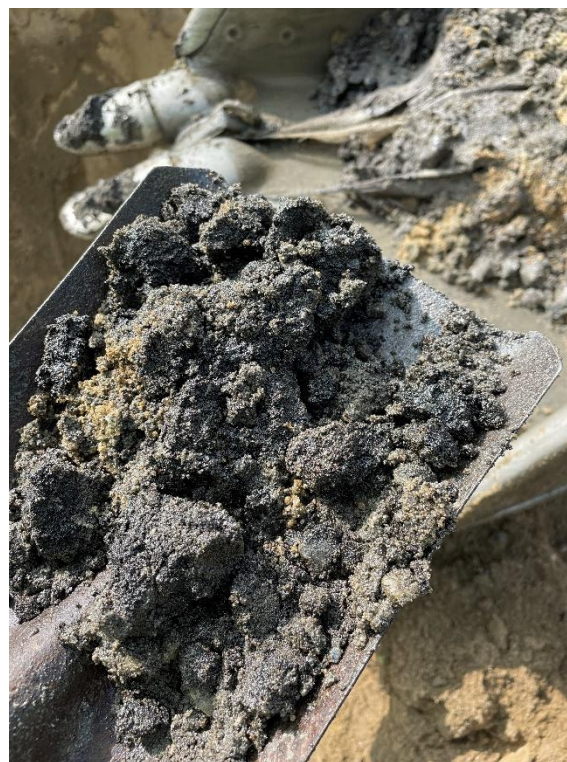
Photo 16: Black, oil-stained soil observed at south and southwest sidewalls of Tank #6 at depths between 10- and 12-feet bgs.

- Evidence of oil and black-stained soil with petroleum odor was encountered at the south and west sidewalls of the Tank #6 excavation at depths between 10- and 12-feet bgs. Upon removal, Tank #6 was observed in good condition with no open holes, pitting, rust, corrosion or leaking condition. The oil-impacted soil appeared to be an aged, weathered release associated with former LUSTs (Tanks #1 and #2) closed and removed in 1986 (see Figure 2).

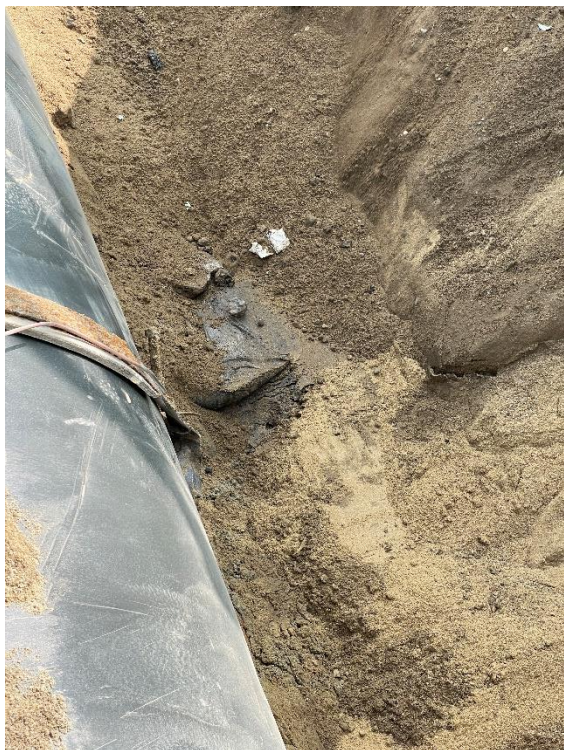
Photo 17: Black, oil-stained soil exposed at base of UST along south sidewall at 10-feet bgs.

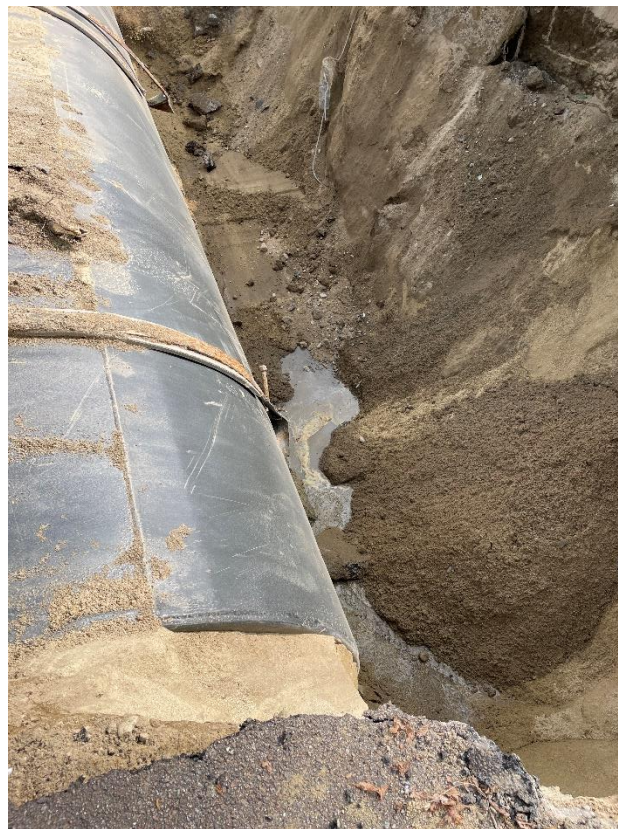
Photo 19: Accumulated groundwater encountered within the excavation along the south sidewall at approximately 9-feet bgs.

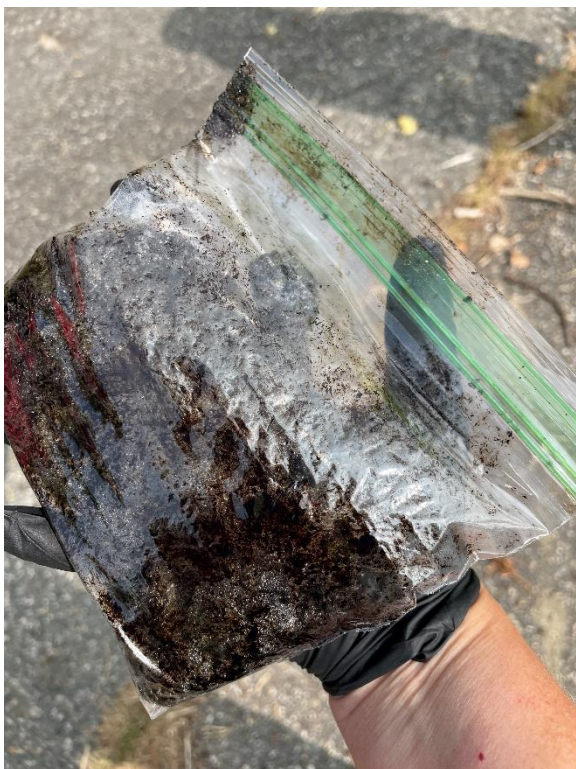
Photo 18: Soil sample from stained layer collected in plastic bag, oil as free product observed in sample.

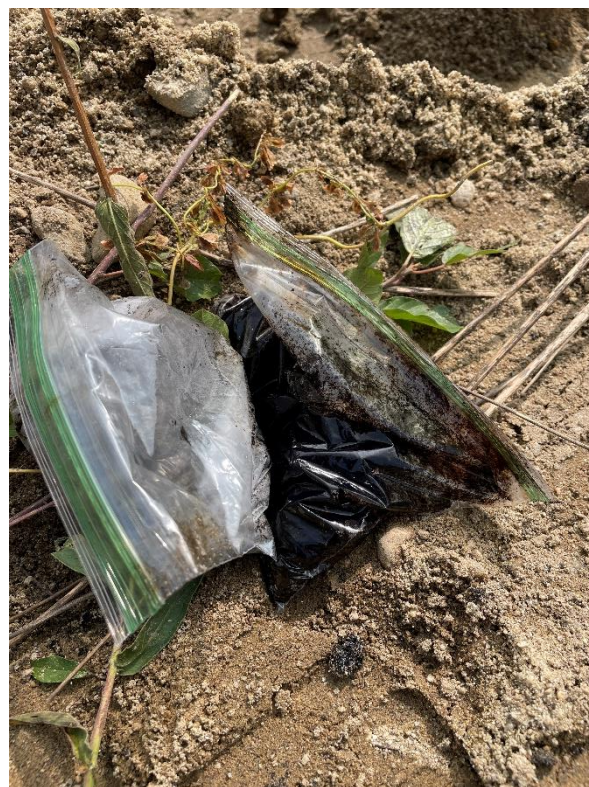
Photo 20: Soil sample collected in plastic bag with heavy oil as free product; sample collected from southwest sidewall at 12-feet bgs.

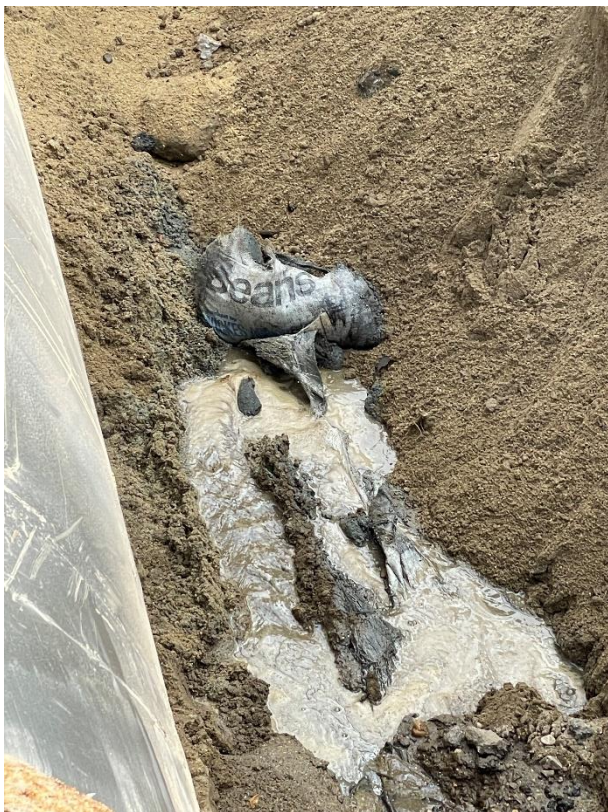
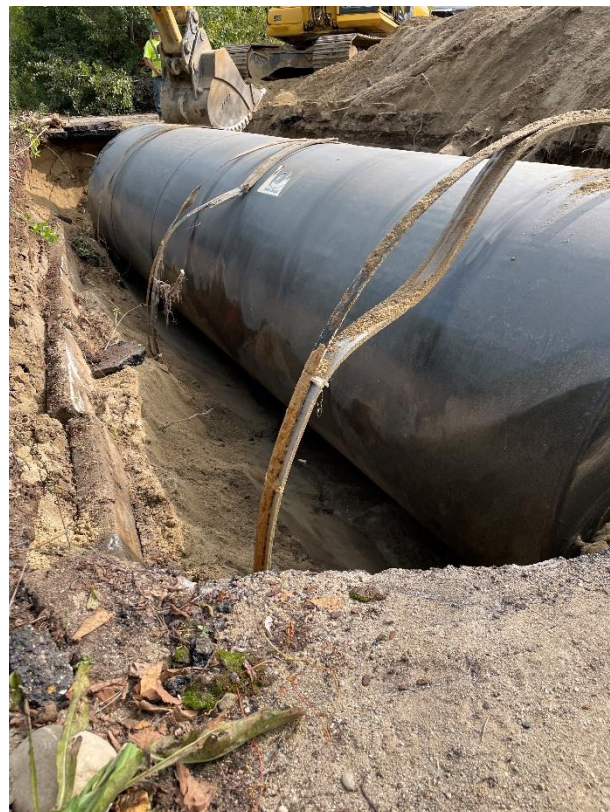
Photo 21: Sand-filled bags and accumulated groundwater observed with globules of oil as free product within the south central portion of the UST excavation.

- Evidence of NAPL as free product was also observed on groundwater accumulated in the tank excavation. The oil impacts to subsurface soil and groundwater are located within an AUR area recorded in 1999 due to the presence of PCB-impacted soil. Petroleum impacts to the subsurface from past LUSTs have not been adequately delineated and may extend outside the AUR area. Additional investigation of soil and groundwater quality is likely required by ORCB due to SRS exceedances and the presence of reportable NAPL.

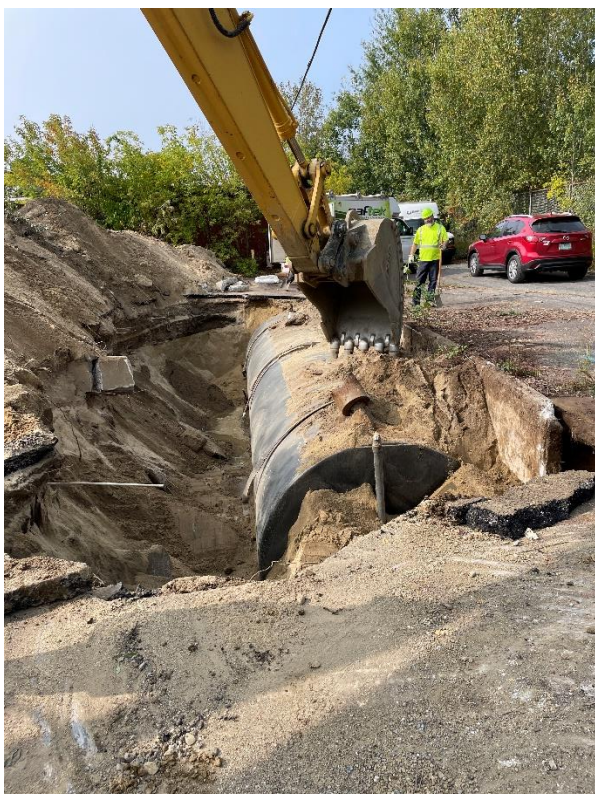
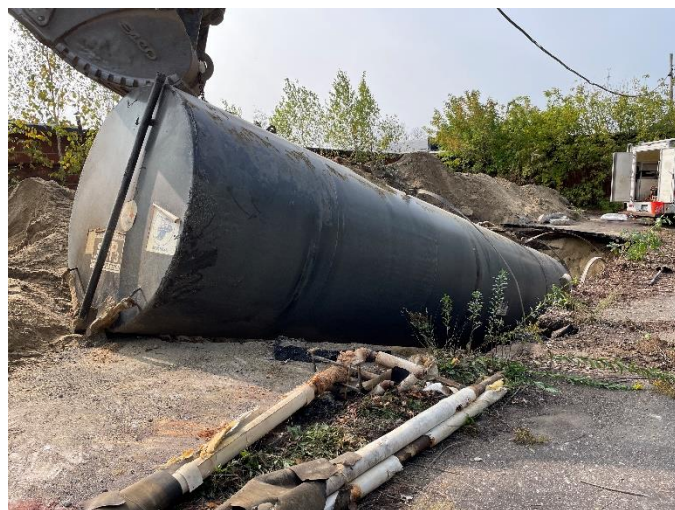
Photos 23 & 24: Tank #6 being removed from the excavation; observed in good condition with no open holes, pitting or corrosion.

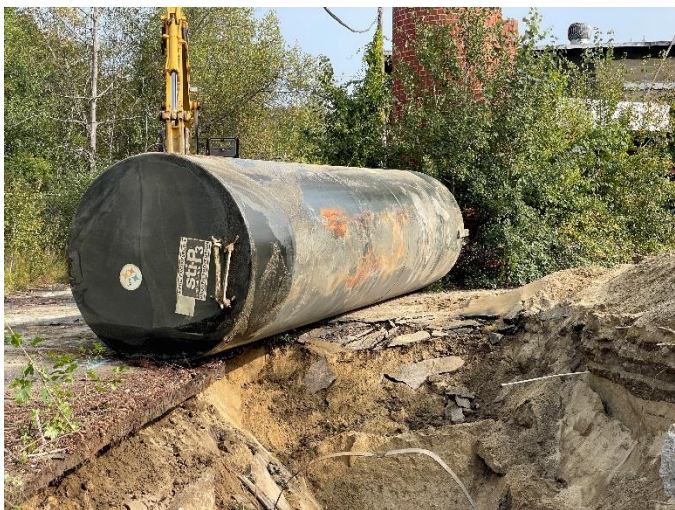
Photo 26: Tank #6 removed from the excavation, base observed clean with no open holes or pitting.

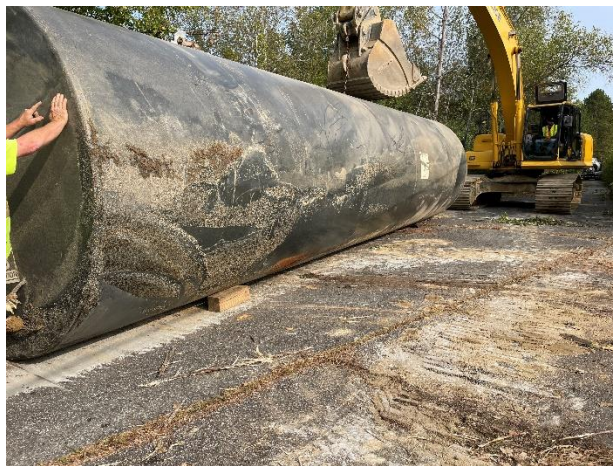
Photo 27: Tank #6 situated on asphalt pavement to prepare for cleaning, base observed in good condition with no evidence of past leaks.

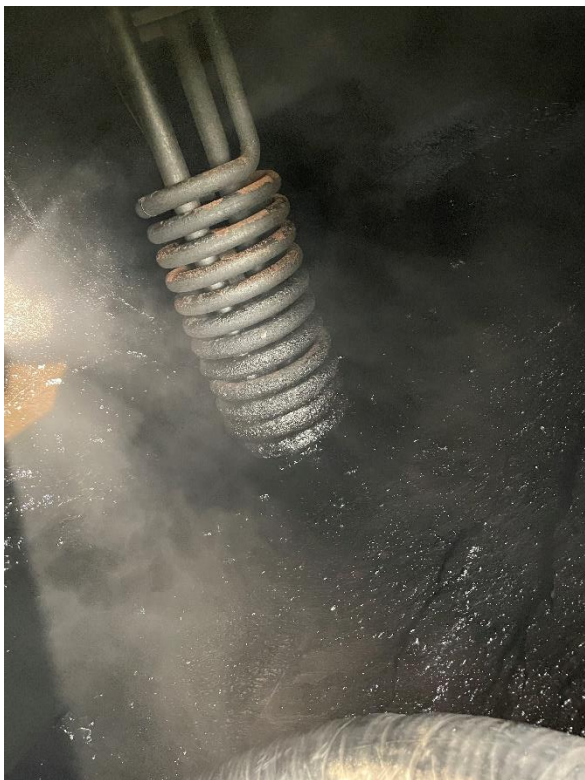
Photo 29: Tank #6 interior observed with heating coil and viscous product sludge indicative of No. 6 heating oil.

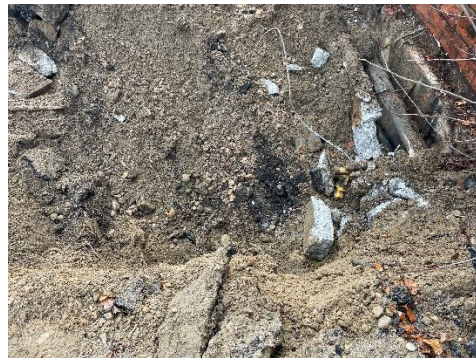
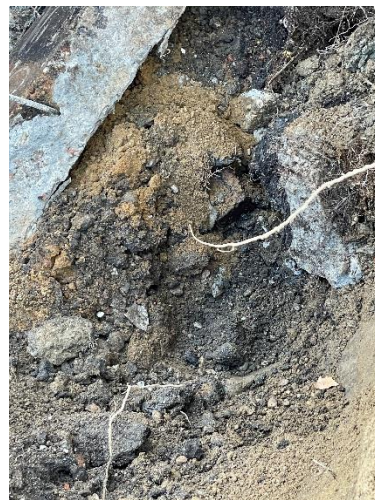
Photos 36 & 37: Black, oil-stained soil on the west end of the pipe excavation after trench removal.

Black oil-stained soil and NAPL was observed on the west and east ends of the piping excavation beneath the concrete containment trench. The oil-stained soil was observed with a petroleum odor indicative of an aged, weathered release. The stained soil is likely present from past releases from buried tank and piping systems associated with Tanks #1 and #2 (see Figure 2).

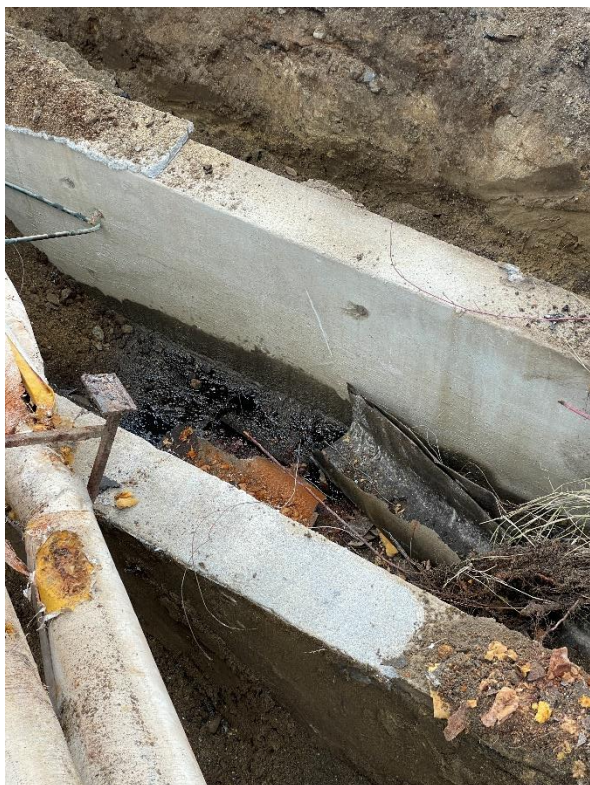
Photos 39 - 41: Accumulated oil and water mixture and debris observed in containment trench on the east end of the pipe run.

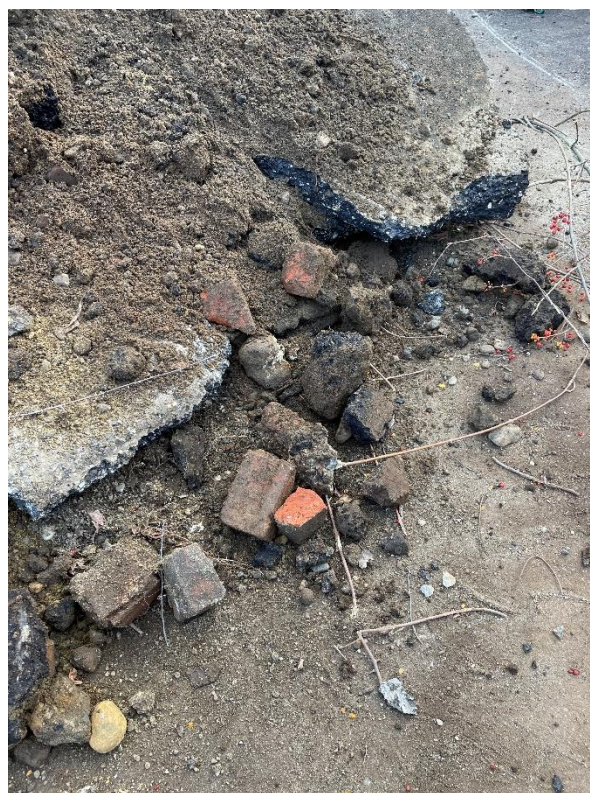
Photo 48: Evidence of buried urban fill material encountered during the pipe run excavation.
