**PHASE I ENVIRONMENTAL SITE ASSESSMENT REPORT**

Dagostino Rose Farm Property (a.k.a. Exeter Rose Farm)  
Oak Street Extension  
Exeter, New Hampshire  
NHDES # 201203003

Prepared By:  
**CREDERE ASSOCIATES, LLC**  
776 Main Street  
Westbrook, Maine 04092  
Phone: (207) 828-1272 ext. 16  
Contact: Judd R. Newcomb, CG, PG

April 23, 2012

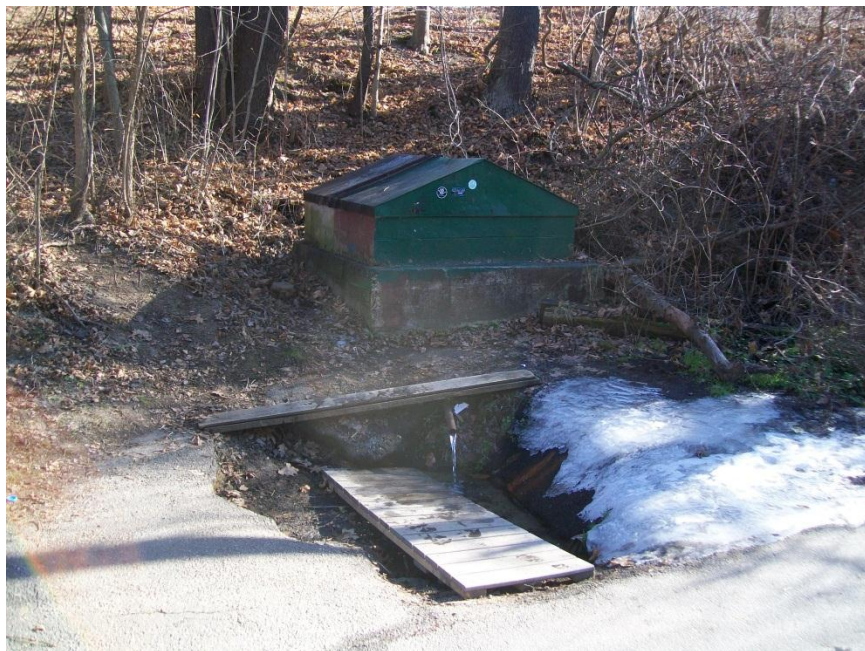
1

Drinking water is provided to the Site's permanent residences by a piping system and pump house that draws water from a natural spring located at the entrance to the Site (see **Figure 2**). The two mobile homes on the Site use water from a drilled bedrock well located near the Packing House. The Site owners reported that a defunct well was also in this area but was replaced several years ago. The defunct well is reportedly located beneath a wooden cover and tarp that was frozen to the ground and could not be opened during the Site visit. The Site owners were unsure whether it is a shallow dug well, or drilled bedrock well. The three bay garage, residential garage and Packing House are not provided with drinking water.

View of natural spring and pump house looking east at the entrance to the Site.

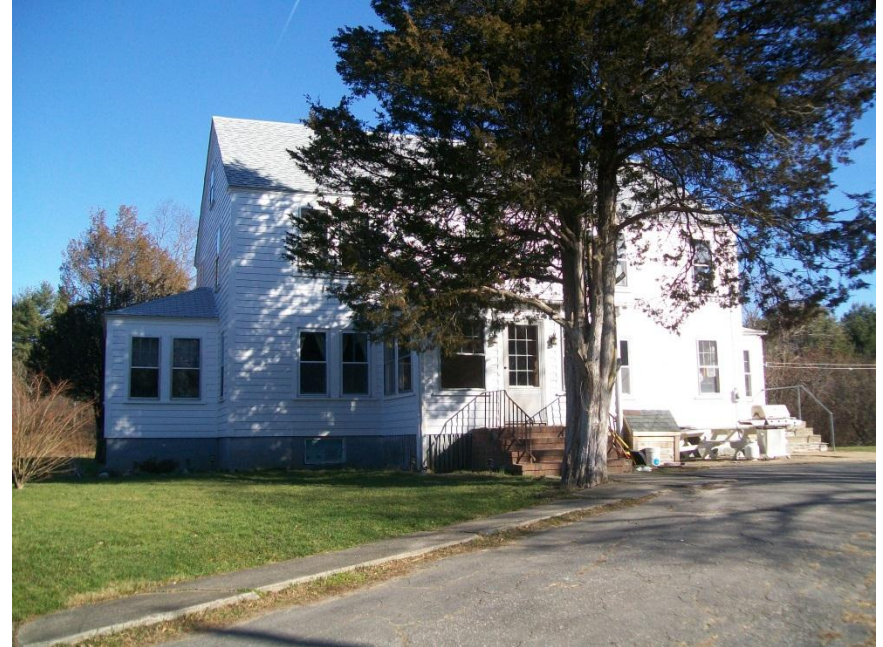
4

off into a stream valley. With the exception of brush and leaves, no dumping was observed in this area. The area to the east of #23 (**Photo 4**) and #24 (**Photo 5**) Oak Street Extension is an overgrown former field (see **Figure 2**).

View of #23 Oak Street Extension looking northeast.

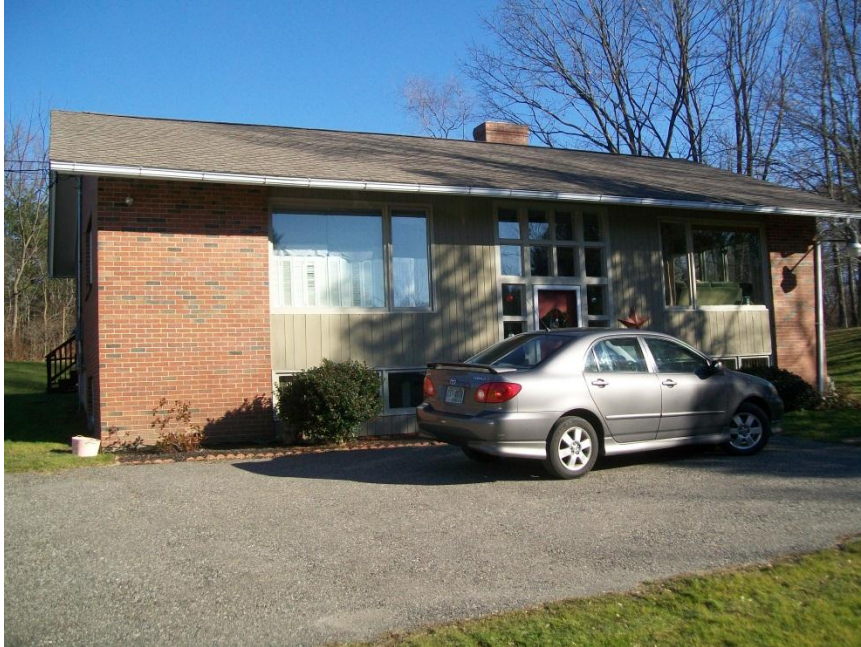
5

View of #24 Oak Street Extension looking northeast.

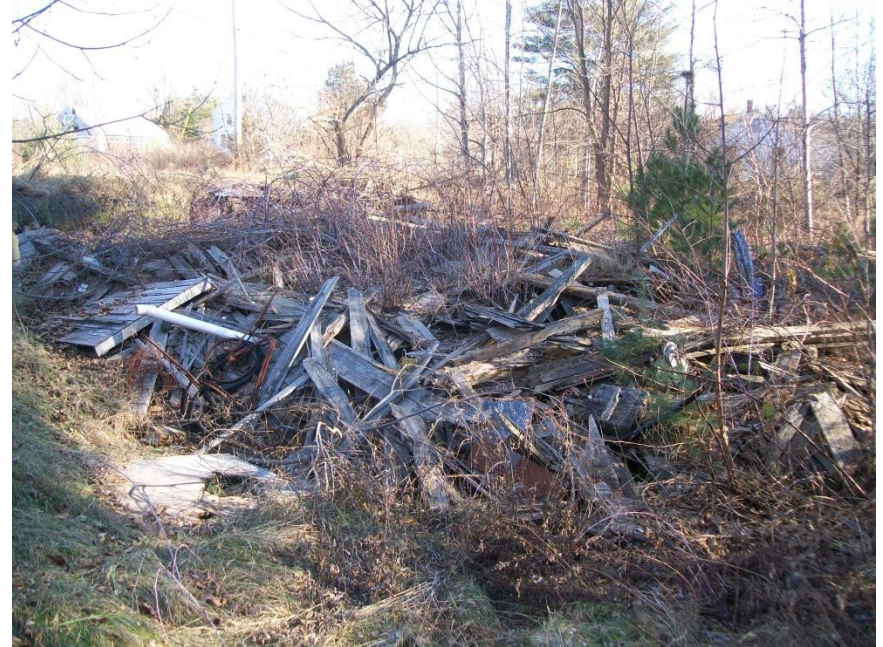
6

The former barn (**Photo 6**) and Packing House (**Photo 7**) are located along the top of slope of a stream channel. The former barn area is currently a pile of debris where the barn collapsed upon itself with whatever remnants were inside. Scrap metal, PVC pipe, and lumber were observed in the pile. The Packing House is a concrete building that was used to process roses for market. The area outside the building was overgrown and no evidence of dumping or petroleum or hazardous materials storage was observed outside the building.

View of the former barn area looking southeast.

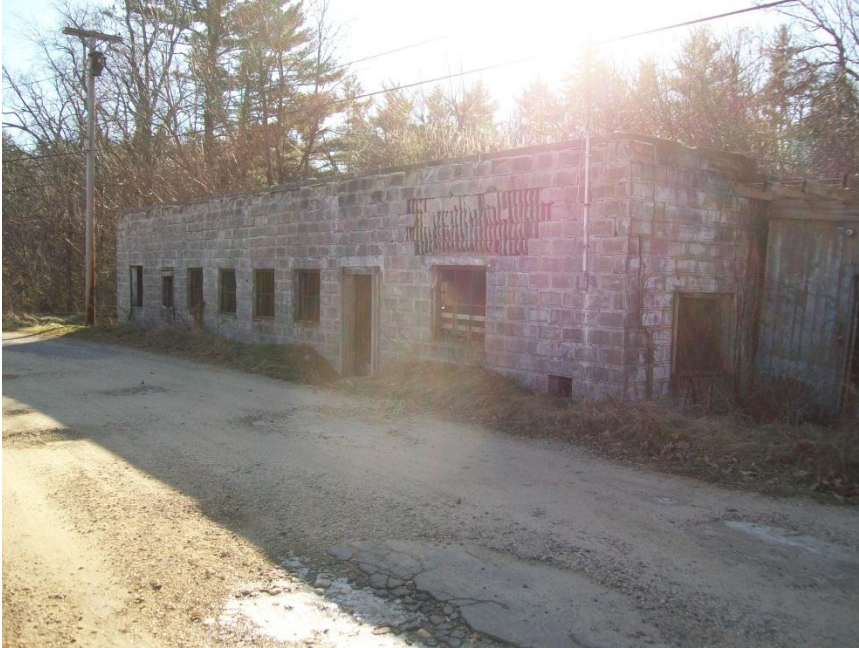
7

View of the Packing House looking south.

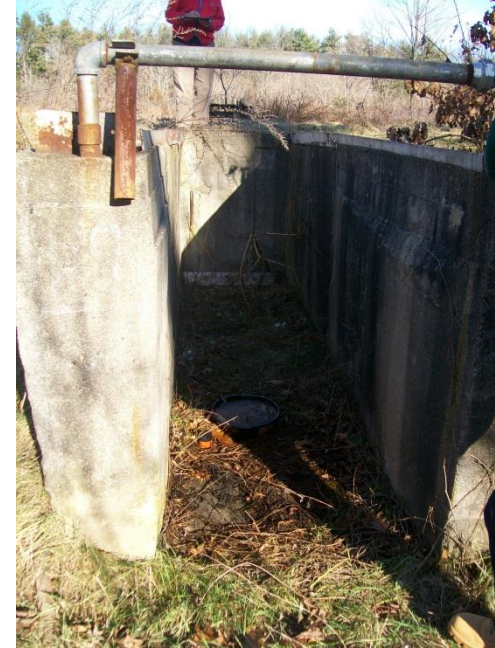
8

- REC-4 – The former use of the open-ended oil change pit represents a REC because undocumented releases of petroleum (waste oil) and associated hazardous materials may have impacted environmental media, such as soil and groundwater, in the area of the pit.

A concrete pit (**Photo 8**) was observed in the area between the former barn and Packing House. According to the owners, this was an oil change pit that was used to service the farm equipment and delivery trucks. The pit had a concrete floor that was covered in organic detritus, and was open ended such that rainwater would drain westward and out of the pit. Due to the detritus, the concrete floor was obscured; however, some oil staining could be seen when it was scraped away.

View of the oil change pit looking northeast.

- Phase II environmental site assessment (Phase II ESA) activities are recommended to confirm or dismiss the identified RECs and other conditions that may have impacted environmental media at the Site. The Phase II ESA should also include hazardous building materials surveys to identify any potential ACM, lead-based paint, or PCB-containing materials in the Site buildings.
- The dumped solid waste on the Site should be consolidated and properly disposed of during Site redevelopment. Universal or hazardous wastes that are present in these dumping areas or within the Packing House, abandoned house, and/or abandoned mobile home should also

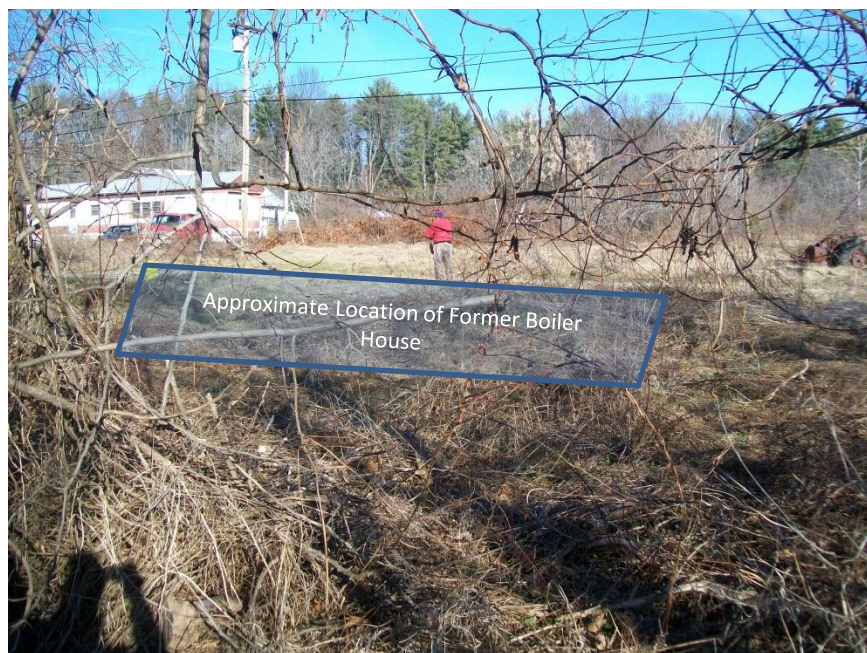
9

- REC-2 – The former presence of a Boiler House with 30,000 gallons of No. 6 fuel oil storage represents a REC because undocumented releases of petroleum or hazardous materials associated with the former operation of this facility may have occurred and impacted soil and/or groundwater in the vicinity of the building.

The former Boiler House (**Photo 9**) area is characterized by the partial concrete foundation that remains. This area is also overgrown, but holes in the concrete slab revealed some process piping and potential petroleum stained soil.

View of the former Boiler House area looking northeast.

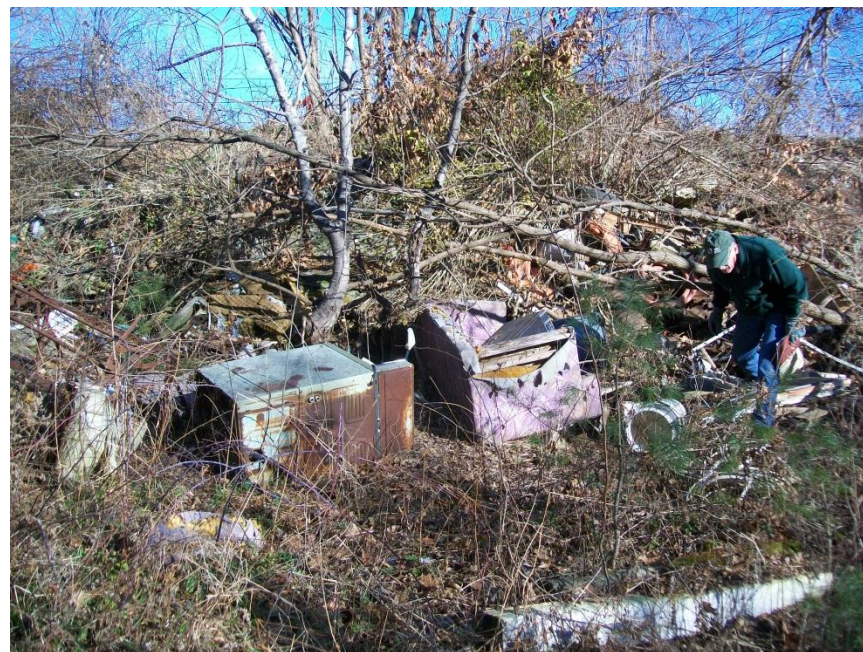
10

- REC-6 – The observed dumping of solid waste and other refuse to the west of the Packing House represents a REC because, if present, petroleum and/or hazardous materials in the waste may have impacted environmental media in its vicinity.

View of the dumping area by the Packing House looking northeast.

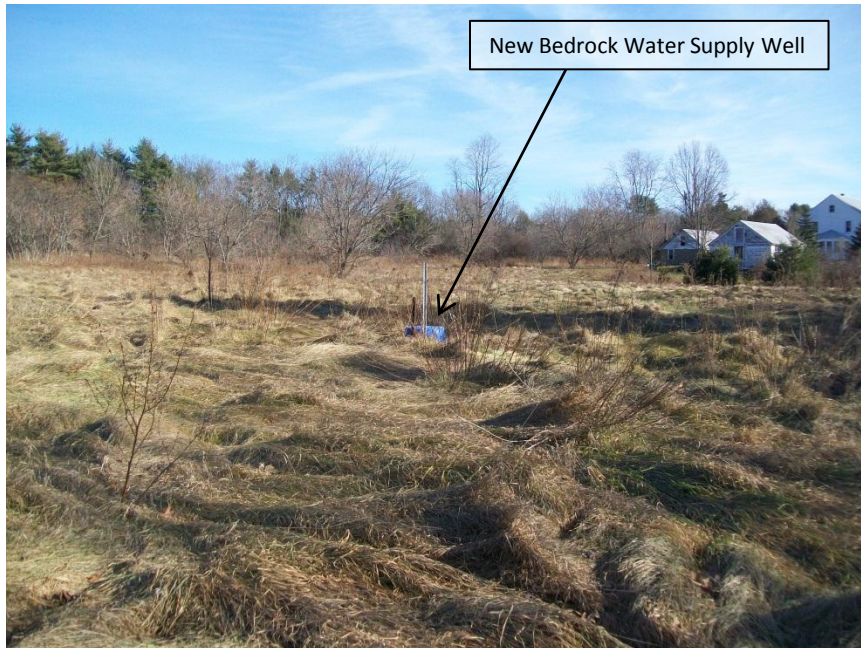
11

The greenhouse area is currently a large grassy field (**Photo 11**). Portions of the concrete floors and footings of three (3) former greenhouses were visible in the area. According to the owners, two of the greenhouses were approximately 600 feet long by 30 feet wide and the third was approximately 800 feet long by 85 feet wide. The concrete floors were noted to have concrete troughs (**Photo 12**) that were reportedly beneath the planting beds. Each of the troughs was reported to drain and collect in a piping system that subsequently discharged to the pond located downslope of the Packing House. Several drains were noted in the area, but the configuration of

View of the former greenhouse area and current field looking east.

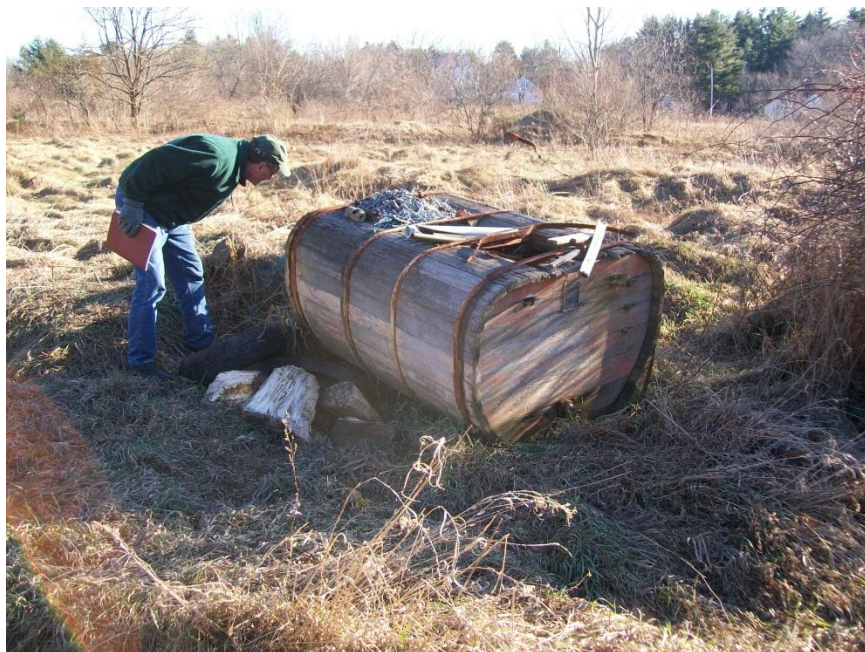
13

The area to the north and east of the former greenhouses is currently overgrown field, and was reportedly historically used as hay field. No evidence of other buildings was noted in this area. A wooden spray tank (**Photo 13**) was noted on the ground to the north of the greenhouses that was reportedly historically housed within the greenhouses and used to mix a pesticide. No evidence of environmental impact (e.g. dead vegetation, staining, etc.) was observed around the tank. A field stone wall that marks the Site property line trends from northwest to southeast in this area. A pile of used bricks, reportedly from old chimneys on the Site, was noted on top of the wall. A single empty 55-gallon steel drum was observed off of the Site in the wooded area outside the wall. The former contents of the drum could not be determined.

View of the wooden tank used to mix and apply pesticide inside the greenhouses looking southeast.

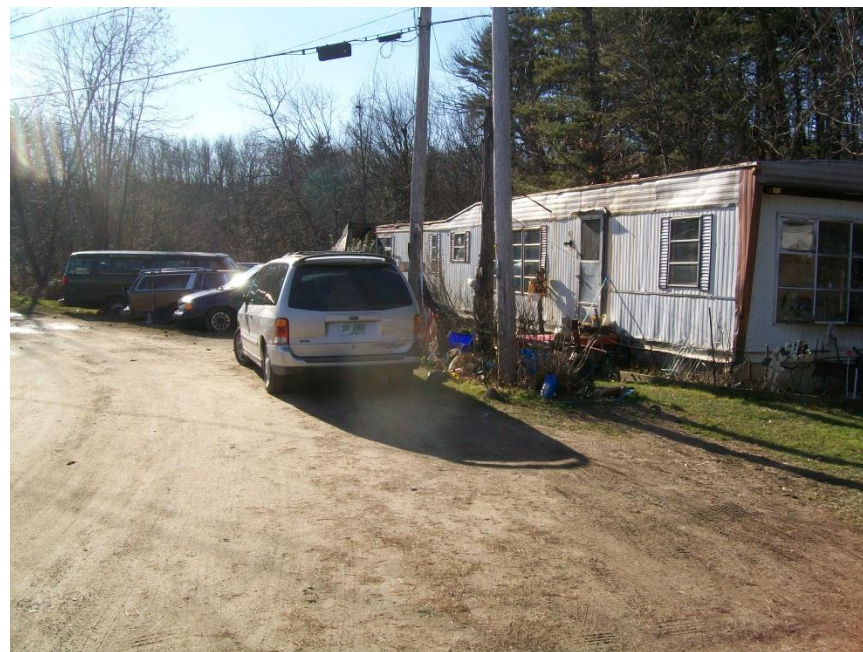
14

This mobile home (**Photo 14**) is currently occupied by a former employee of the Dagostinos'. Several junk vehicles, scrap wood and metal, and household refuse were observed around the home.

View of the mobile home located at #42 Oak Street Extension looking south.

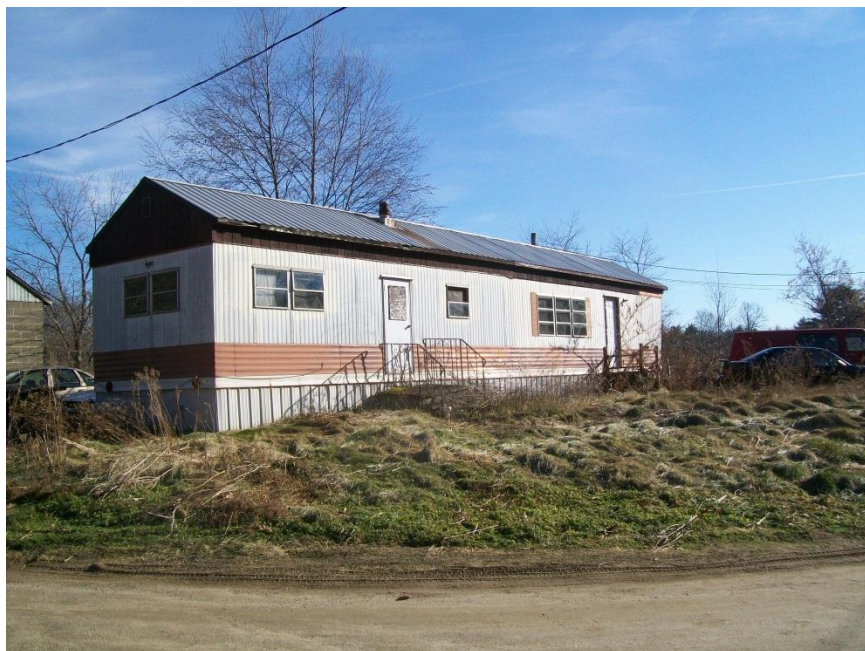
15

The abandoned mobile home (**Photo 15**) has reportedly been unoccupied since approximately 2002 and is completely empty. One (1) empty 275-gallon No. 2 fuel oil AST was observed outside and the east of the home (**Photo 16**). The fuel oil feed line entered the ground surface below the tank and appeared to trend beneath the mobile home. No evidence of leaks or spills was observed around this tank and it was reportedly drawn empty before the building was abandoned.

View of the abandoned mobile home looking southeast.

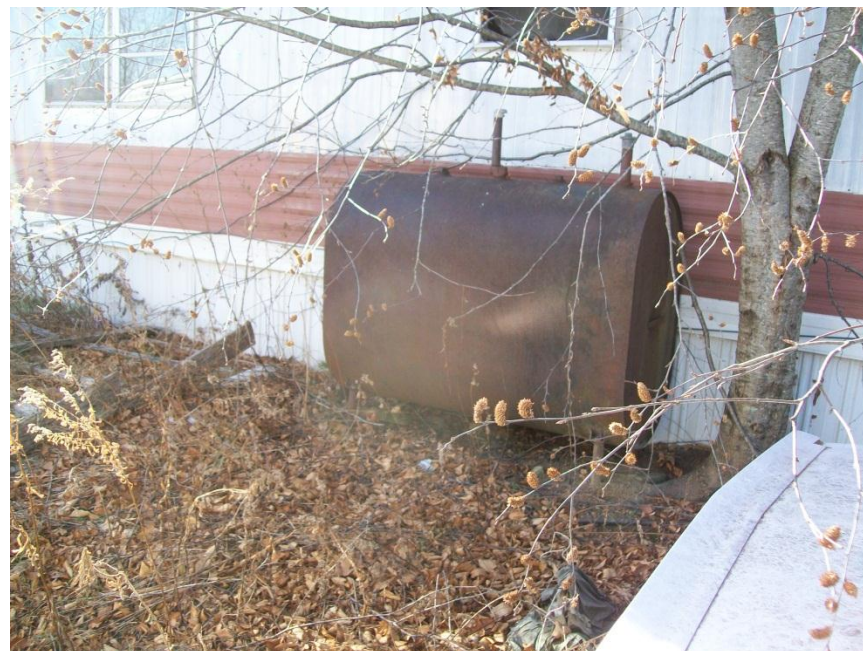
16

- REC-8 – The out-of-service 275-gallon fuel oil AST located to the rear of the abandoned mobile home represents a REC because there is a potential that undocumented leaks to have occurred from its buried supply line and impacted soil and/or groundwater in its vicinity.

View of an empty fuel oil aboveground storage tank (AST)  
located outside the southeast of the abandoned mobile home.

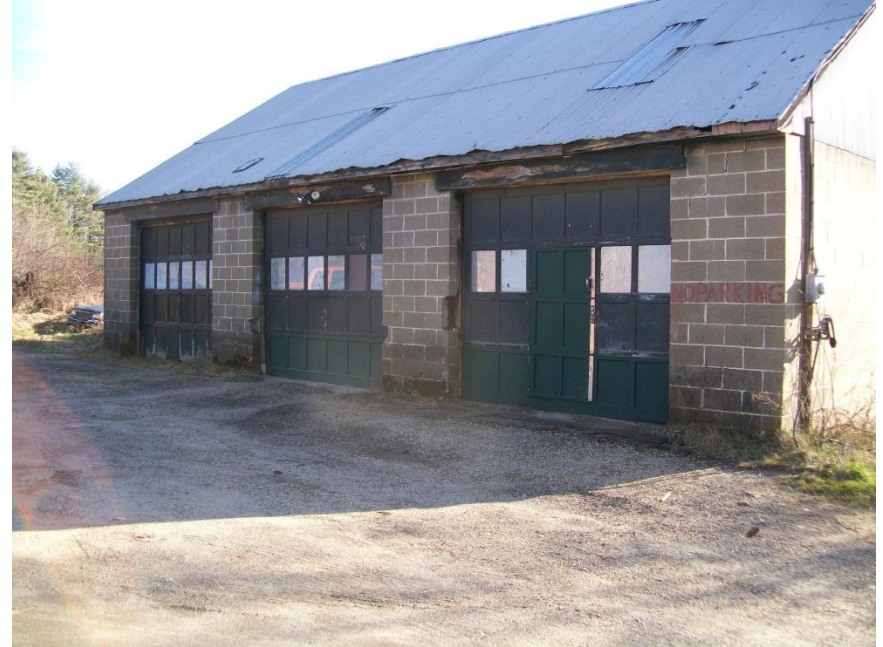
18

- REC-7 – The historical use of the three bay garage in the central portion of the Site as an automotive maintenance and/or repair facility represents a REC because undocumented releases of petroleum and/or hazardous materials used in connection with this building may have occurred and impacted environmental media in its vicinity.

The three bay garage (**Photo 18**) is a concrete block building that was historically used to store greenhouse supplies including PVC piping, plastic tubing, and planting supplies during greenhouse operations, and is currently leased by a local resident to store tools and cars. Several junk cars, tires, scrap metal, various car parts, and boats were observed to be in poorly organized piles around the building (**Photo 19**). Several 5-gallon steel containers of a solvent labeled as Lenium ES (produced by Petroferm, Incorporated) were observed beneath a pile of tires against the building. Due to their location, it could not be determined if the containers were empty or if there was any evidence of leaks or spills around the containers. Several empty canisters of vehicle air condition refrigerant were also noted in the pile. A steel vent pipe (**Photo 20**) that is typical of ASTs was observed protruding through the rear wall of the building during the Site reconnaissance. The pipe was loose and could be moved easily, so may not currently be connected to a tank. No fill pipe was observed in this area, and no evidence of petroleum leaks or spills were observed beneath the vent.

View of the three bay garage looking southeast.

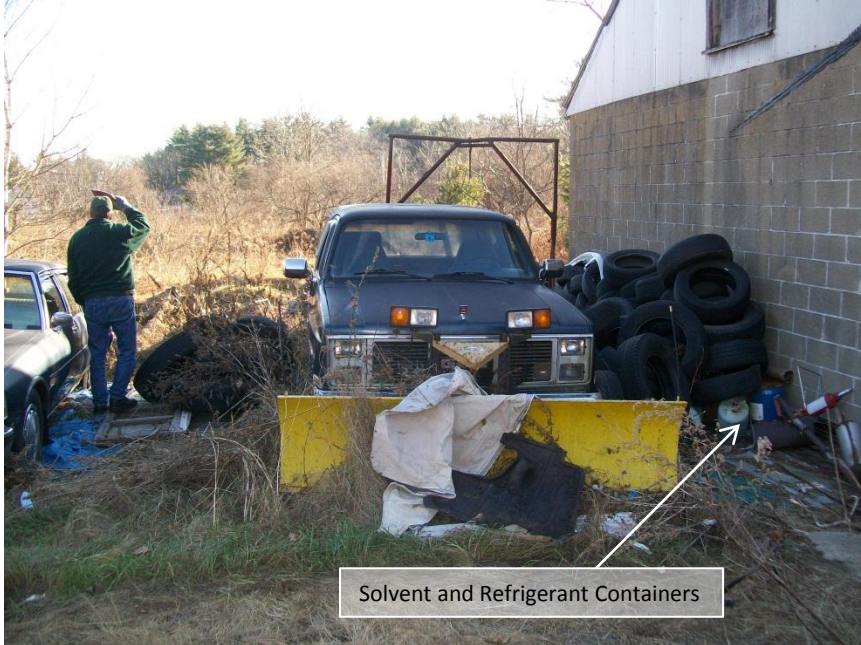
19

View of typical waste tires, car parts, and containers outside the three bay garage looking south.

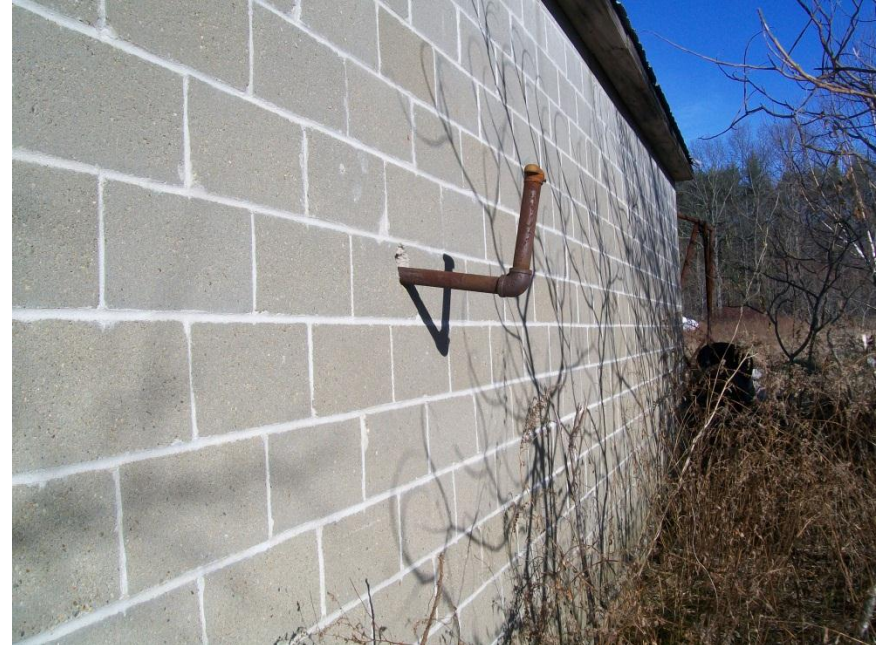
20

View of a potential AST vent pipe protruding through the rear wall of the three bay garage looking northeast.

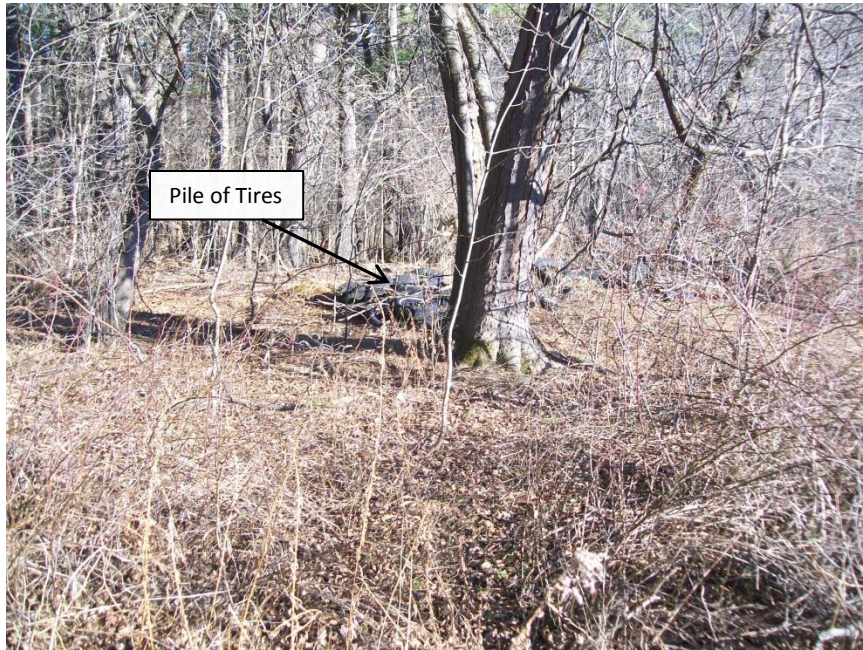
21

The area to the northeast of the three bay garage was grassy, but was uneven lumpy ground. Tires were observed scattered throughout the area and may be partially buried. A large tire dump (**Photo 21**) with at least 50 tires was also observed along the field stone wall further northeast of this area. A large, flat circular area with reduced vegetation and partially bare ground was also noted in this vicinity. The owners were not aware of any materials or items being stored in the area, but it is possible the tenant of the three bay garage had parked vehicles in the area.

View of the tire dump to northeast of three bay garage looking northeast.

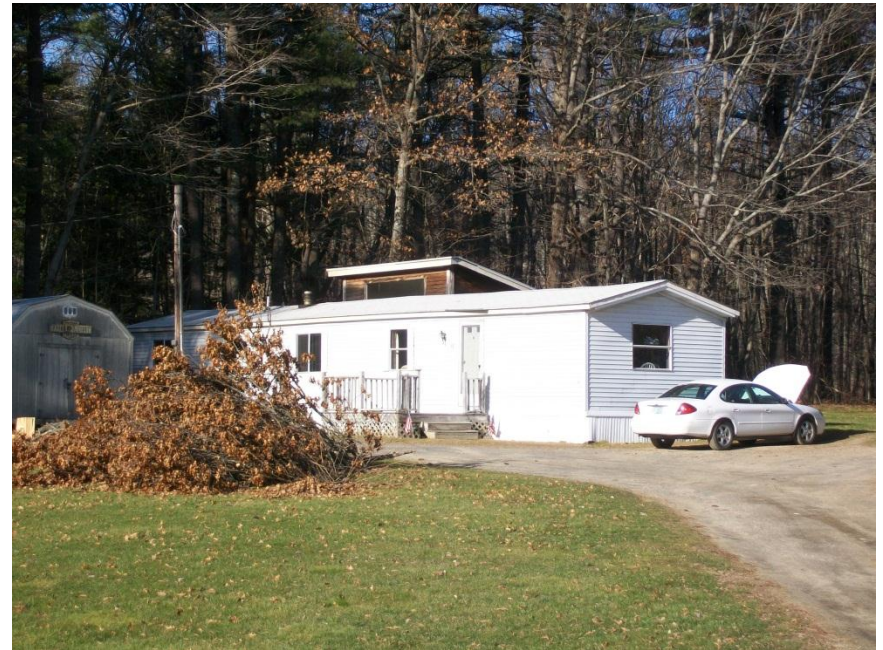
22

The area around the mobile home (**Photo 22**) located at #41 Oak Street Extension has been maintained as a yard. A small shed containing a motorcycle was located at the end of the driveway adjacent to the home. One (1) 275-gallon kerosene tank is located outside the rear of the building. No evidence of leaks or spills was observed around the tank.

View of the mobile home located at #41 Oak Street Extension looking north.

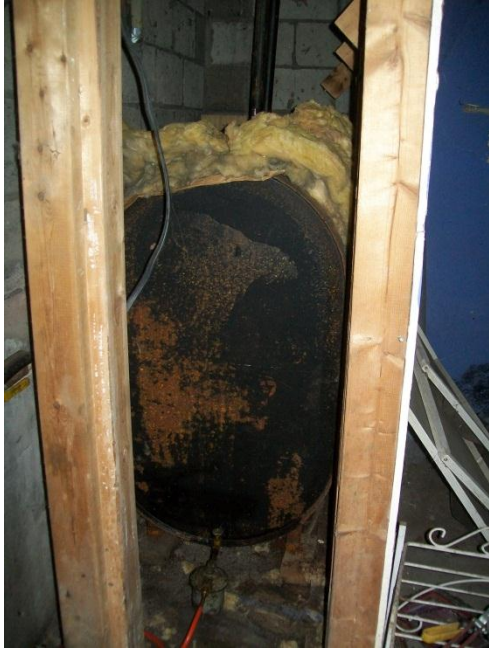
23

View of the 275-gallon fuel oil AST in basement of #4 Oak Street Extension.

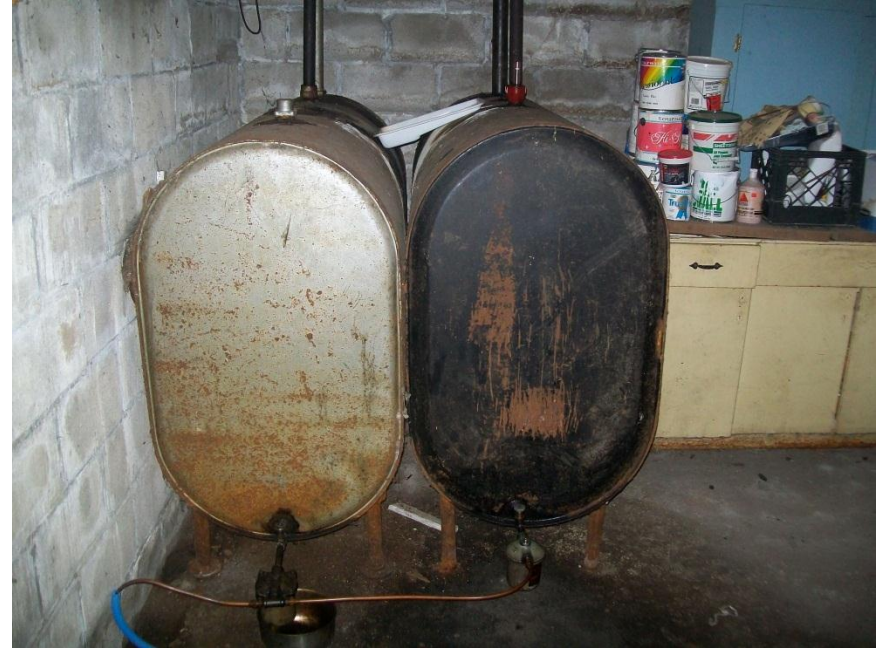
24

View of two fuel oil ASTs located in the basement of #22 Oak Street Extension. Note: slight petroleum staining on the floor likely from a surficial spill during a filter change.

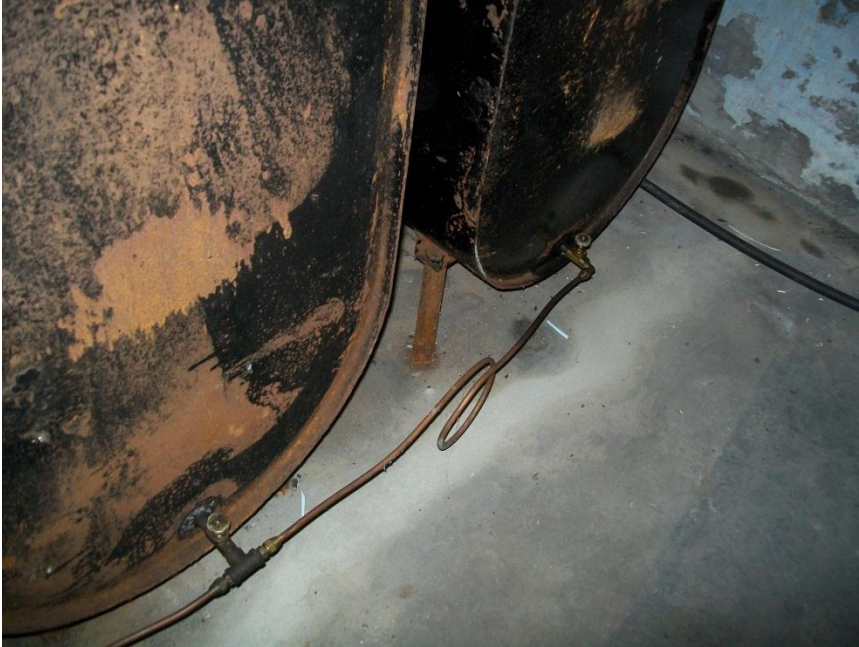
25

View of the floor around the fuel oil ASTs in the basement of #23 Oak Street Extension.
