**REPORT ON 2018 STORMWATER AND
SURFACE WATER ACTIVITIES
VOLUME I – TEXT, TABLES, FIGURES**

**Saint-Gobain Performance Plastics
701 Daniel Webster Highway
Merrimack, New Hampshire 03054
NHDES Site No.: 199712055
Project Number: 36430**

REPORT ON 2018 STORMWATER AND SURFACE WATER ACTIVITIES - VOLUME I - REPORT

*Saint-Gobain Performance Plastics
Merrimack, New Hampshire*

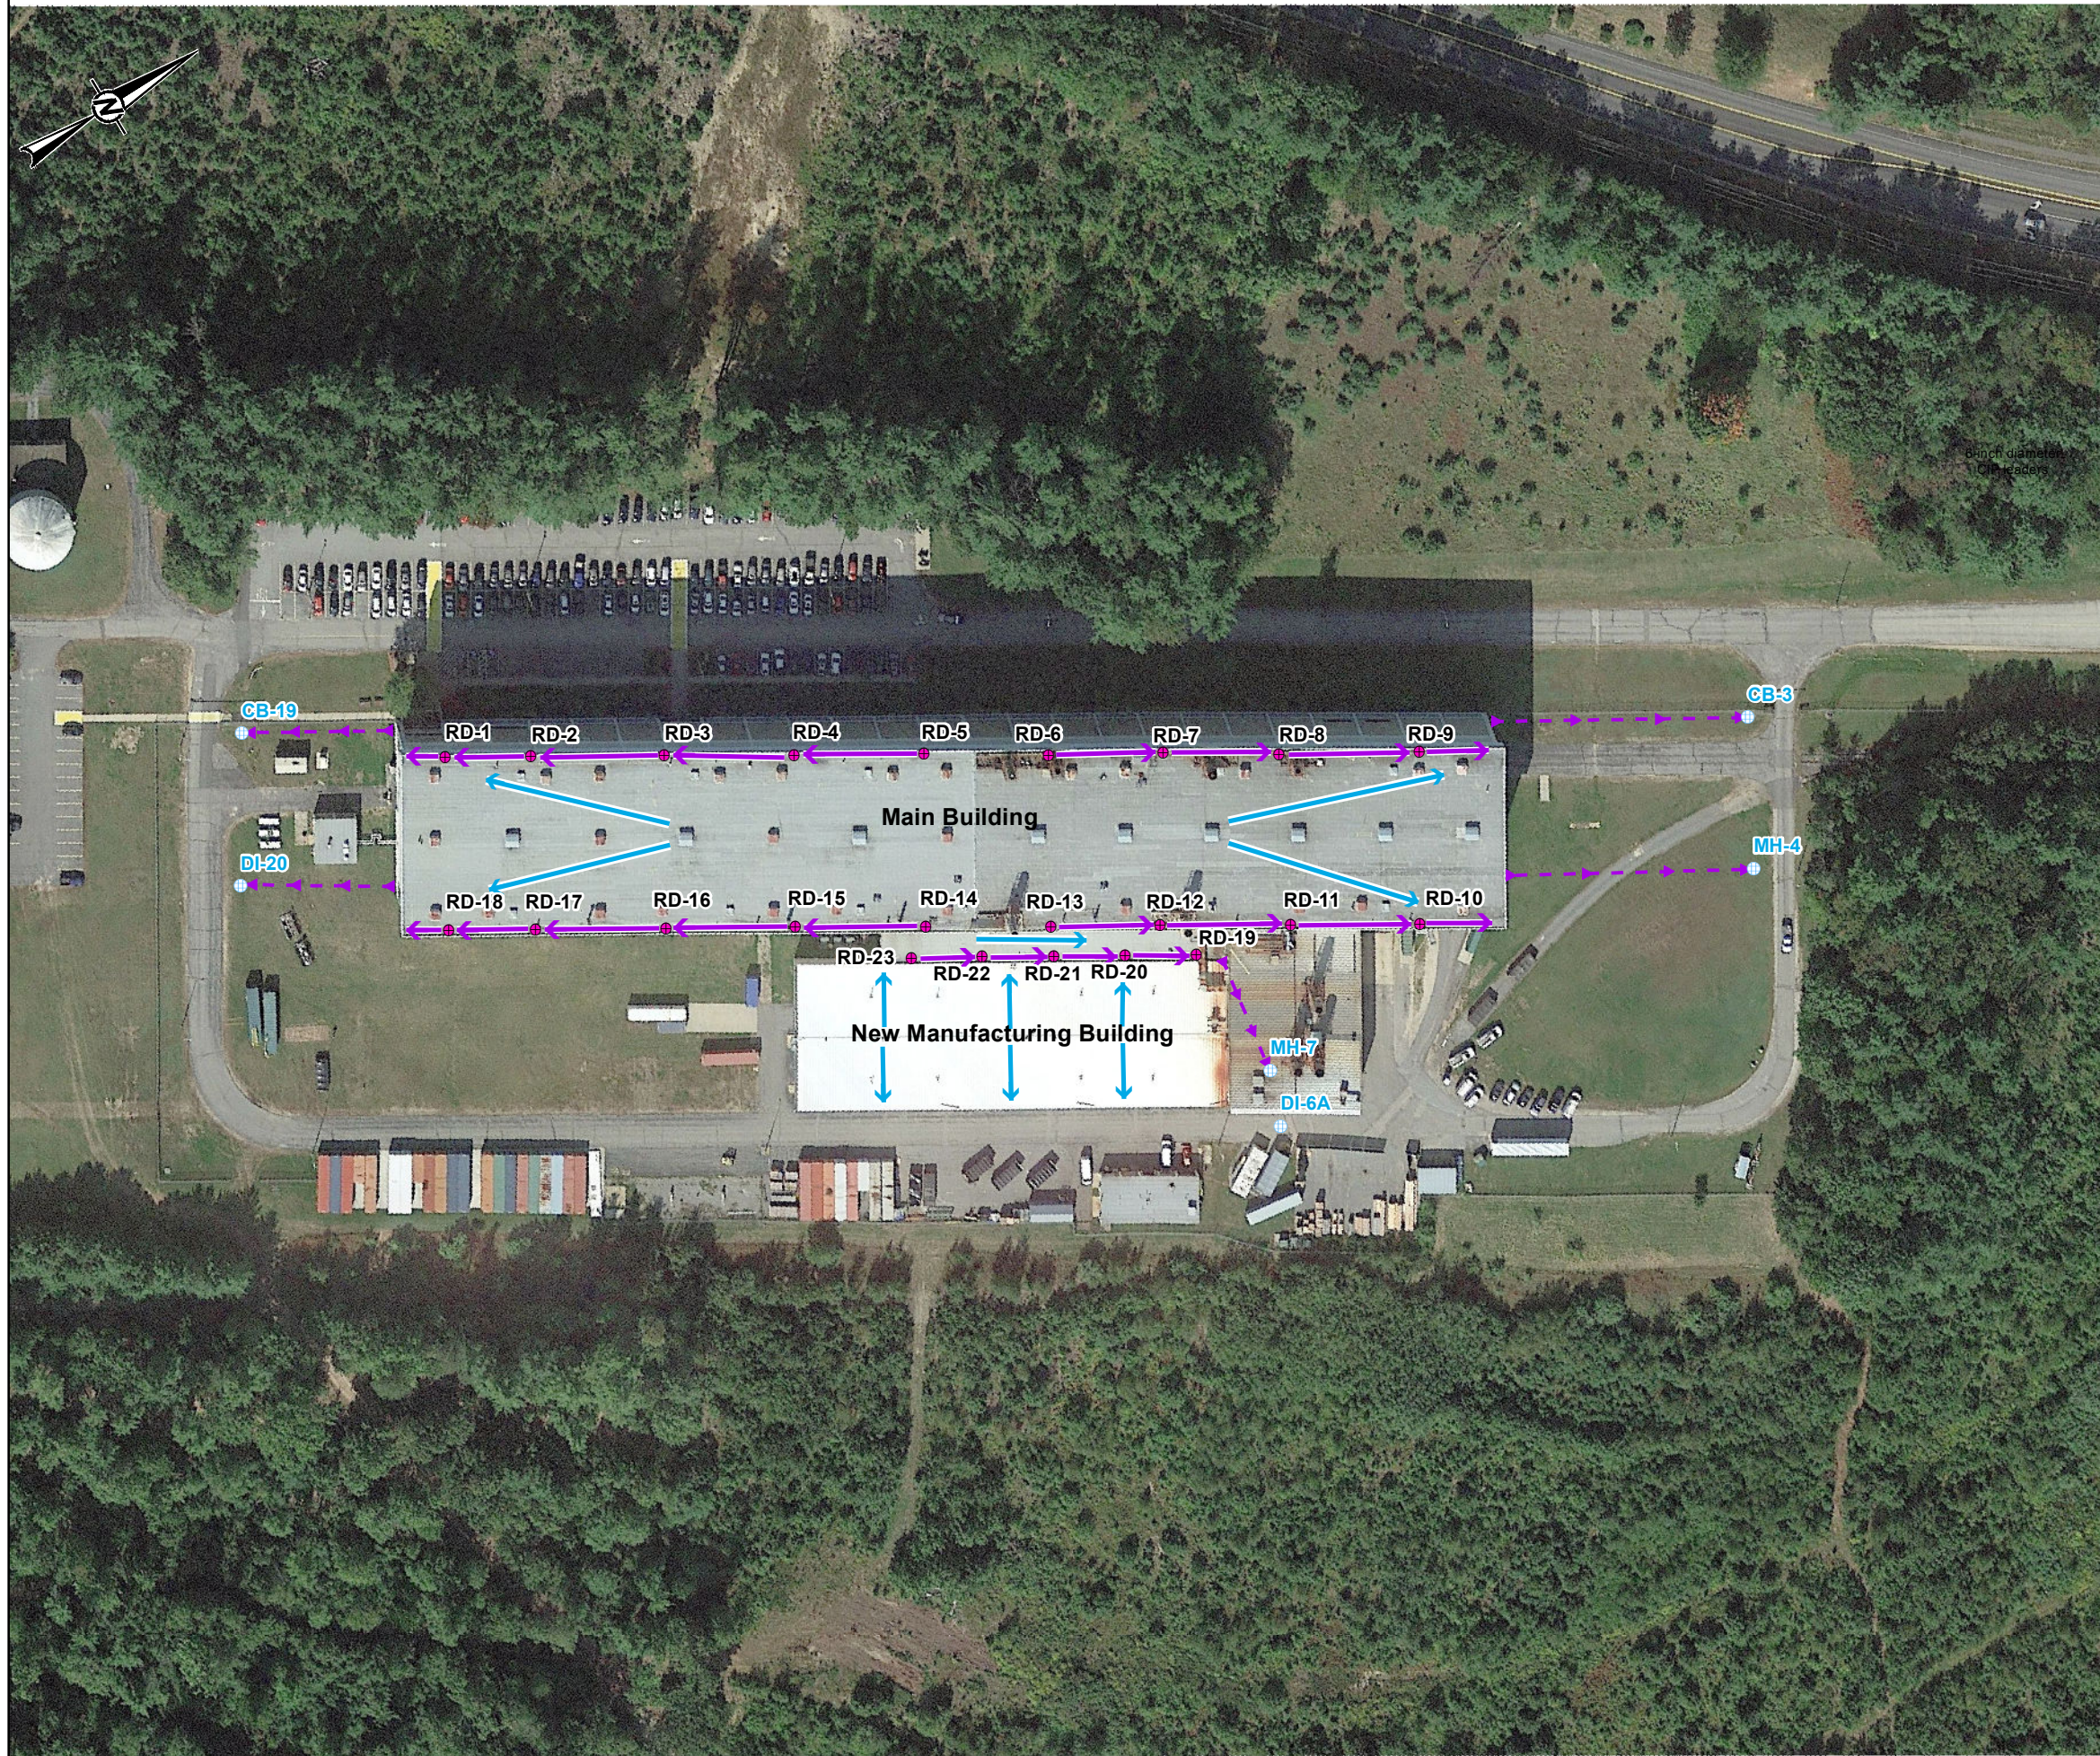
FIGURE
5

- Roof Drain Inlet
- RD-6 Stormwater catch basin
- MH-7
- ← Approximate Roof Drain Line (See Note 2)
- ← Surface Water Flow Direction
- Approximate Underground Roof Drain Line (See Note 2)

Golder subcontracted EcoClean, LLC (EcoClean) of Portland, Maine to complete a push-camera survey and cleaning of the main building roof drain system. Golder did not complete a camera survey or cleaning of the New Manufacturing Building roof drain system because materials/debris were not observed during 2017 activities. EcoClean performed a pre-cleaning camera survey of the roof drain system on April 23, 2018 and performed the roof drain cleaning and post-cleaning camera survey on May 17 and 21, 2018. Roof drain camera survey videos are included in Appendix B-1 (pre-cleaning) and Appendix B-2 (post-cleaning). The layout of the roof drain system is depicted in Figure 5.
