Coakley Landfill Community Update

March 3, 2021

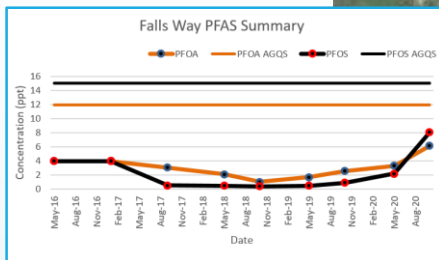
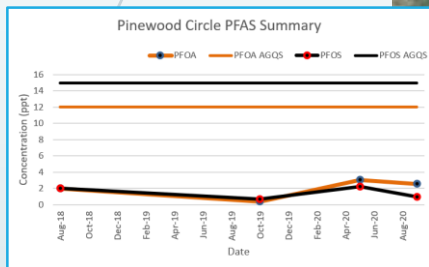
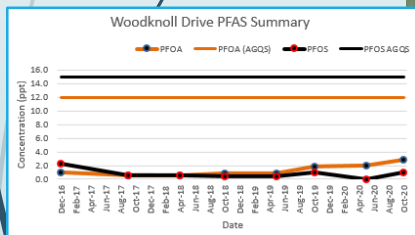
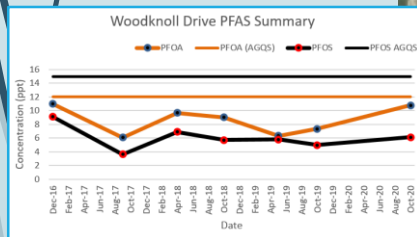
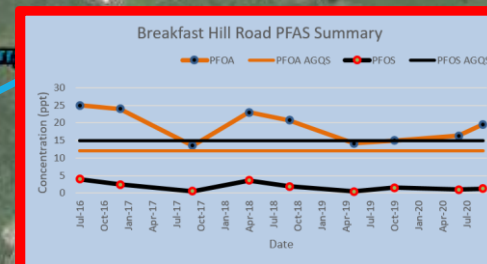
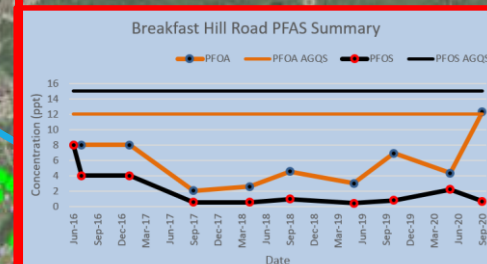
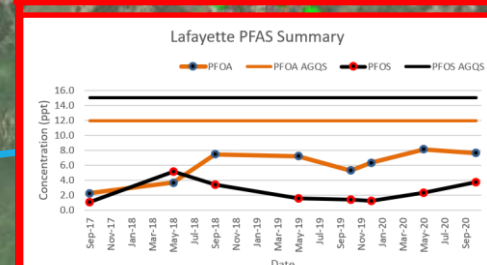
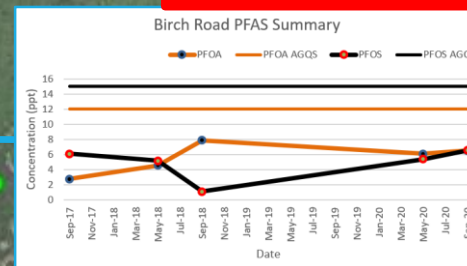
PFAS Summary Private Wells

Private wells
sampled biannually

● PFOA
 — PFOA AGQS
 ● PFOS
 — PFOS AGQS

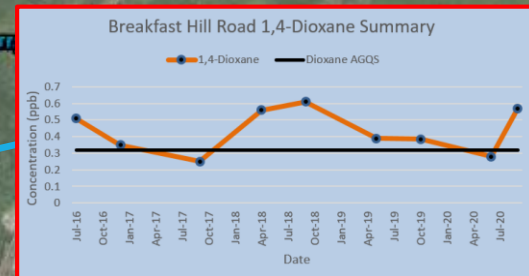
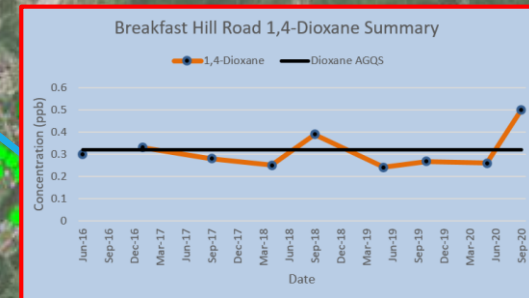
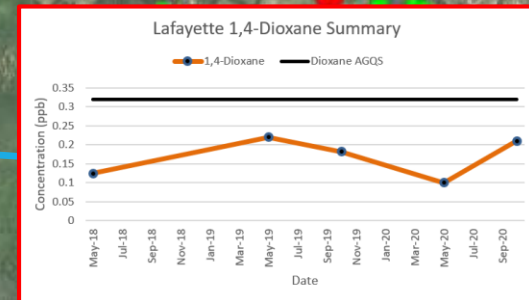
1,4-Dioxane in Private Wells

Private wells
sampled biannually

● 1,4-Dioxane — 1,4-Dioxane AGQS

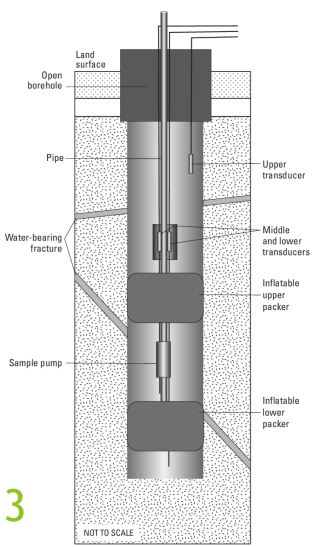
- MW-20/MW-21/MW-22
- 6 New Nested Bedrock Wells Constructed - 2019

Straddle Packer Diagram taken from Design and Operation of a Borehole Straddle Pack for Ground-Water Sampling and Hydraulic Testing of Discrete Intervals at U.S. Air Force Plant 6, Marietta, Georgia, (Halloway and Wadell, 2008)

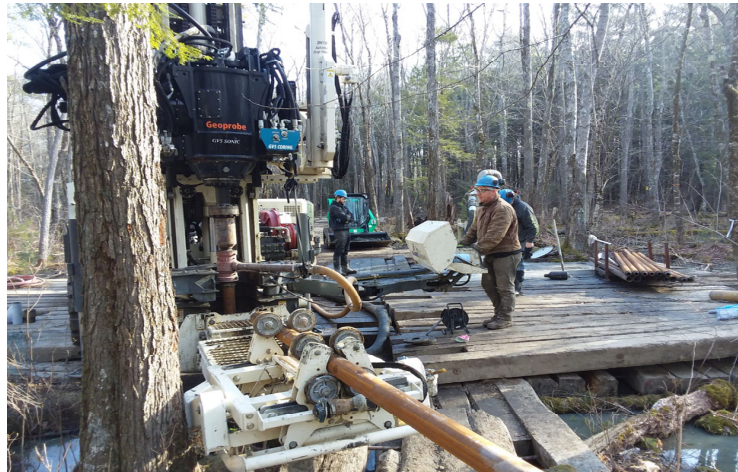
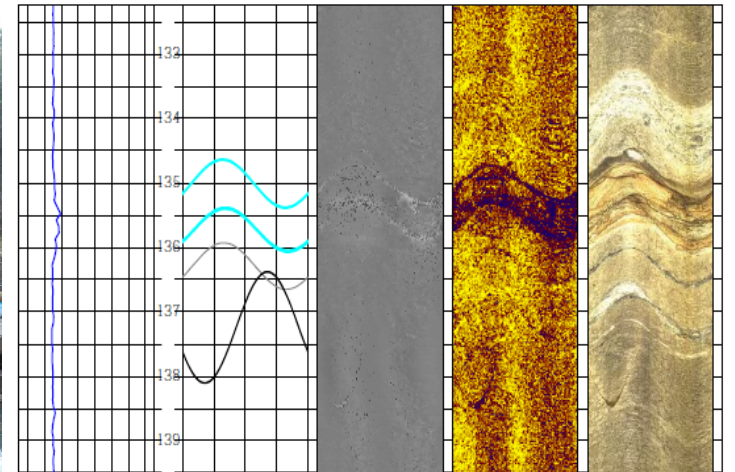
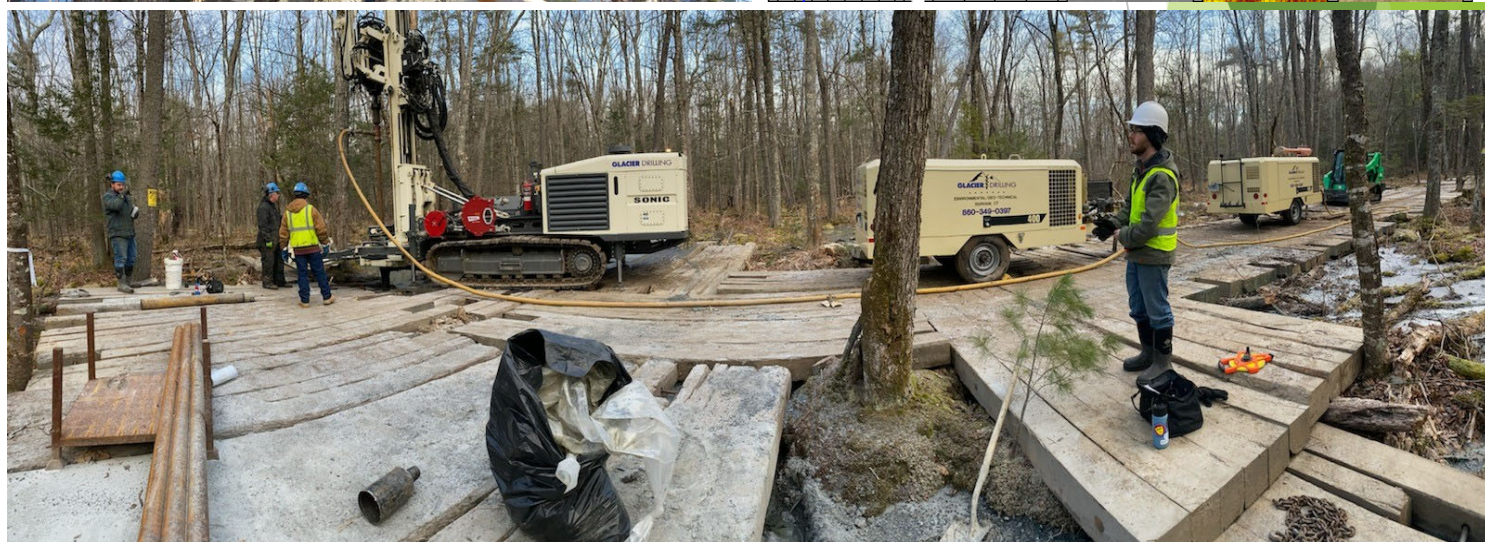
New Boring Completion (MW-25)

- Data Gap
 - Southern Migration
- Surface Geophysics
- Access Agreements
 - NHDOT
- BMPs
- Drilling
- Borehole Geophysics
- Interval Packer Sampling*
- Well Construction*

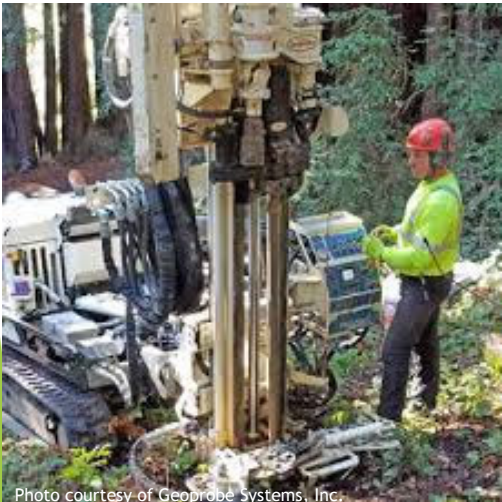
- Data Gap
 - Overburden Groundwater
- 11 Locations Completed
- 10 Total GW Samples
- Definition of GMZ Western Boundary

Photo courtesy of Geoprobe Systems, Inc.

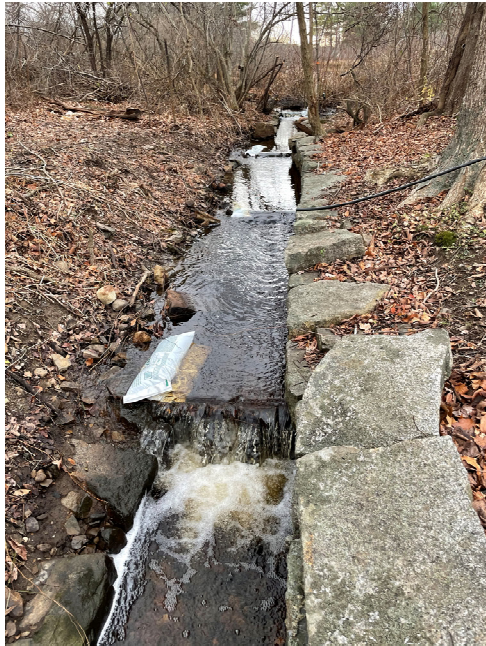
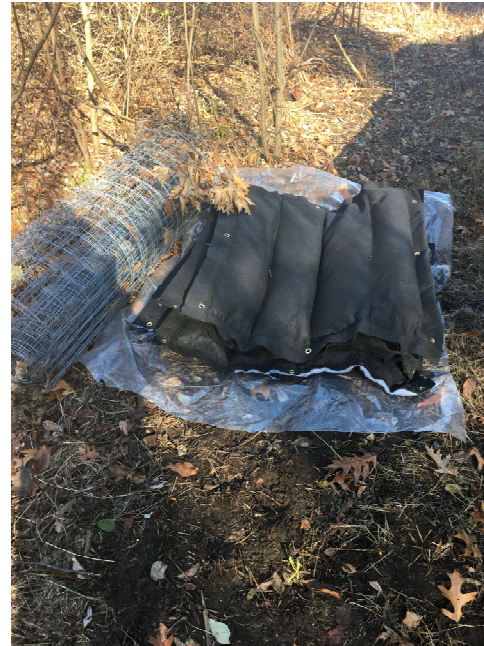
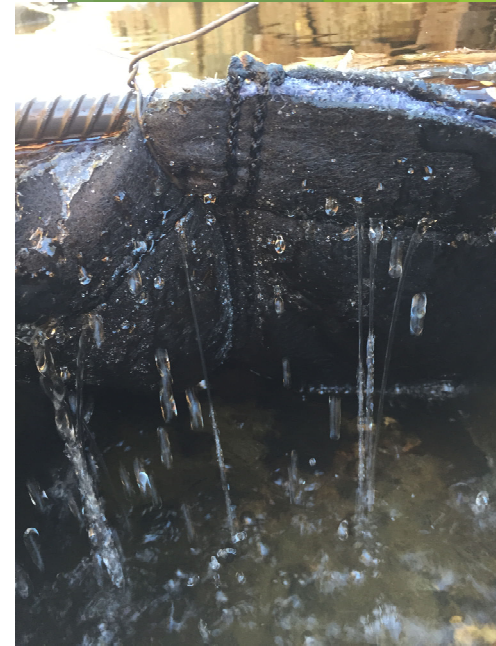
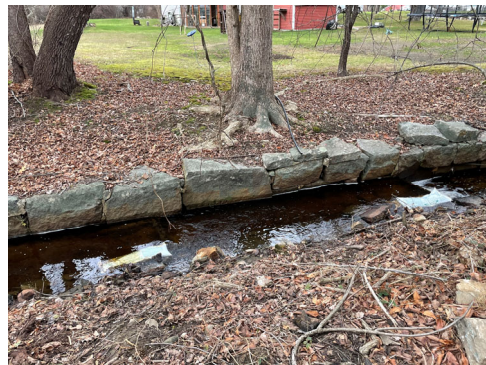
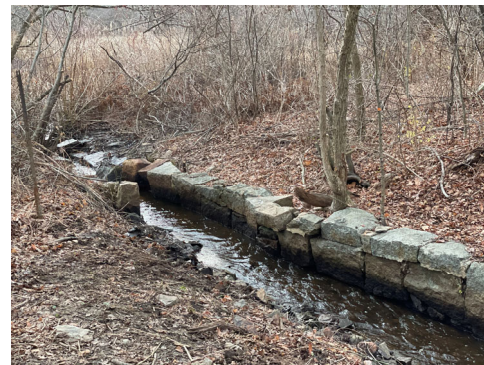
Surface Water Treatment

- Remedy Options
 - Modifications
- Site Preparation
 - Flow Restoration
 - Channel
- Inter-agency Effort
 - USEPA
 - NHDES
 - NHDOT
 - USDA
- Deployment/Sampling
- Evaluation
