## CAMPERS WORK TO PROTECT OSSIPEE LAKE AT CAMP ROBIN HOOD, FREEDOM, NH

### BACKGROUND

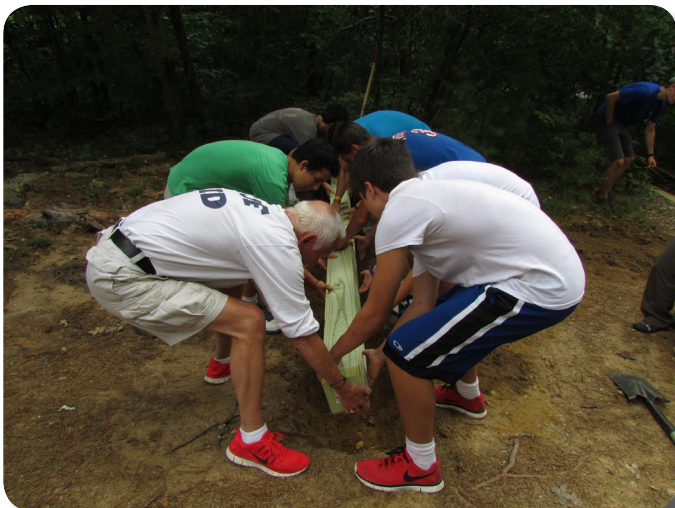
Many hands make light work to install the timbers for the water bars.

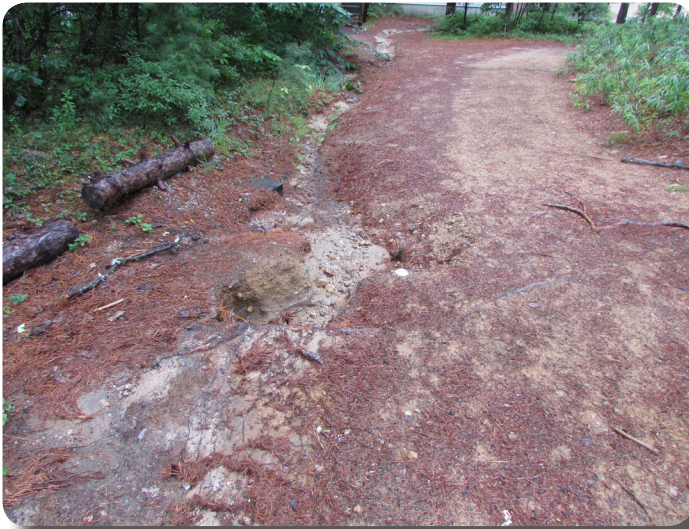
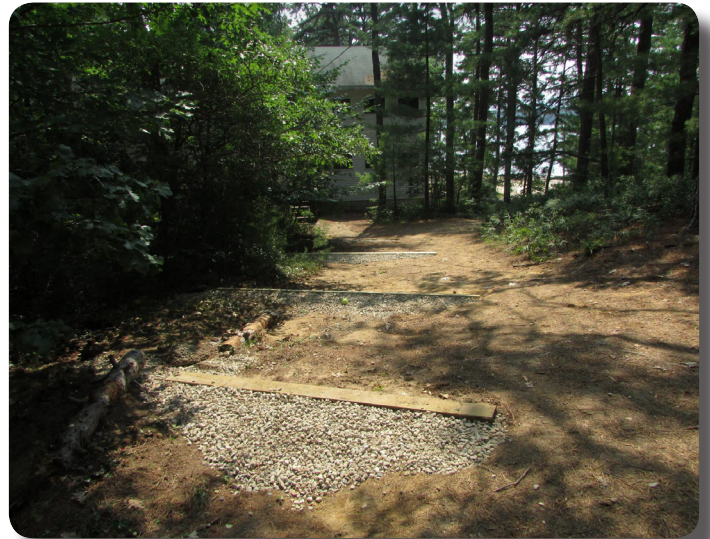
The photo on the left shows the walking path with a large eroded gully caused by stormwater runoff during heavy rain storms. The photo on the right shows the same path with the water bars installed and the gully repaired.

To stabilize the gully and prevent further erosion, the DES SOAK team designed a series of water bars along the upper portion of the path and a set of infiltration steps along a sleeping cabin closer to the beach. With a little background on how the project would benefit the lake and a few instructions, the campers went to work digging trenches, setting timbers, and shoveling drainage stone. Now, as runoff makes it way down the path, the water bars trap the runoff. Water soaks into the drainage stone and is directed to a wooded area next to the path, where it is soaked up by soil and plants.

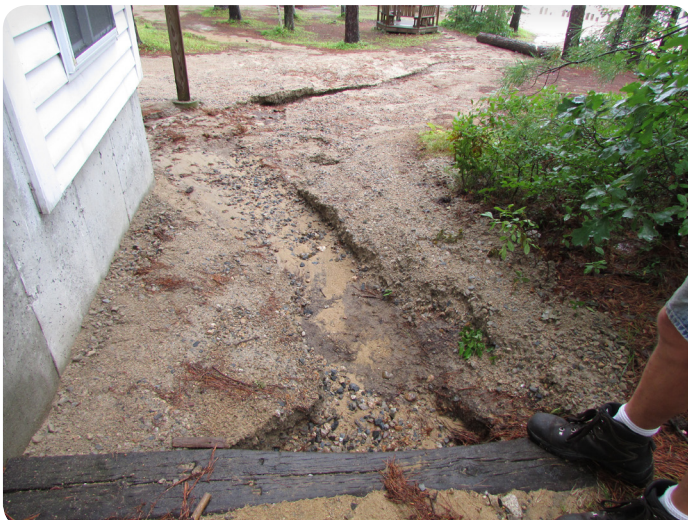
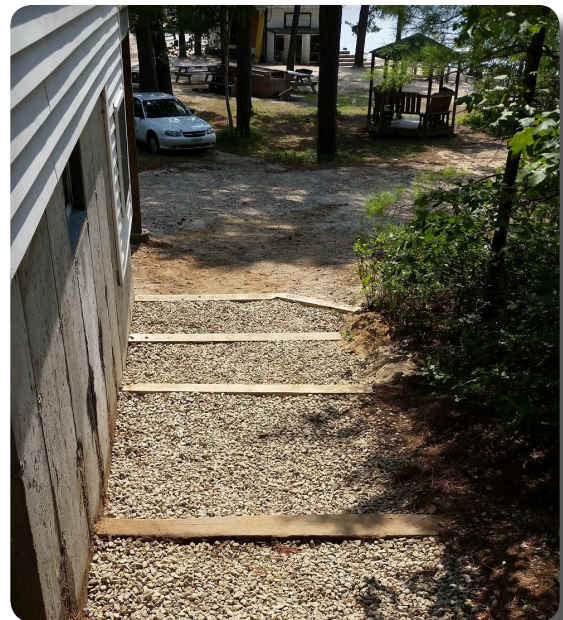
The photo on the left shows erosion from the steps before replacing them with infiltration steps. You can see that the erosion makes its way to the lake in the distance. The photo on the right shows the finished infiltration steps and repaired gully.

Further on down the hill and adjacent to a sleeping cabin, an existing set of steps were retrofitted with infiltration steps. Campers removed compacted soil and hard pack from the existing steps and replaced it with drainage stone. The hard pack material was used to fill in and repair the gullies that had formed. Below the new infiltration steps, several hard working campers worked tirelessly to build two new steps. These too were filled in with drainage stone. Now, as the stormwater runoff makes its way to the steps, it gets traps in the drainage stone and soaks into the ground. As each step receives more water than it can drain, the water spills over to the next step and so on.
