## Camp Cody Youth & Water Bars Protect Lake Health

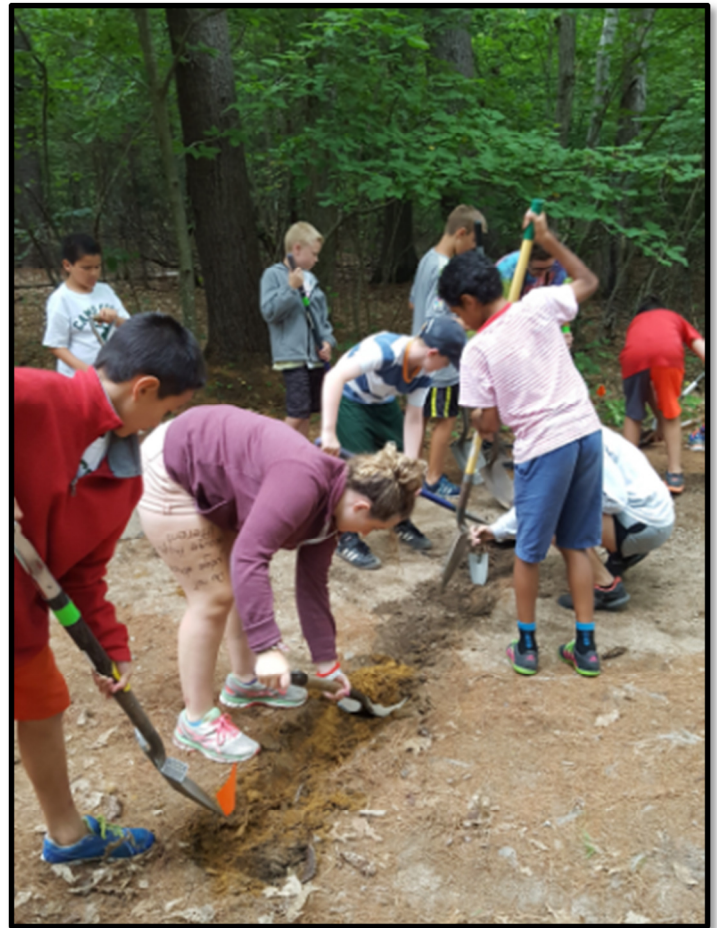
Camp Cody campers and counselors digging a trench for one of the two water bars installed to prevent runoff from entering Ossipee Lake.

maintenance department by sandwiching strips of used conveyor belt material between two pieces of lumber. Then the bars were installed by hard-working groups of campers and counselors taking turn digging trenches, fitting the bars in place, and hauling stone to backfill the bars.

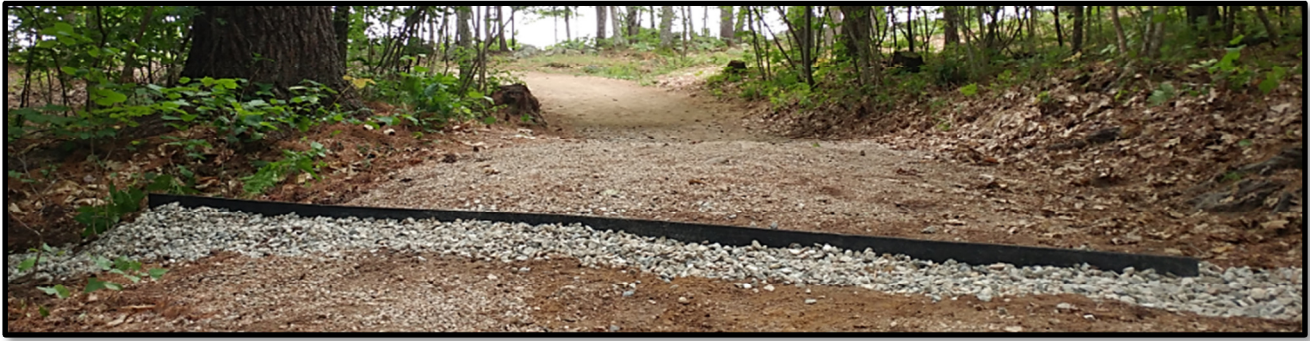
The water bar's flexible rubber material allows bikes, golf carts, and trucks to drive over it, bending back into place to stop the flow of water down the path toward Ossipee Lake

The result was exactly what was needed to help address the erosion issue: two water bars installed along a well-used path to the lake. Water flowing down the path hits the water bars and is directed off the path into the vegetation. This prevents the water from continuing down the path toward Ossipee Lake. This in turn helps prevent sand, sediment, and nutrients from entering the lake protecting the clean, clear water enjoyed by the campers and wildlife.
