Balmoral Improvement Association Landscaping for Water Quality

Location: 255 Paradise Drive, Moultonborough, NH

Project Summary:

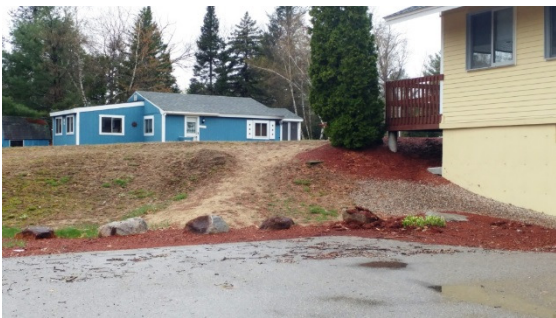
Recommendation F: Restrict access or create defined access on the slope behind the clubhouse. The slope behind the clubhouse from the side yard to the driveway turn-around area at the southern corner (on the left when viewed from behind the club house) is exposed and eroding. Consider installing infiltration steps to create defined access or planting the slope heavily to eliminate use of the hill as a pathway.

Eroded pathway from side area to back parking lot
Date: 5/2/17

Cathy Neal, Landscape Horticulture Specialist with UNH Cooperative Extension, provided a planting plan for the site. Infiltration steps were installed, and the slope planted with hardy and drought tolerant species.

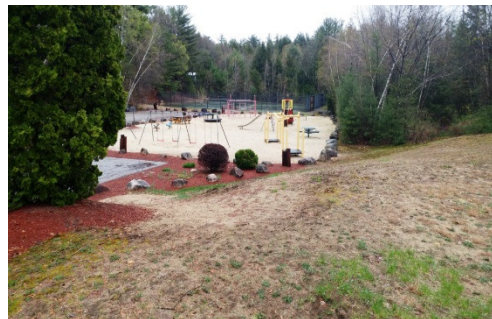
Eroding slope. Date: 5/2/17

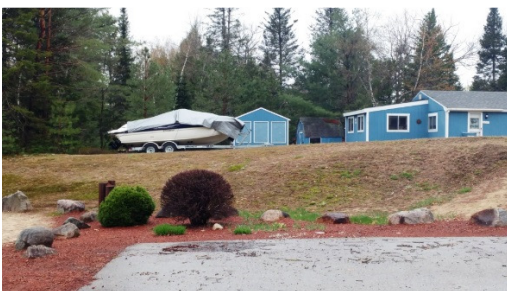
Bare slope. 5/2/17
