Road Management Plan for Brackett and Pond Roads, Wakefield, NH

Prepared by
The University of New Hampshire Stormwater Center

Prepared with Support from NH Department of Environmental
Services
May 2011

Province Lake Road Management Plan Implementation Phase I

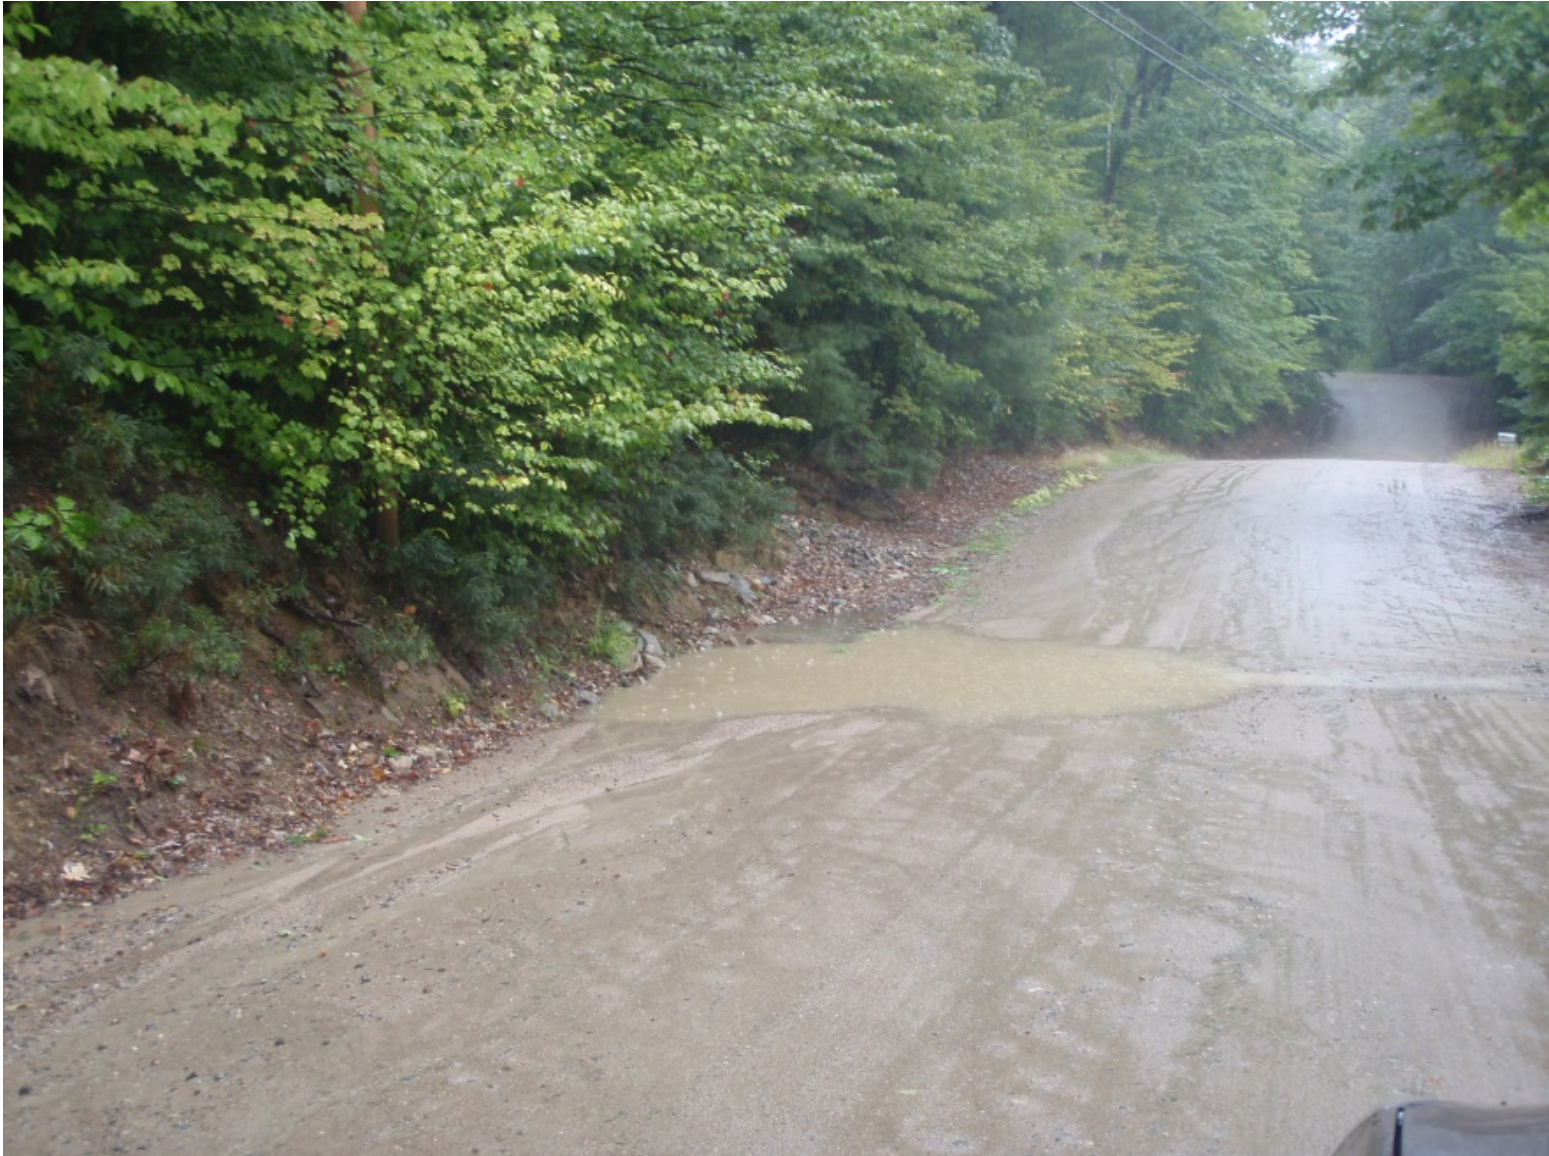
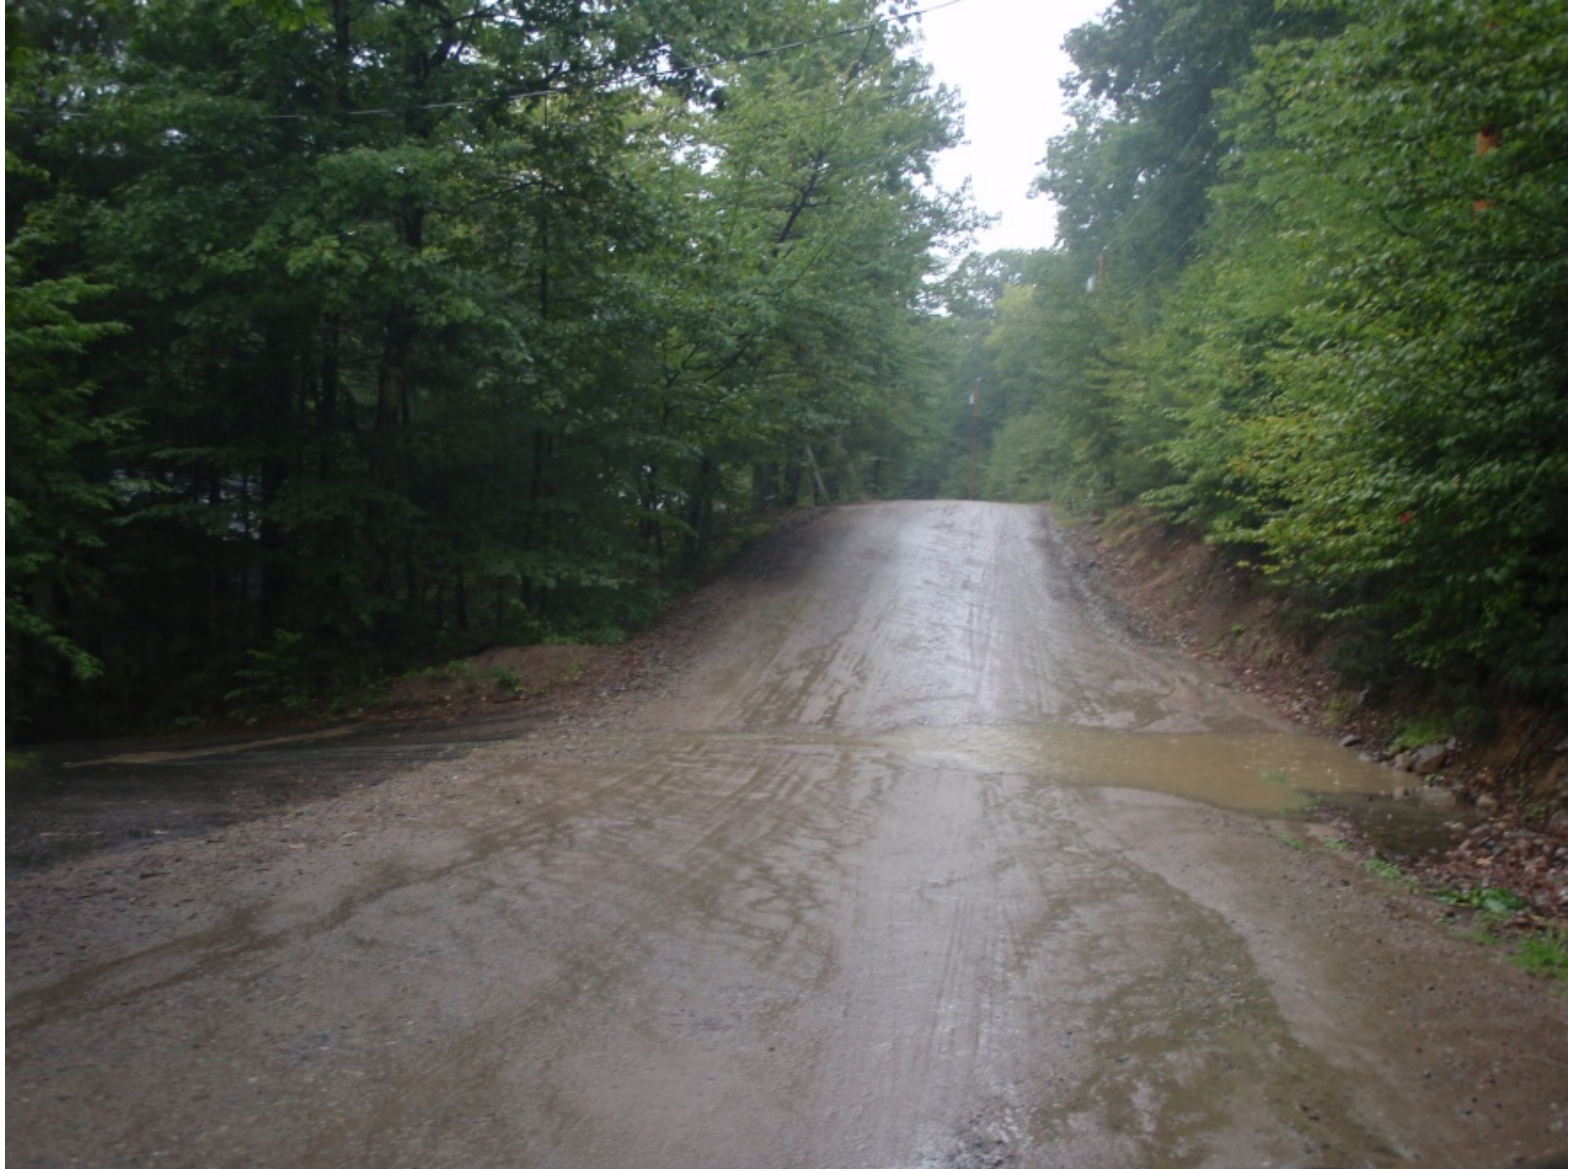
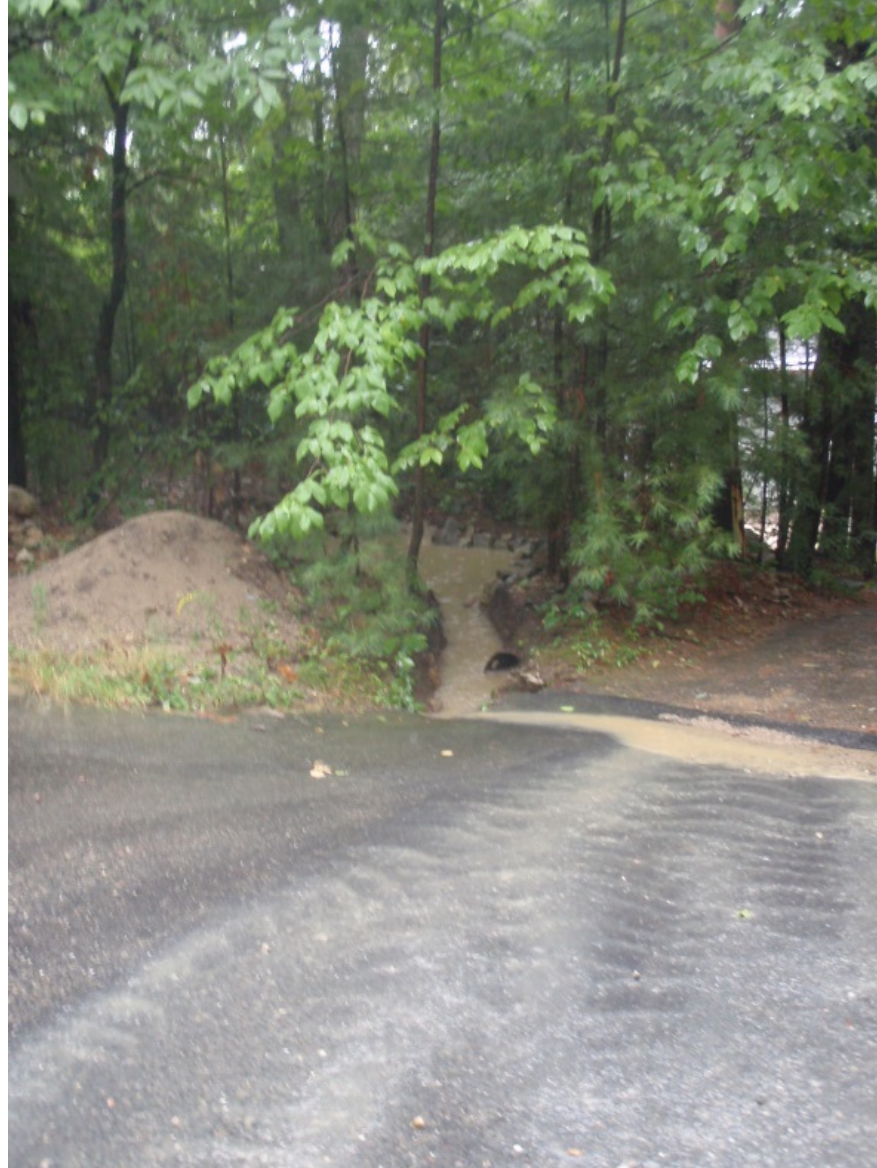
Examples – BR008 Existing

#BR007	32,000	32,000 ft2	Swale to Lovell Lake	Steep > 15%	8,291	1,174	7,118	86%	\$ 1,905.00
#BR008	6,500	6,500 ft2	Swale Along Side of 726 Brackett Road	Moderate to Steep	1,684	238	1,446	86%	\$ 3,923.57

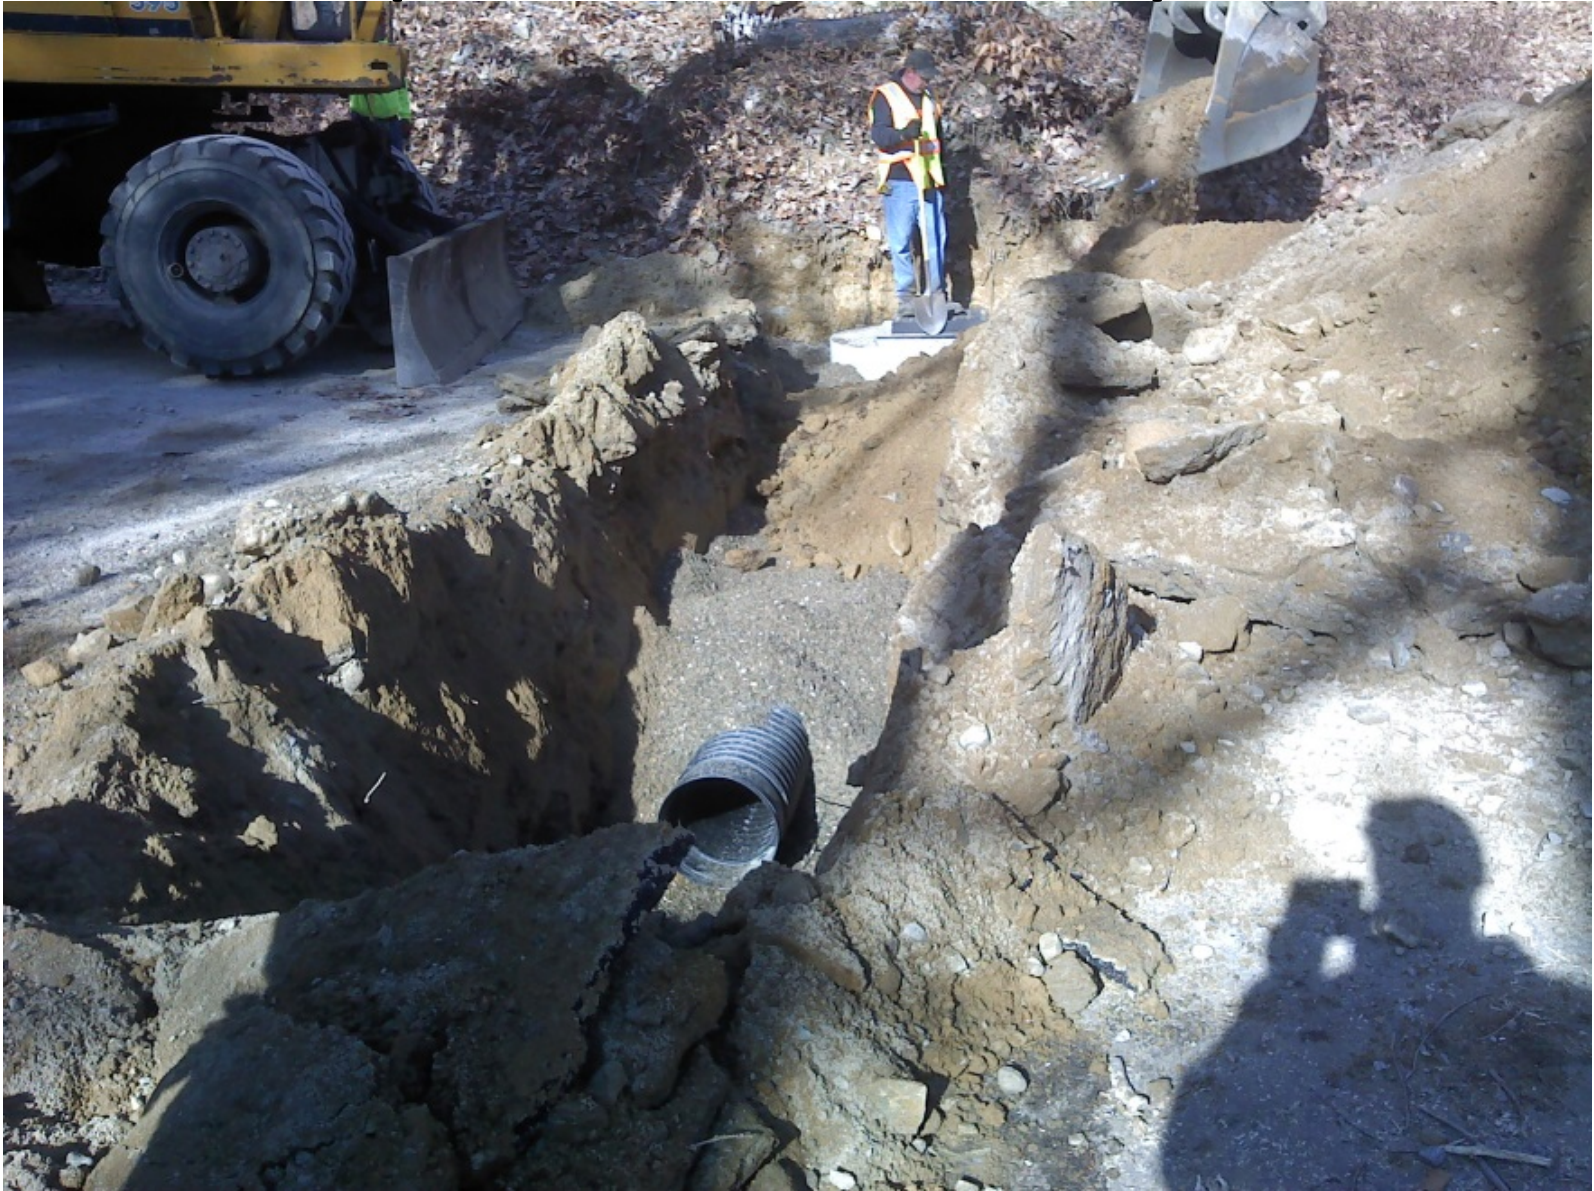
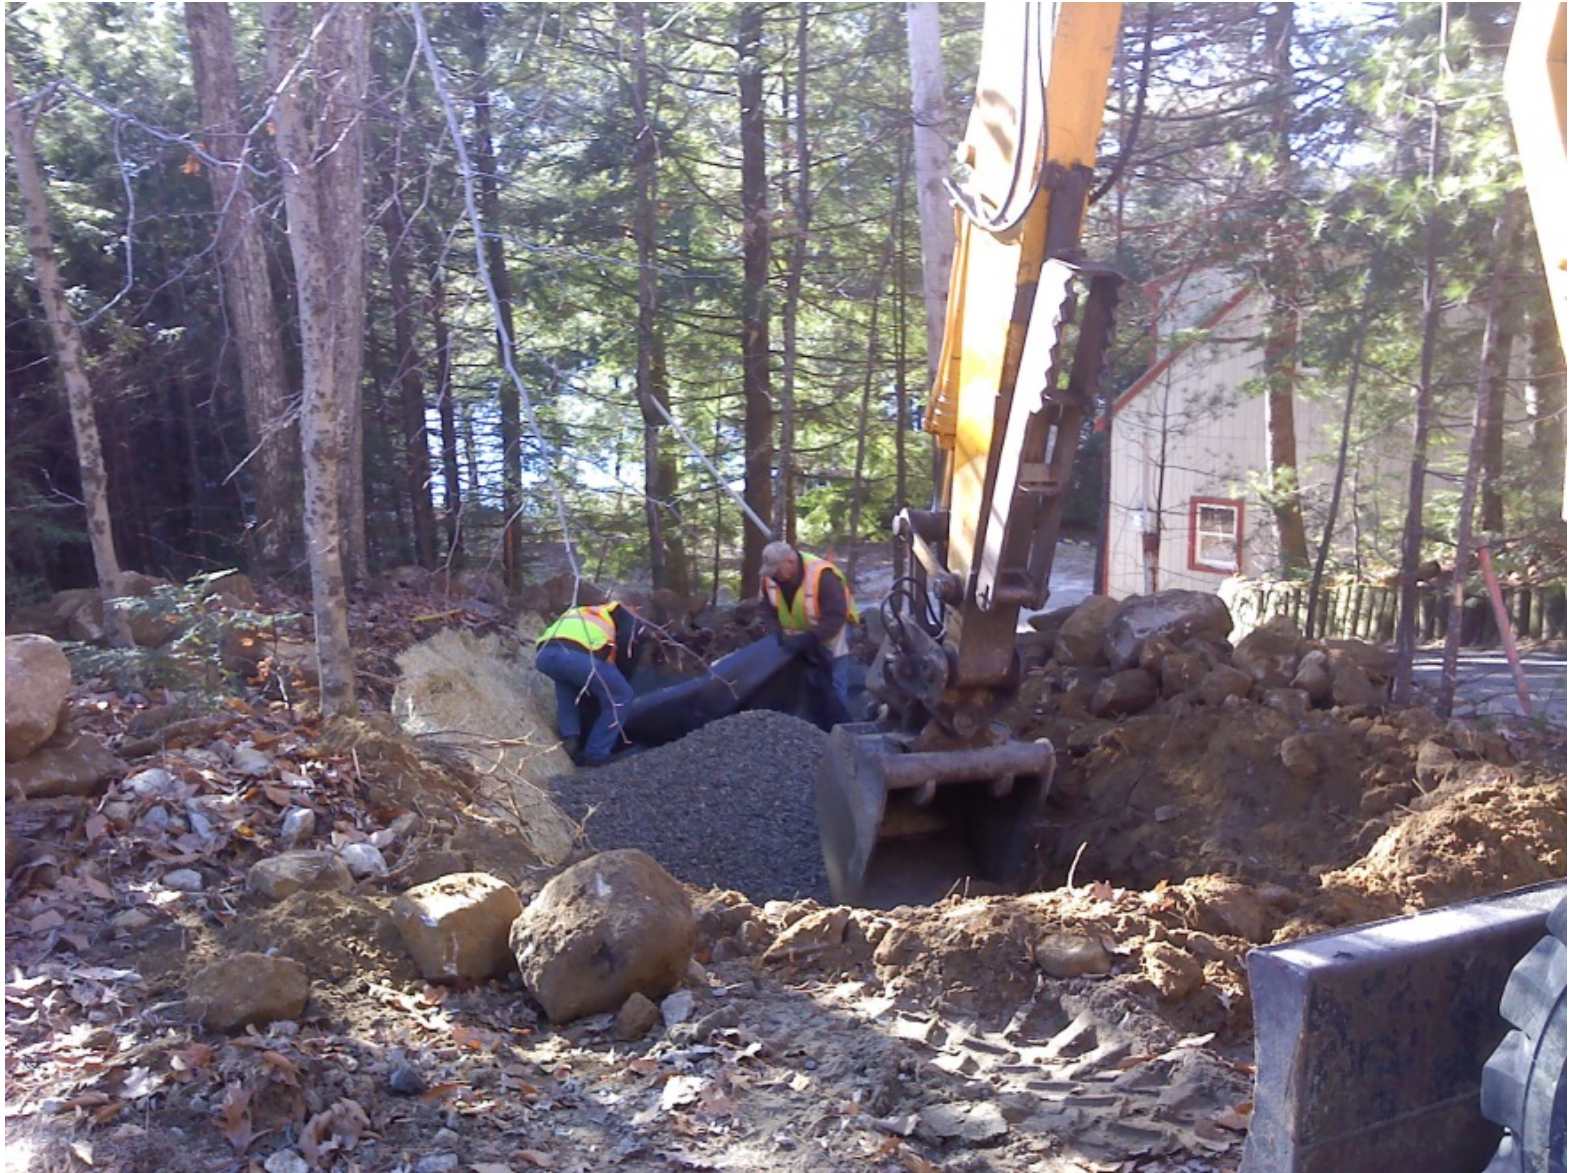
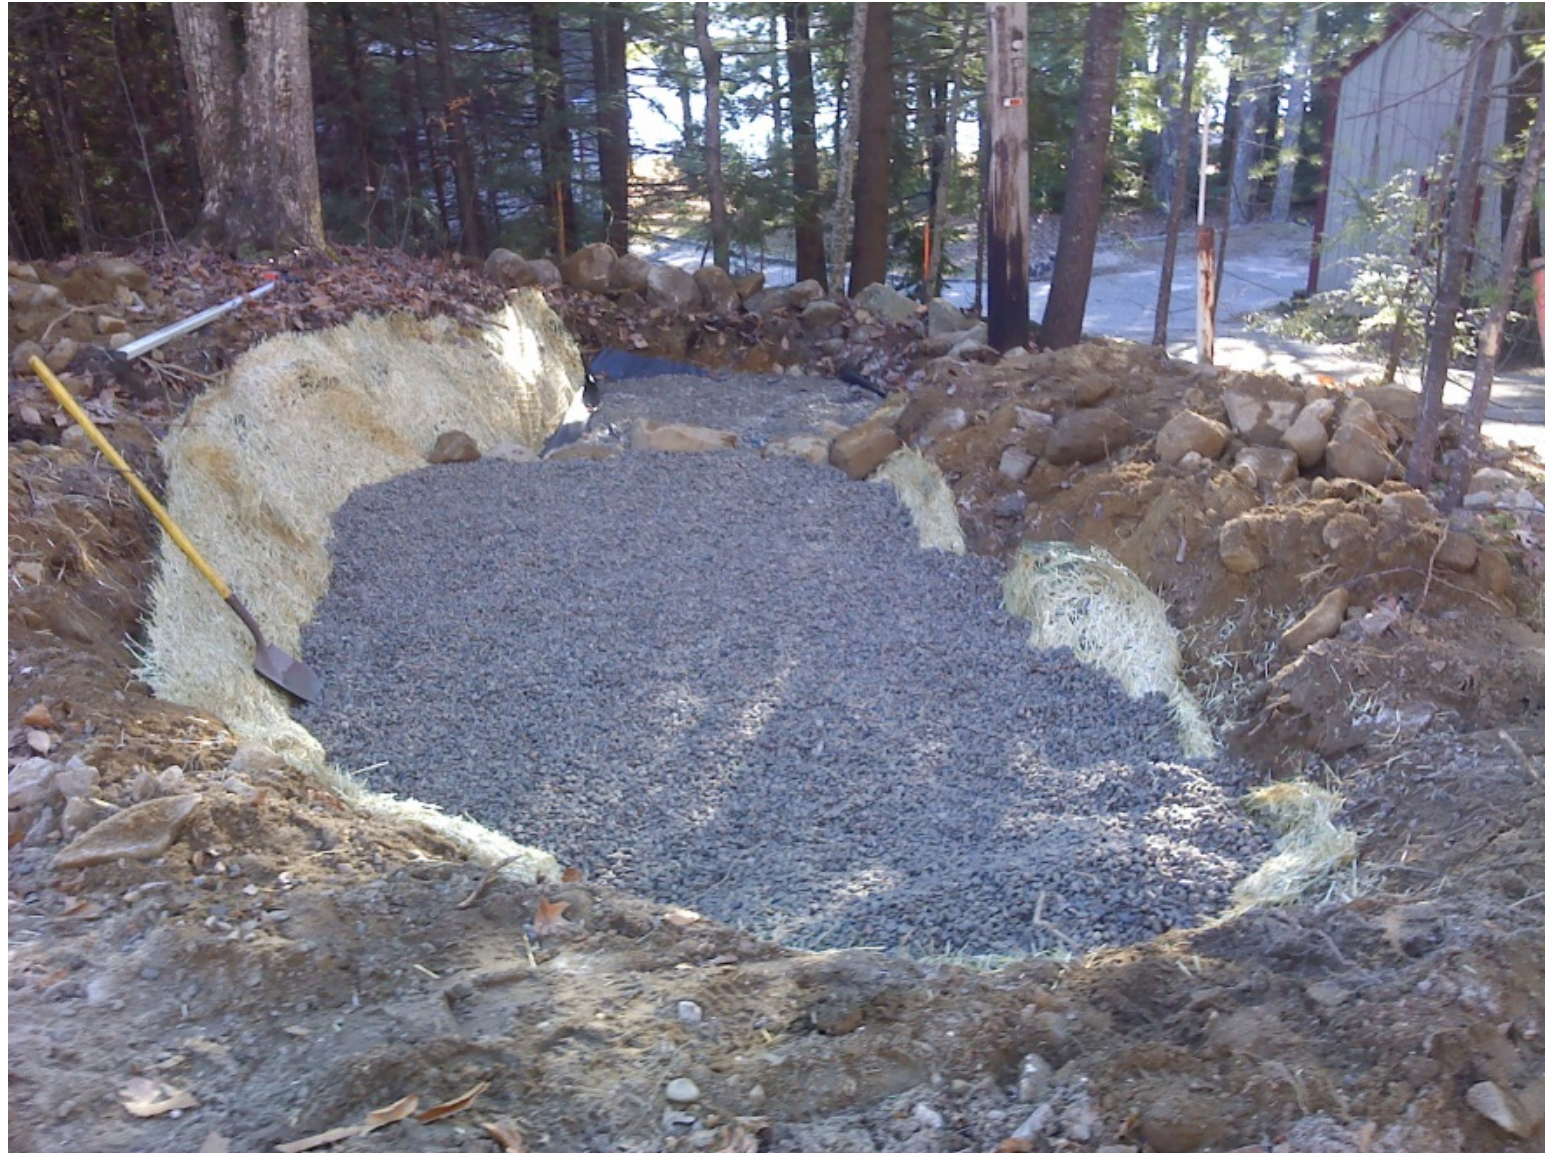
Examples – BR008 Improved

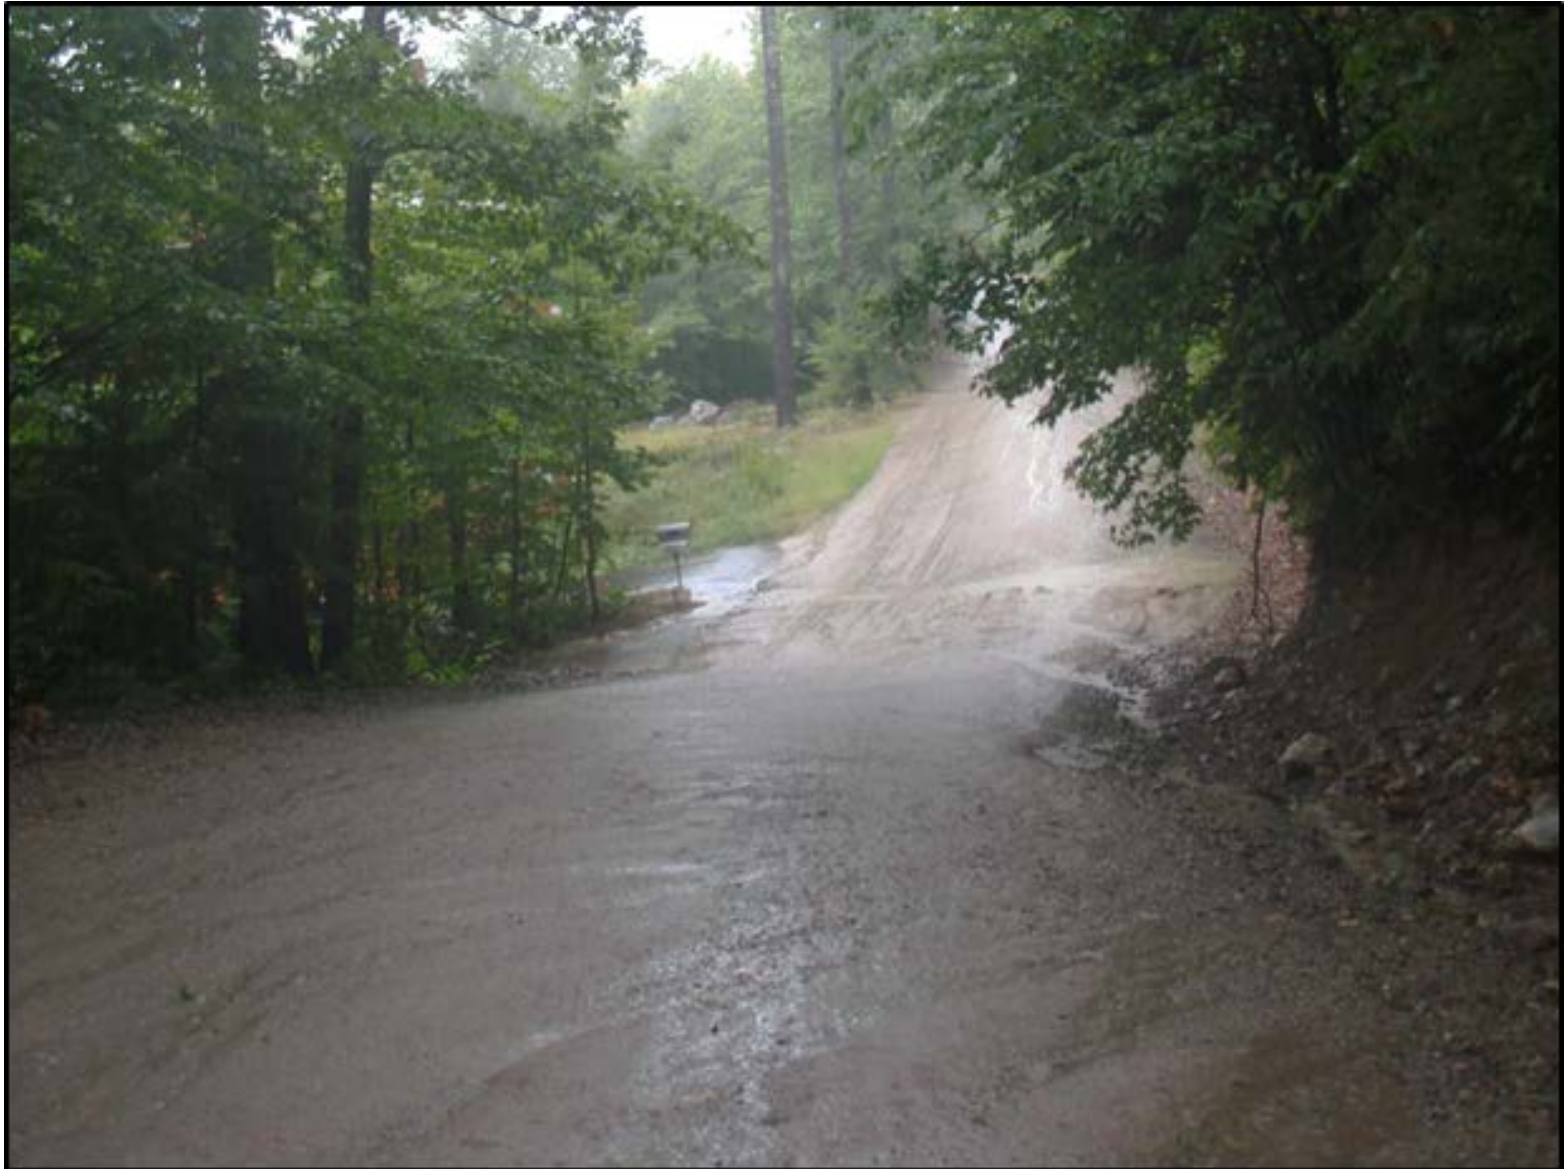
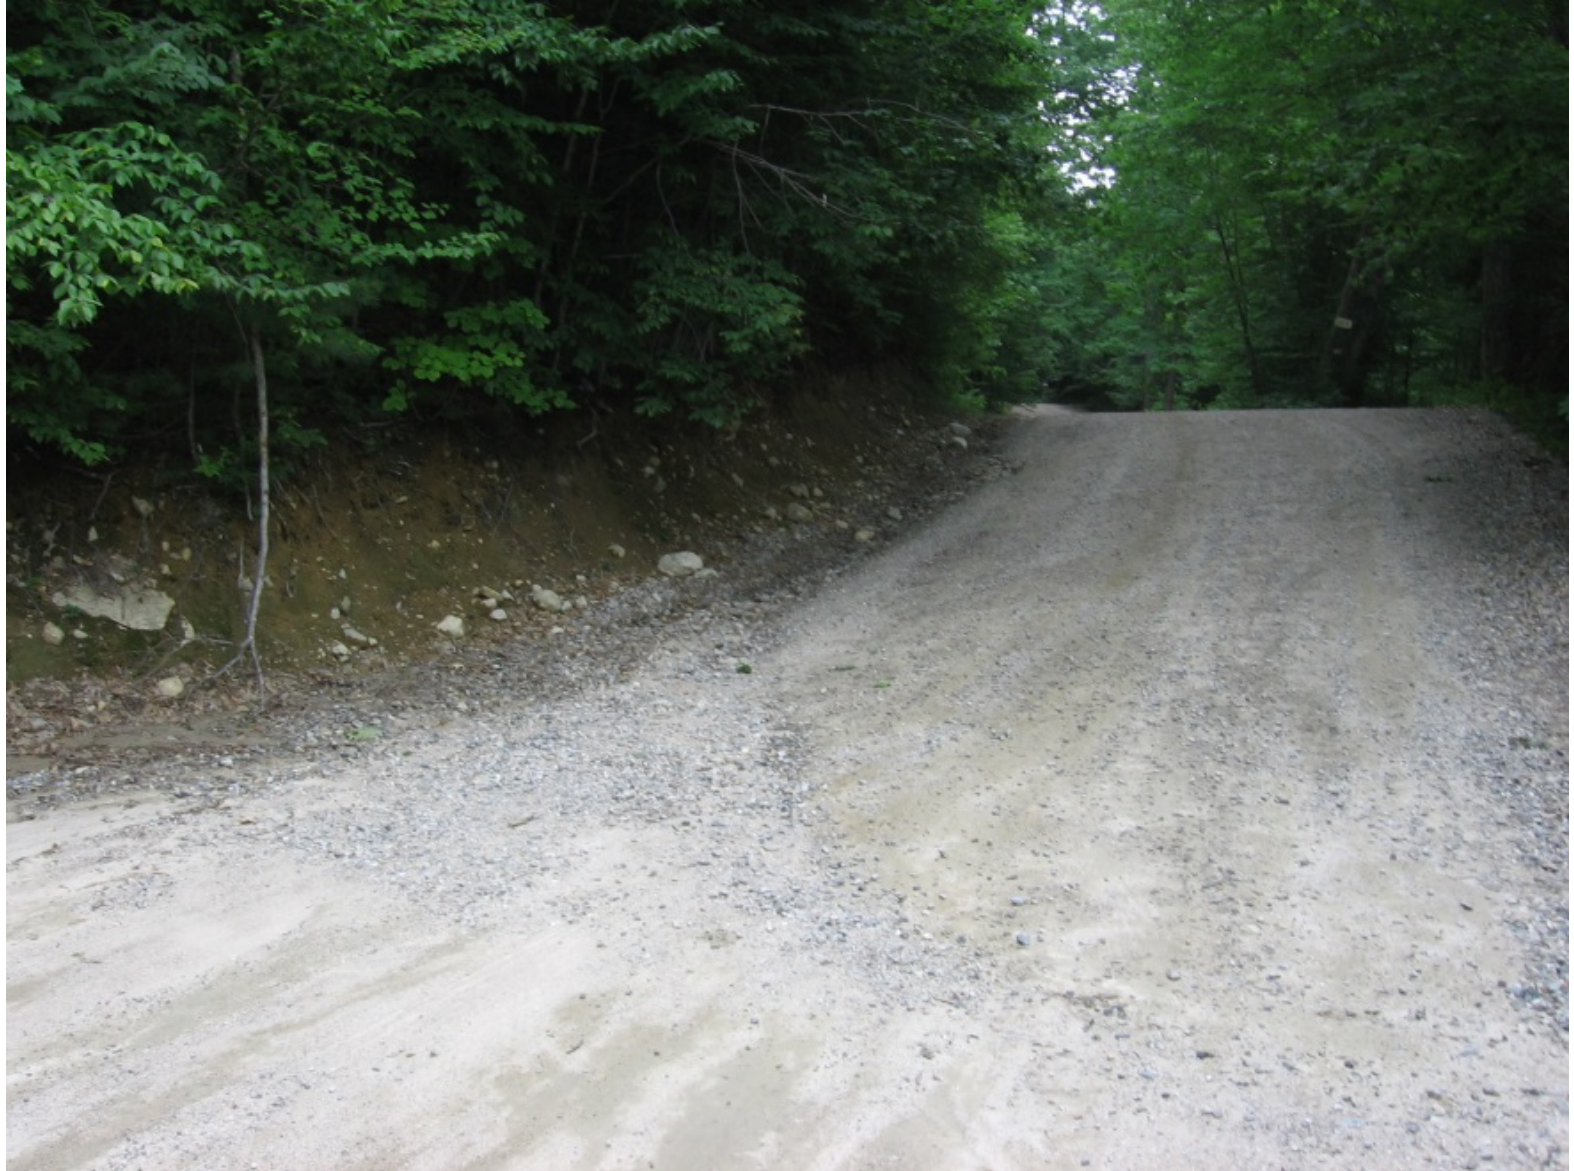
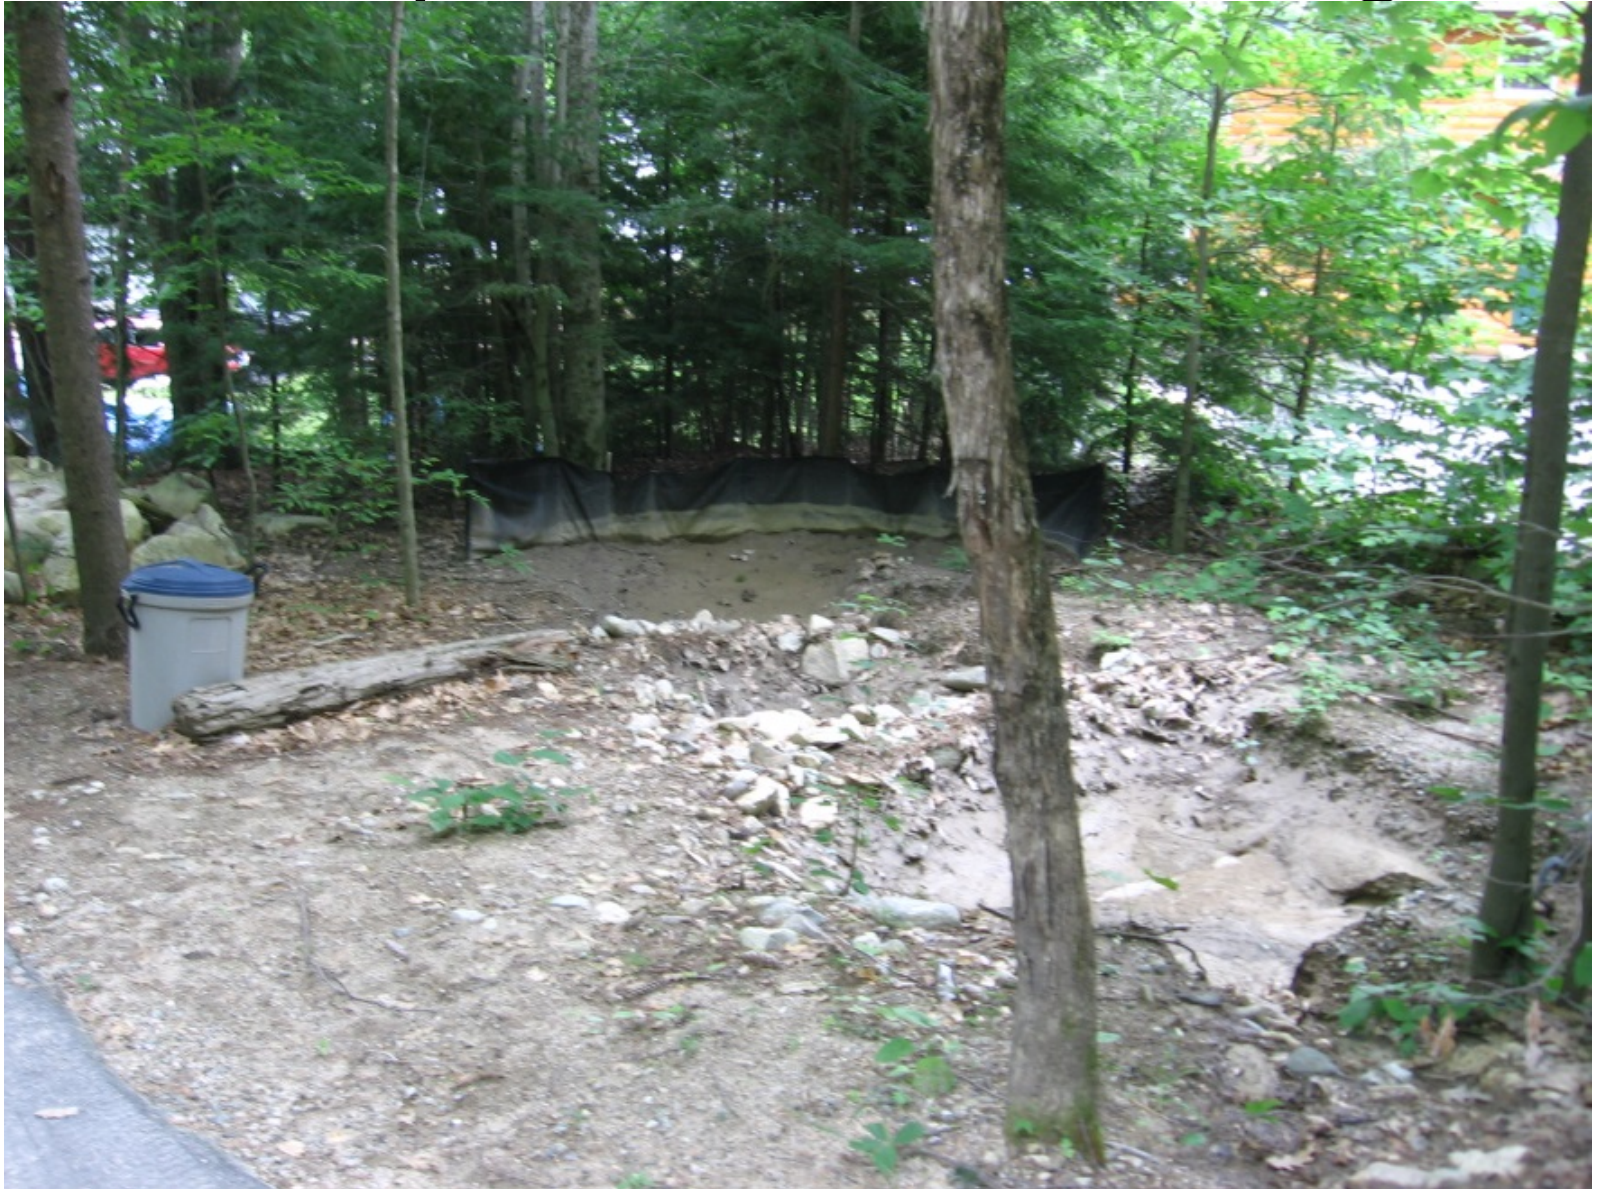
Examples – BR009 Existing

#BR009	7,100	7,100 ft2	Homeowner Step Pool in Front of 740 Brackett Road	Moderate to Steep	1,840	260	1,579	86%	\$ 3,990.00
#BR010	3,600	3,600 ft2	Driveway of 722 & 758 Brackett Road	Moderate	622	88	534	86%	\$ 3,704.29

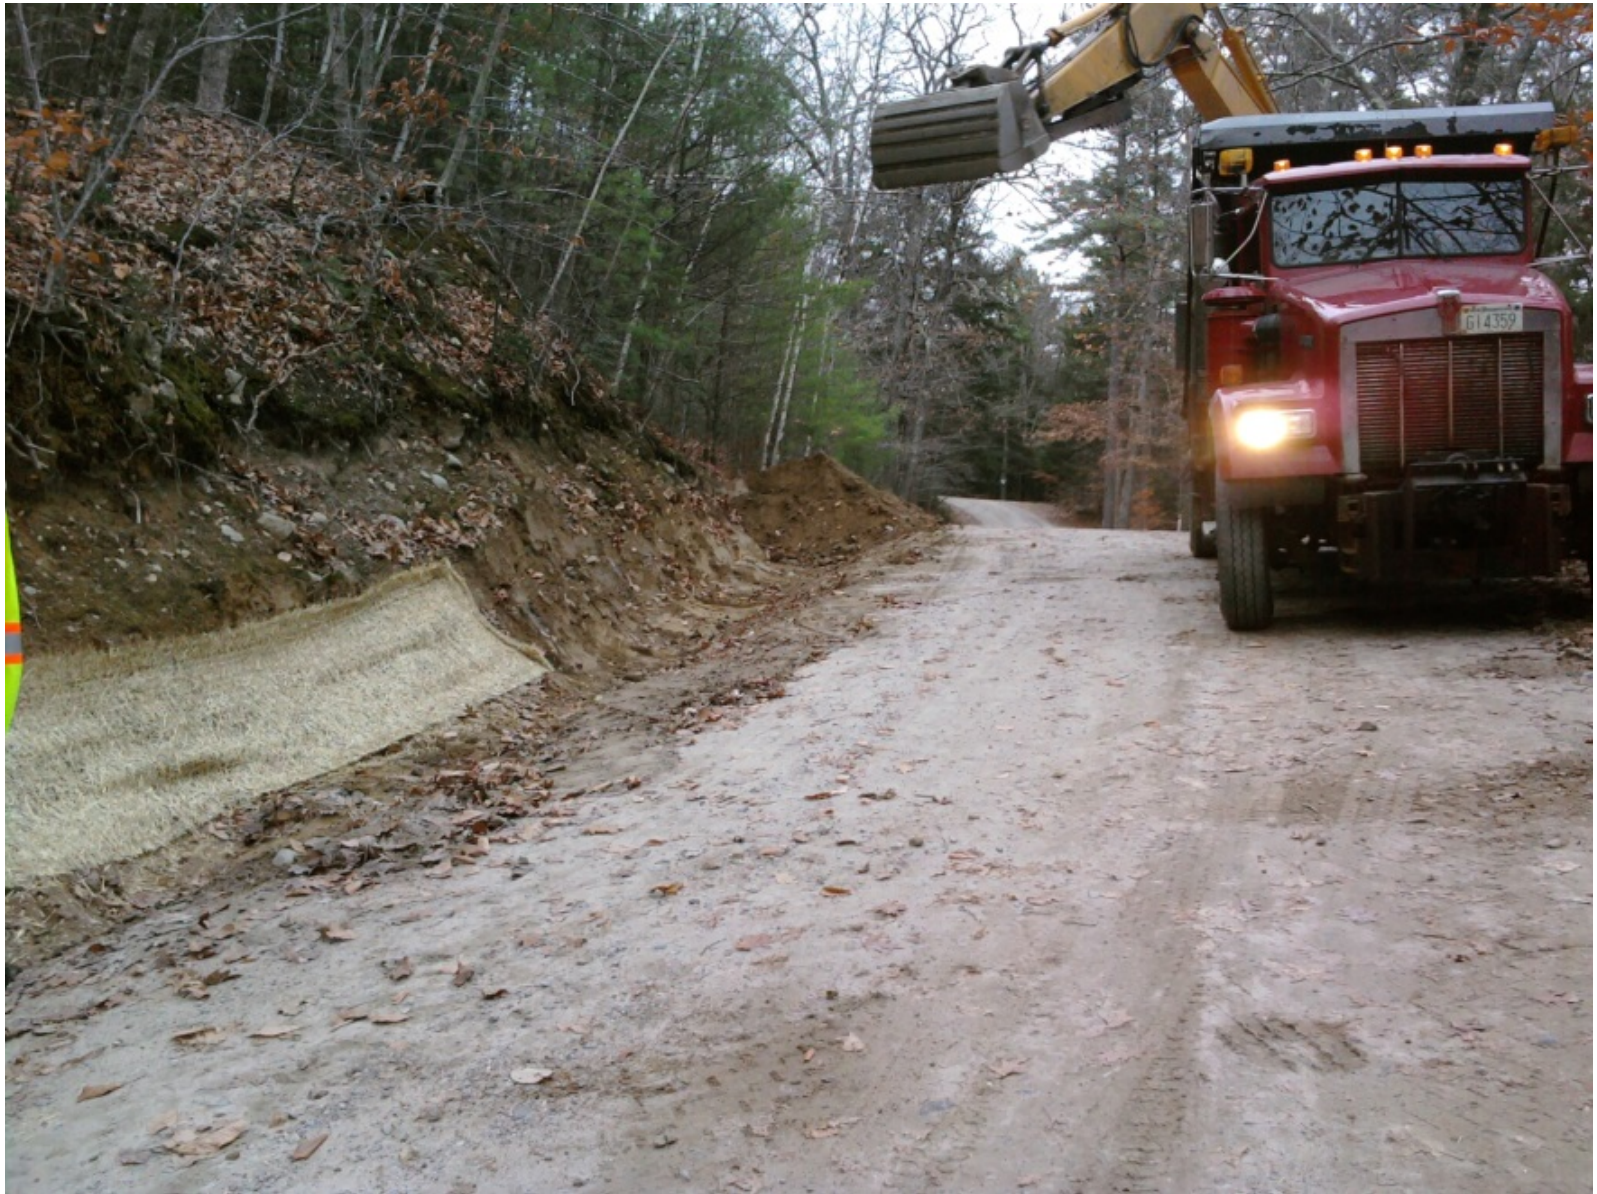
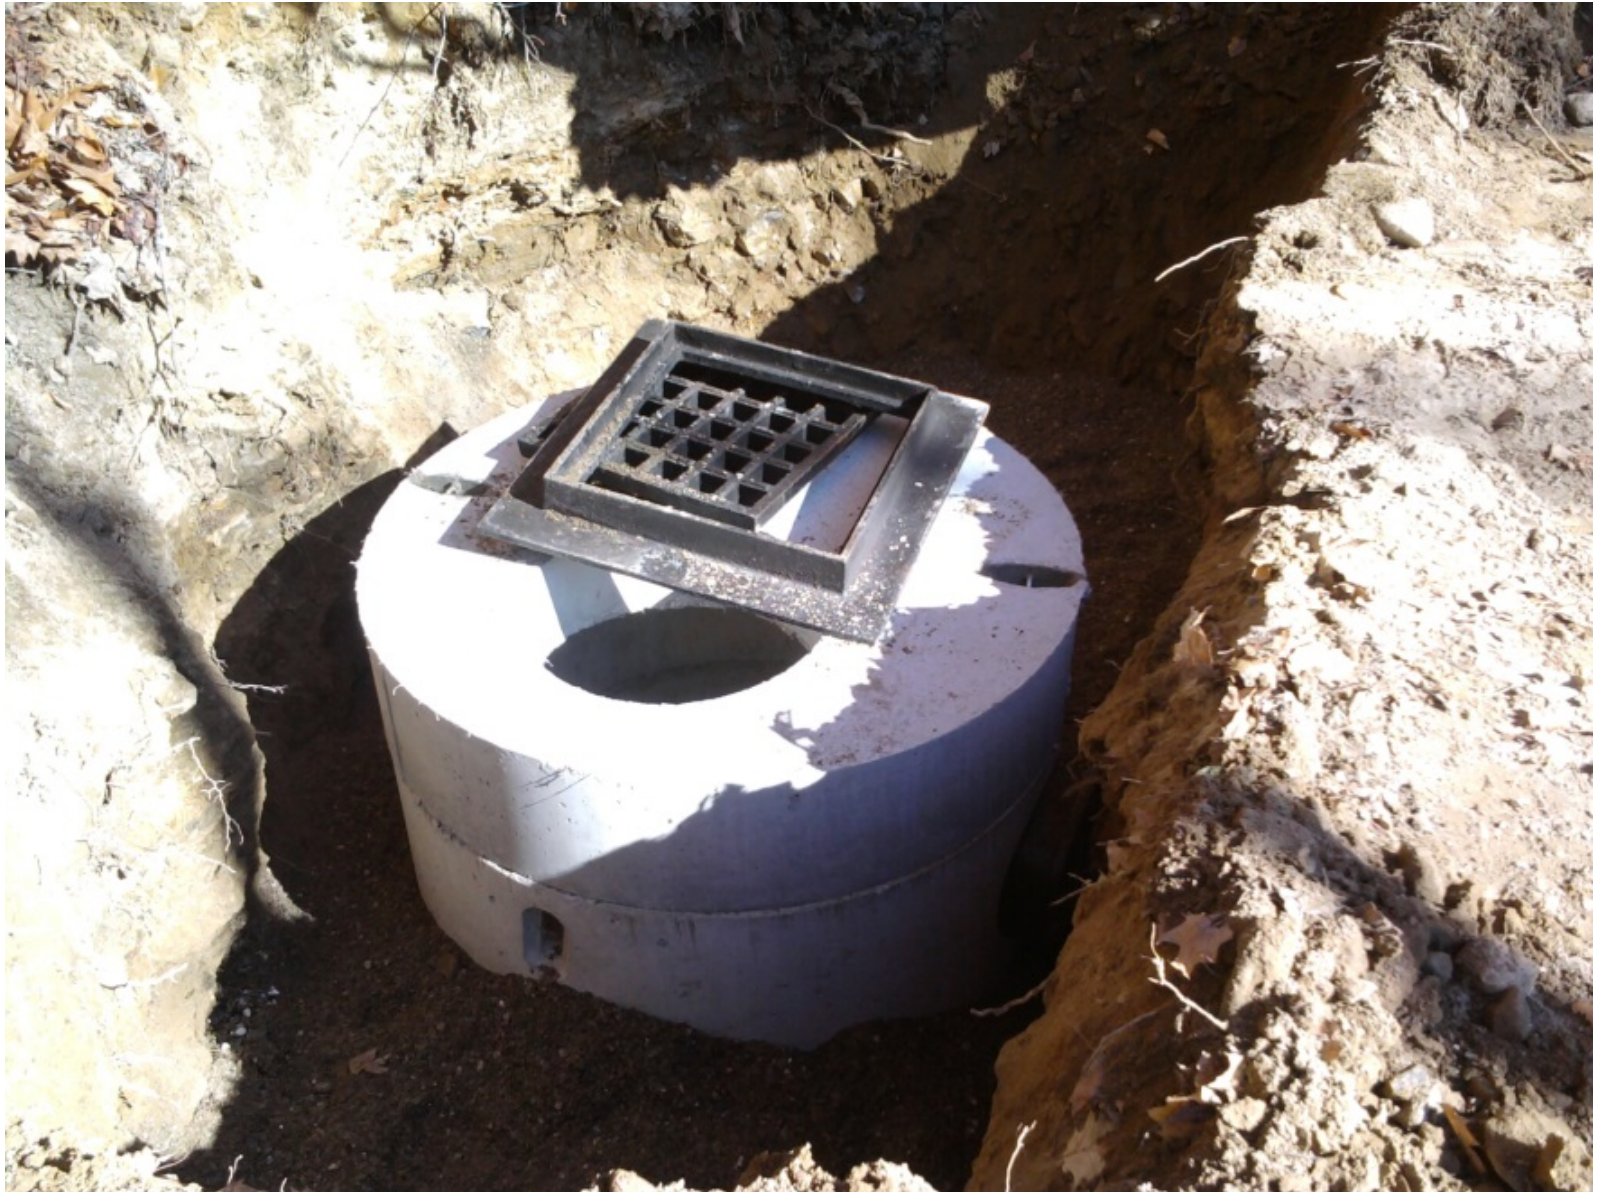
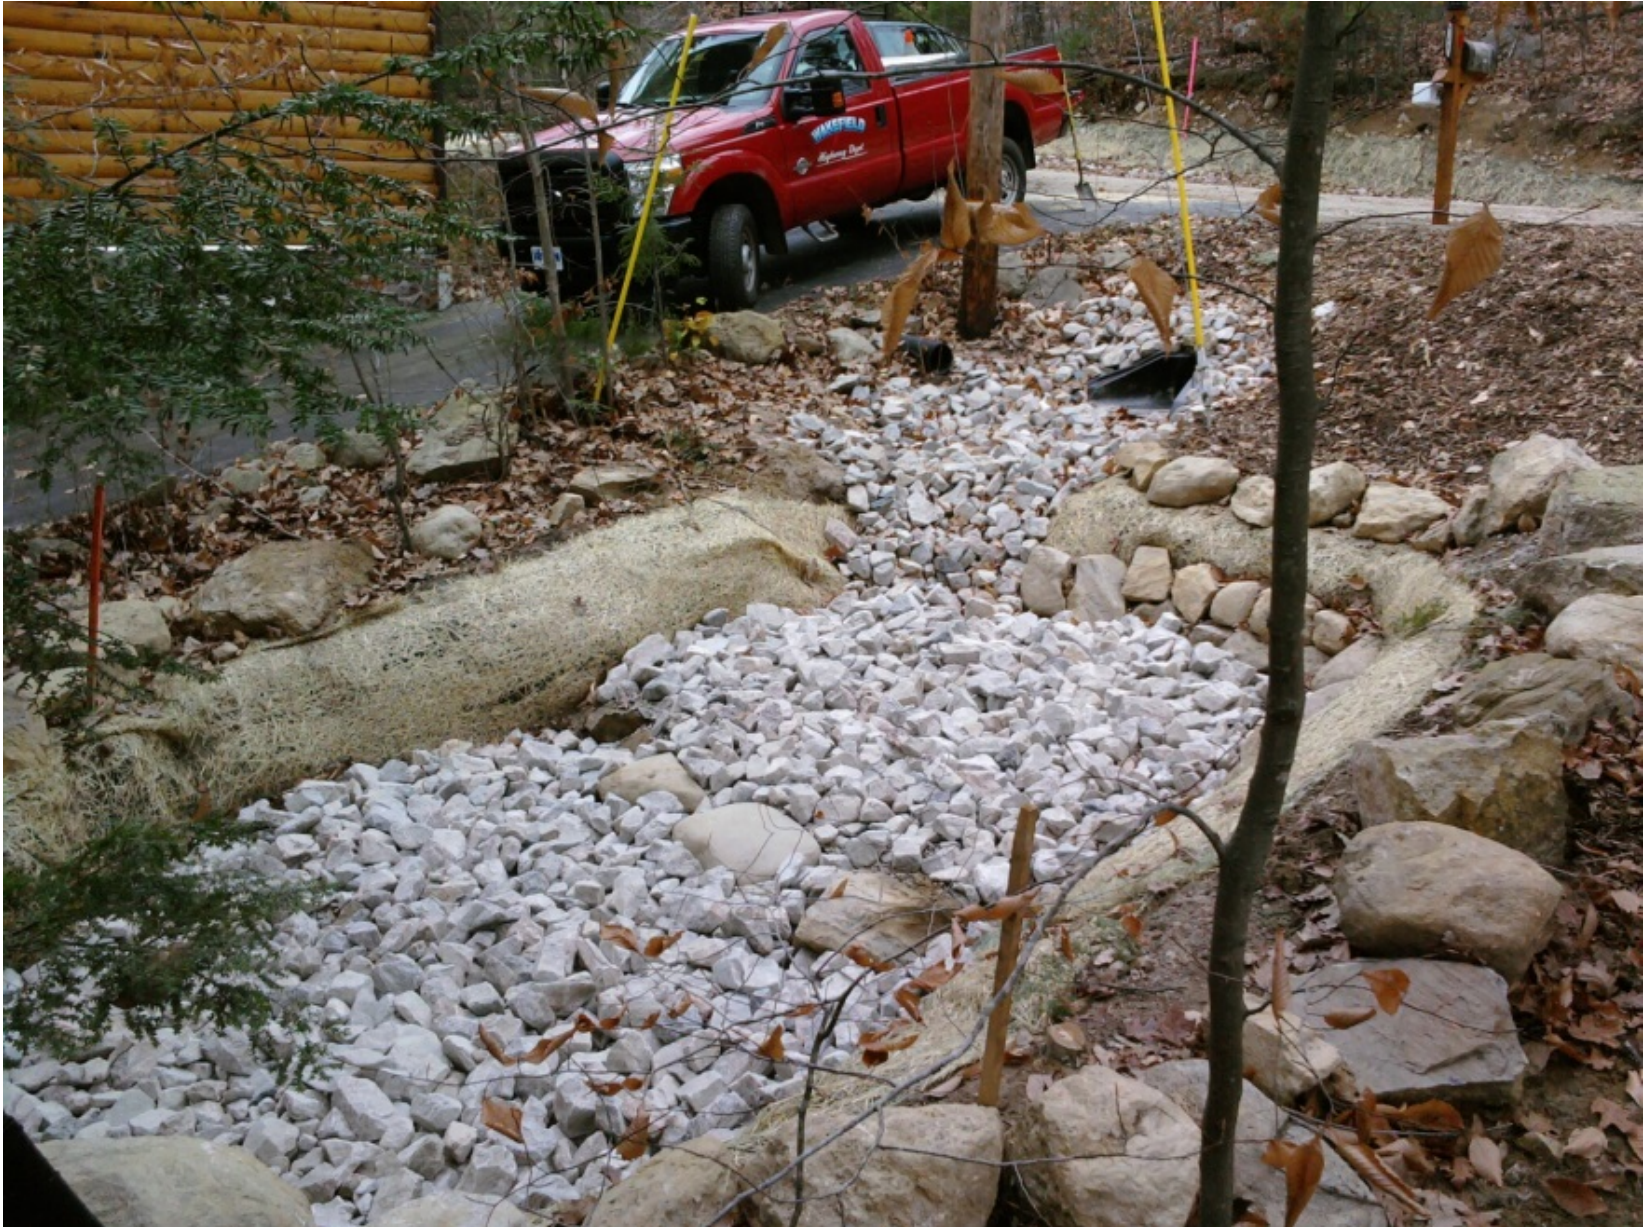
Examples – BR009 Improved
