Road Management Plan for Brackett and Pond Roads, Wakefield, NH

Prepared by
The University of New Hampshire Stormwater Center

Prepared with Support from NH Department of Environmental
Services
May 2011

Province Lake Road Management Plan Implementation Phase I

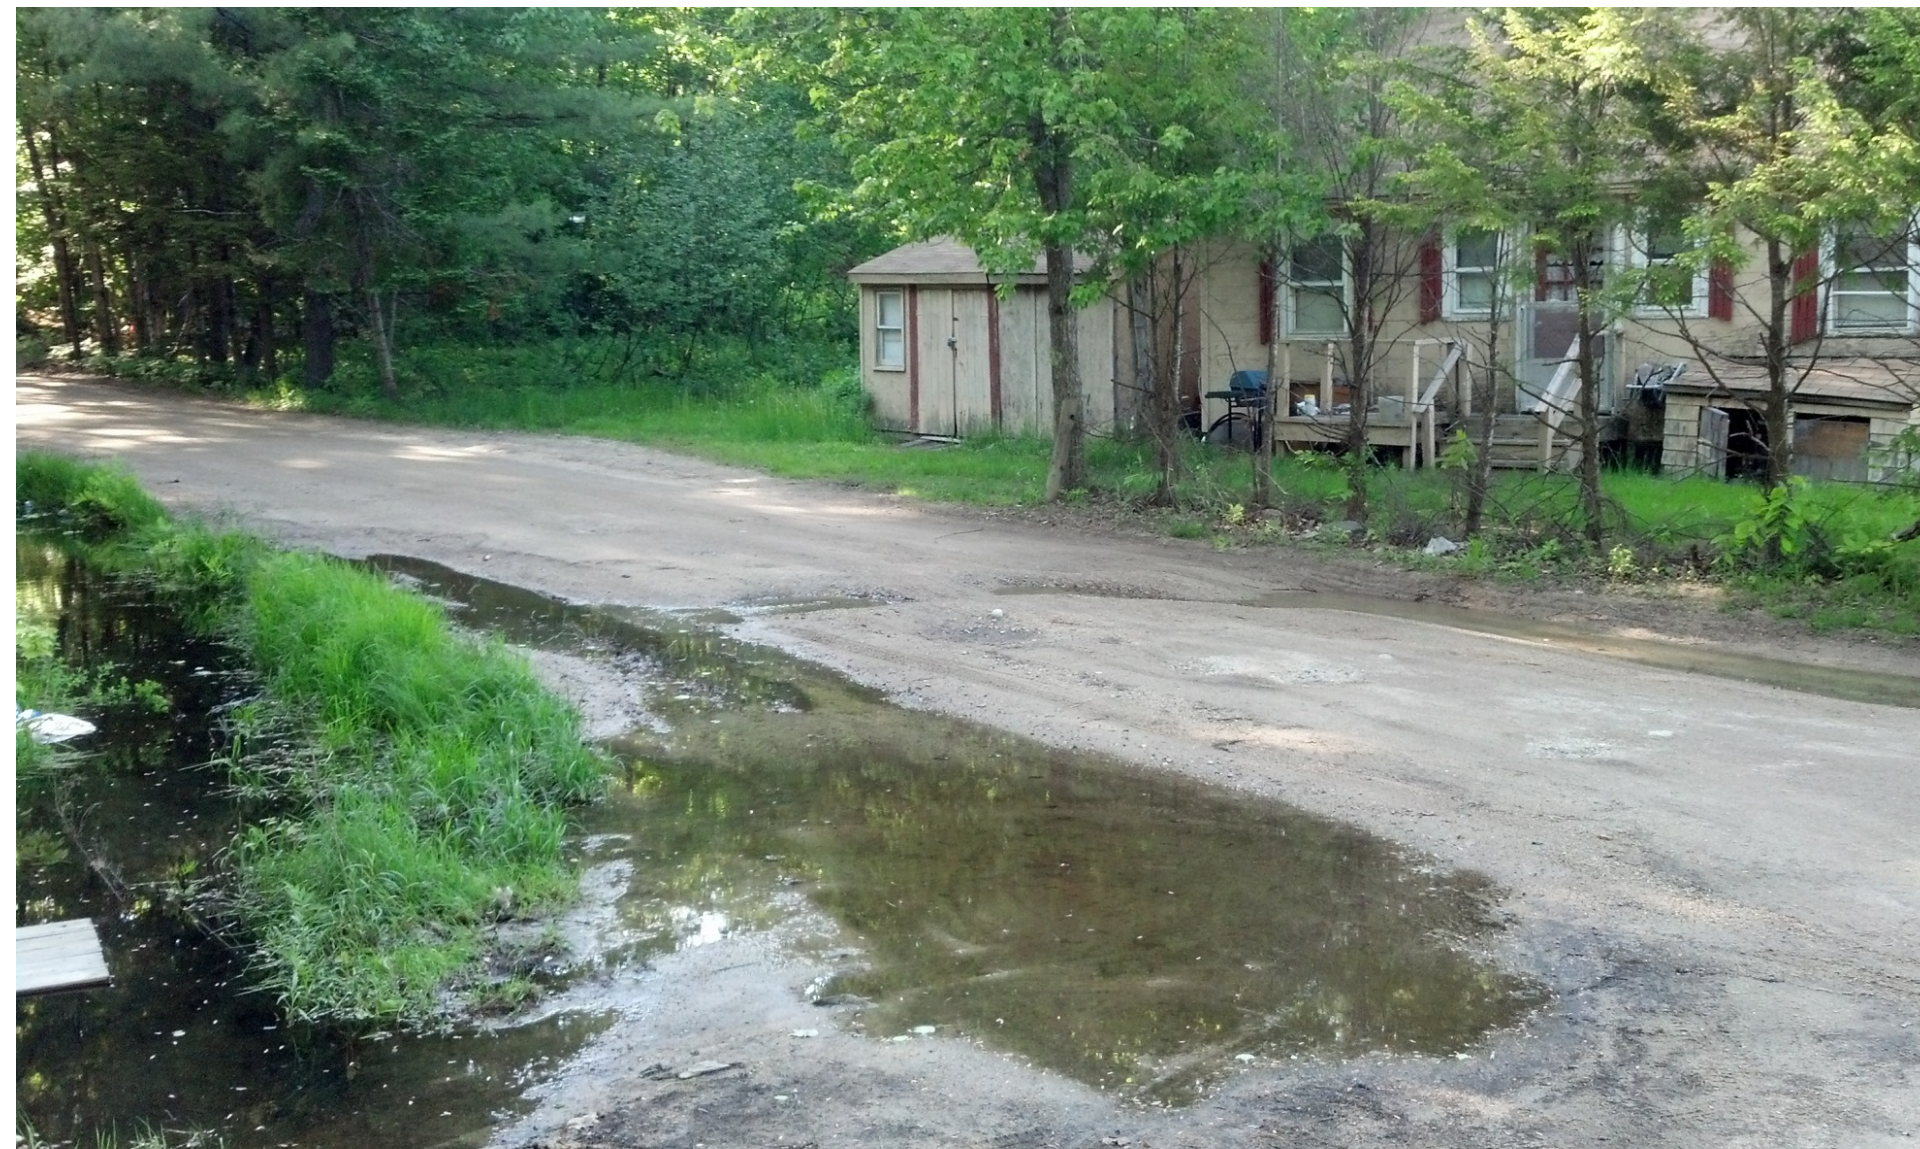
Towle Farm Road Pre-existing condition

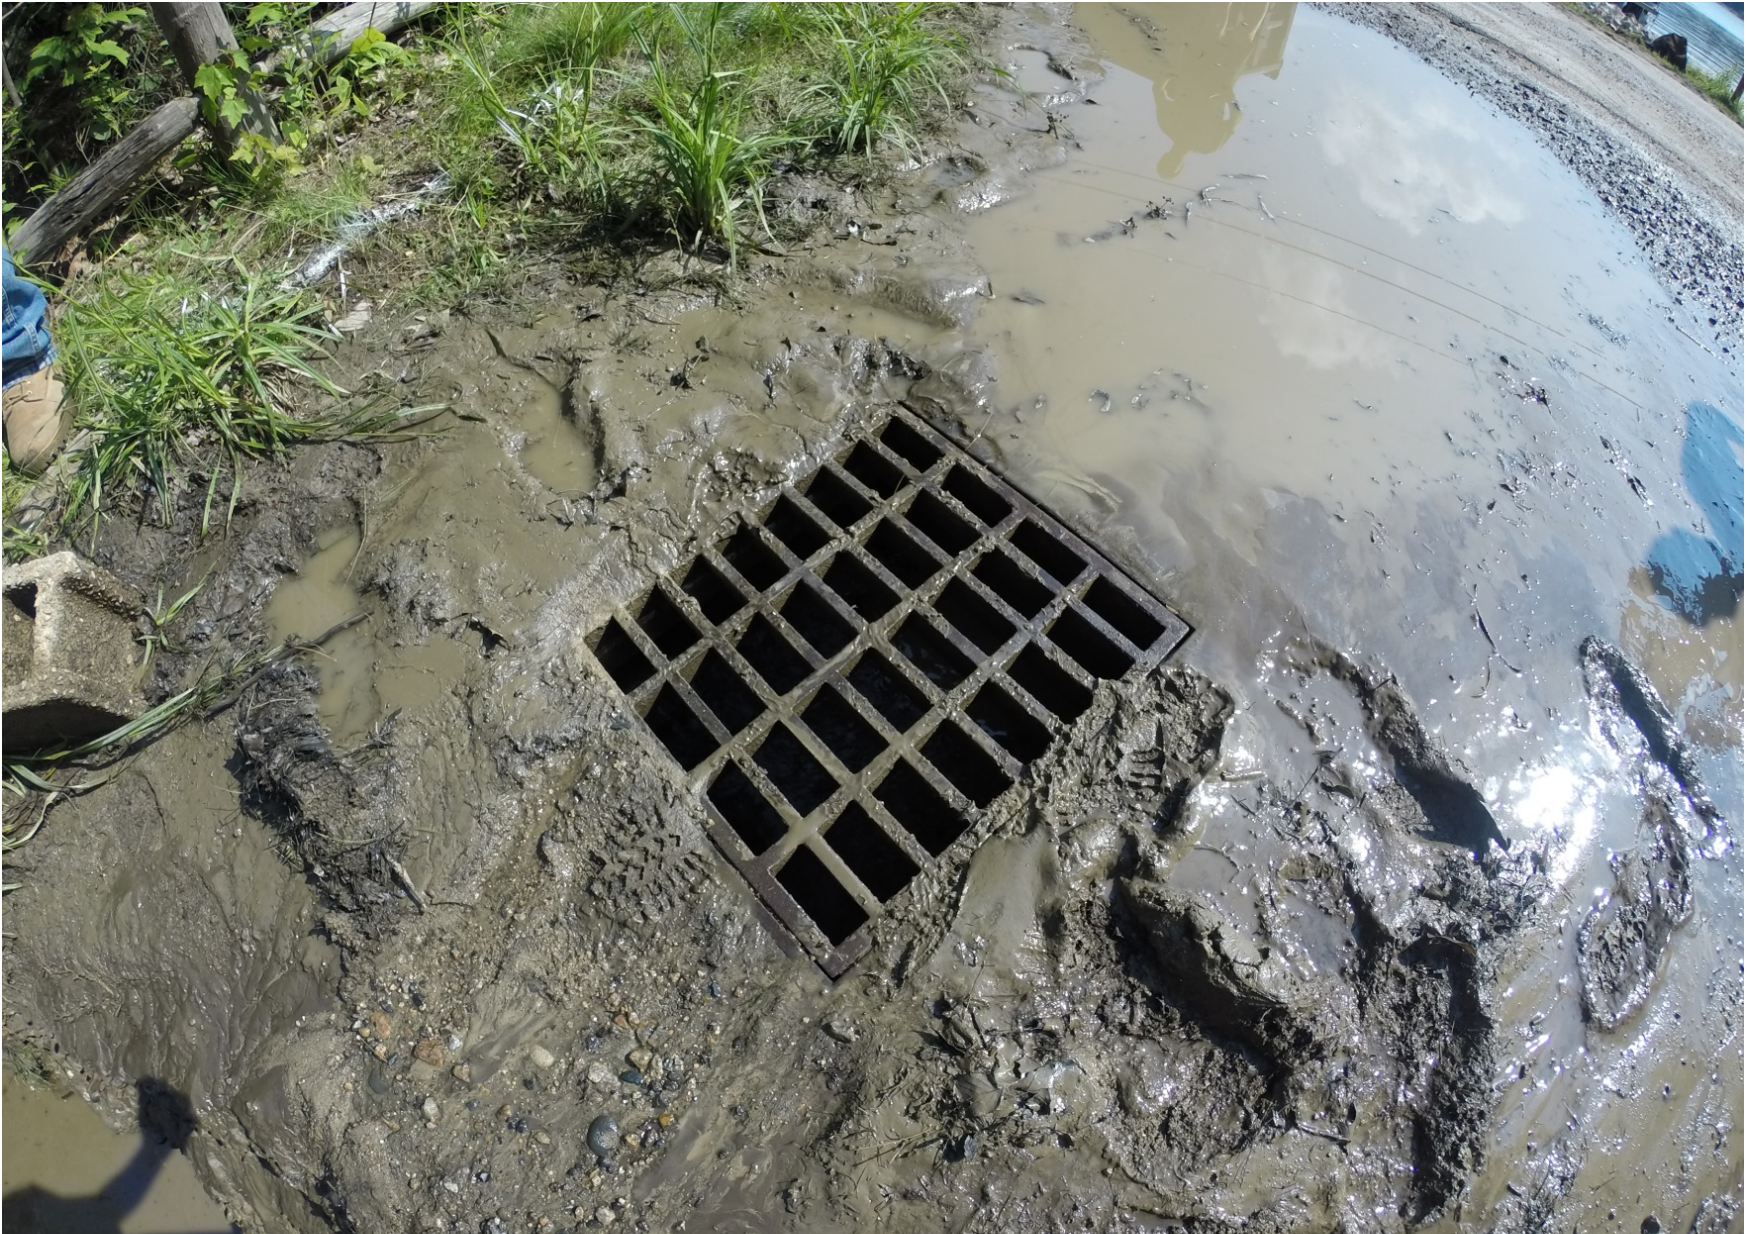
Pre-existing structure

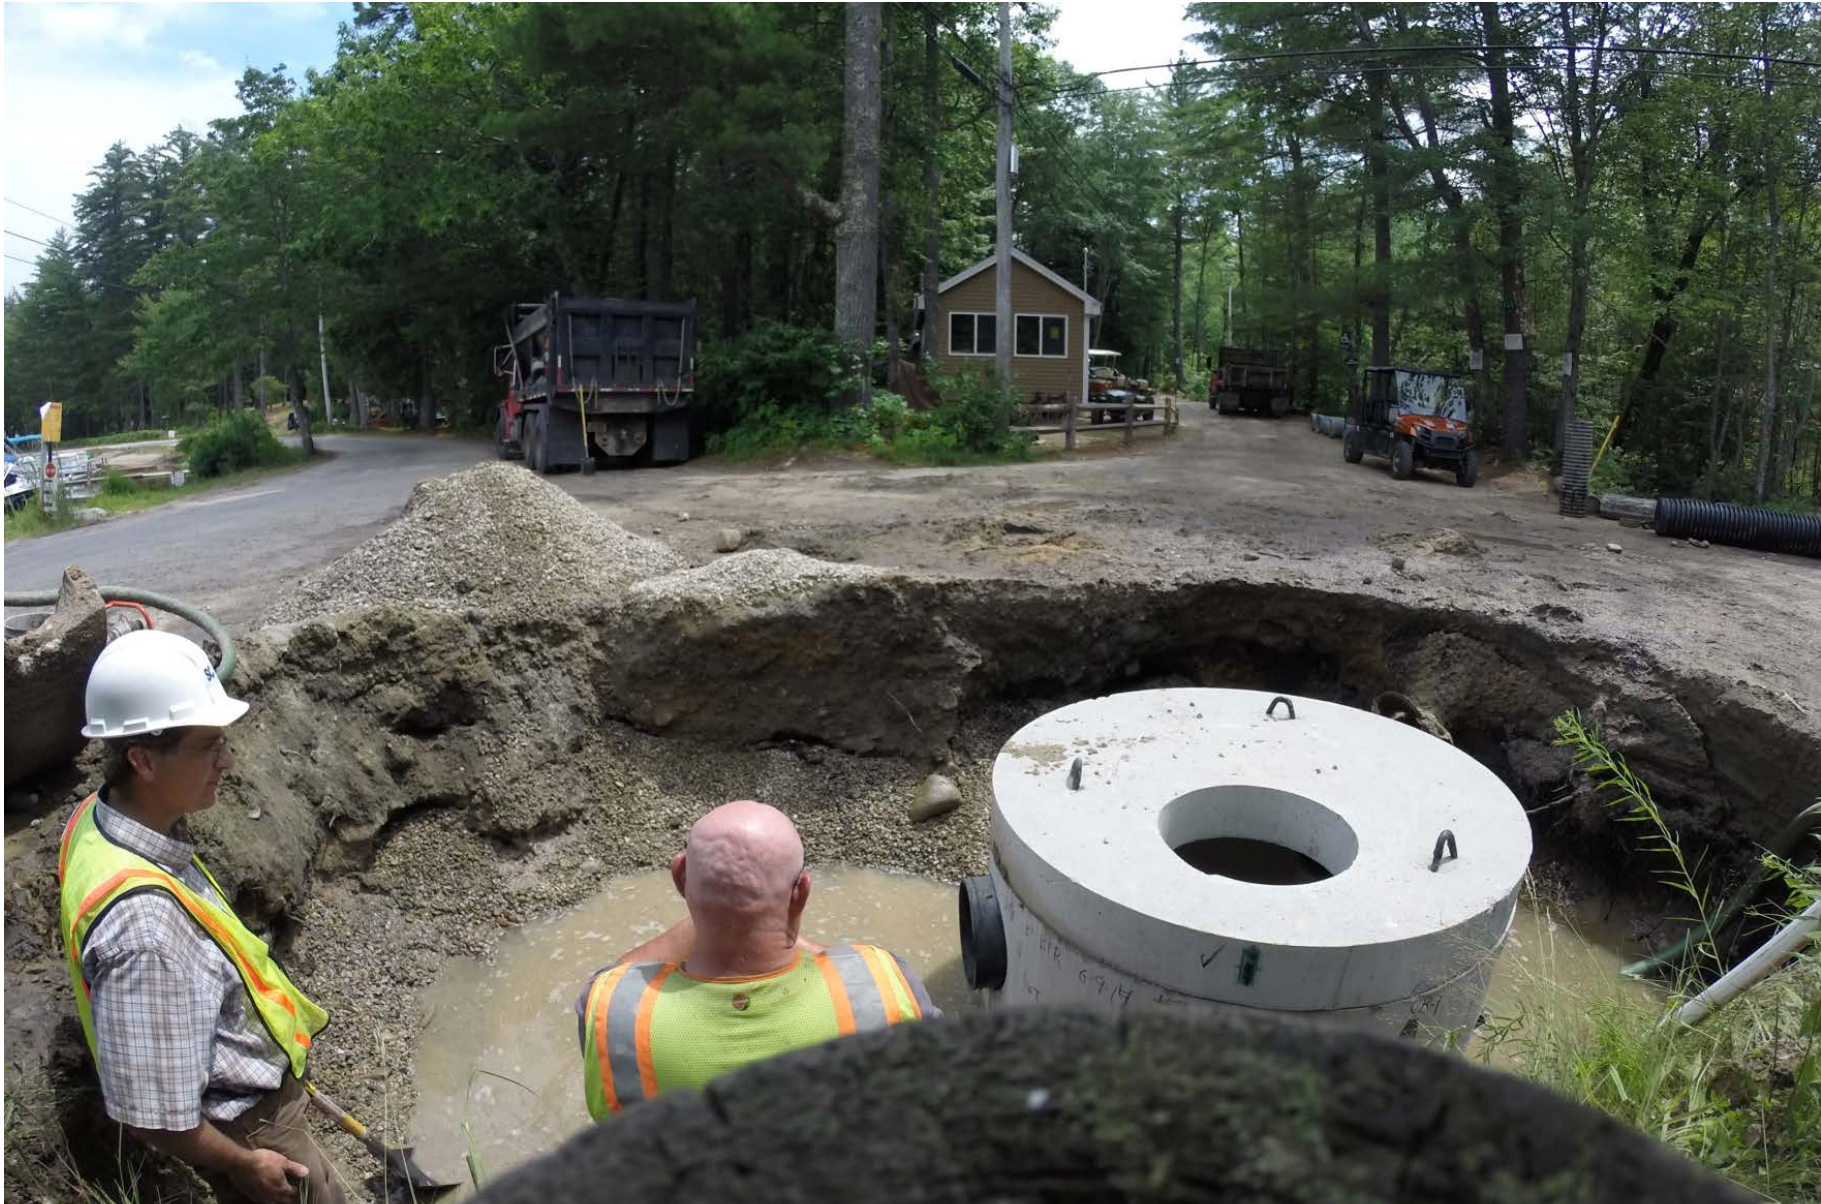
BMP Installation

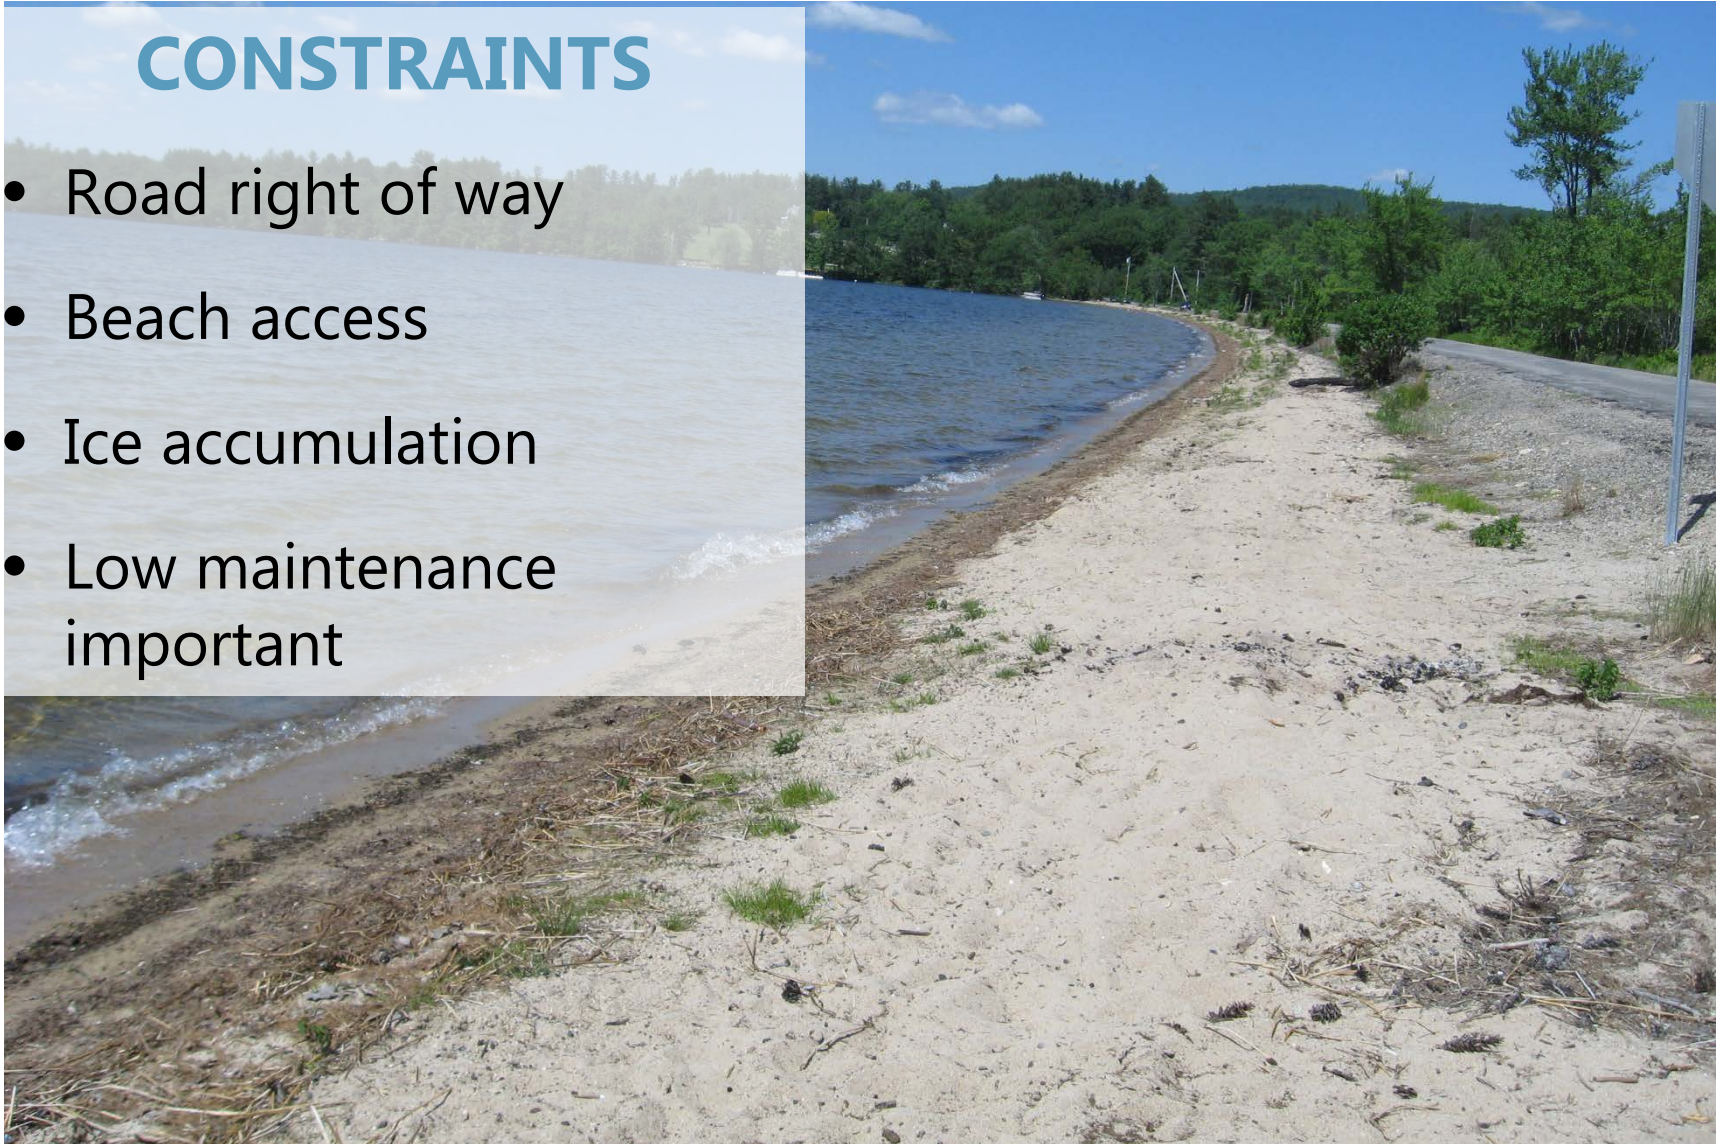
Rte 153 Province Lake

CONSTRAINTS

- Road right of way
- Beach access
- Ice accumulation
- Low maintenance important

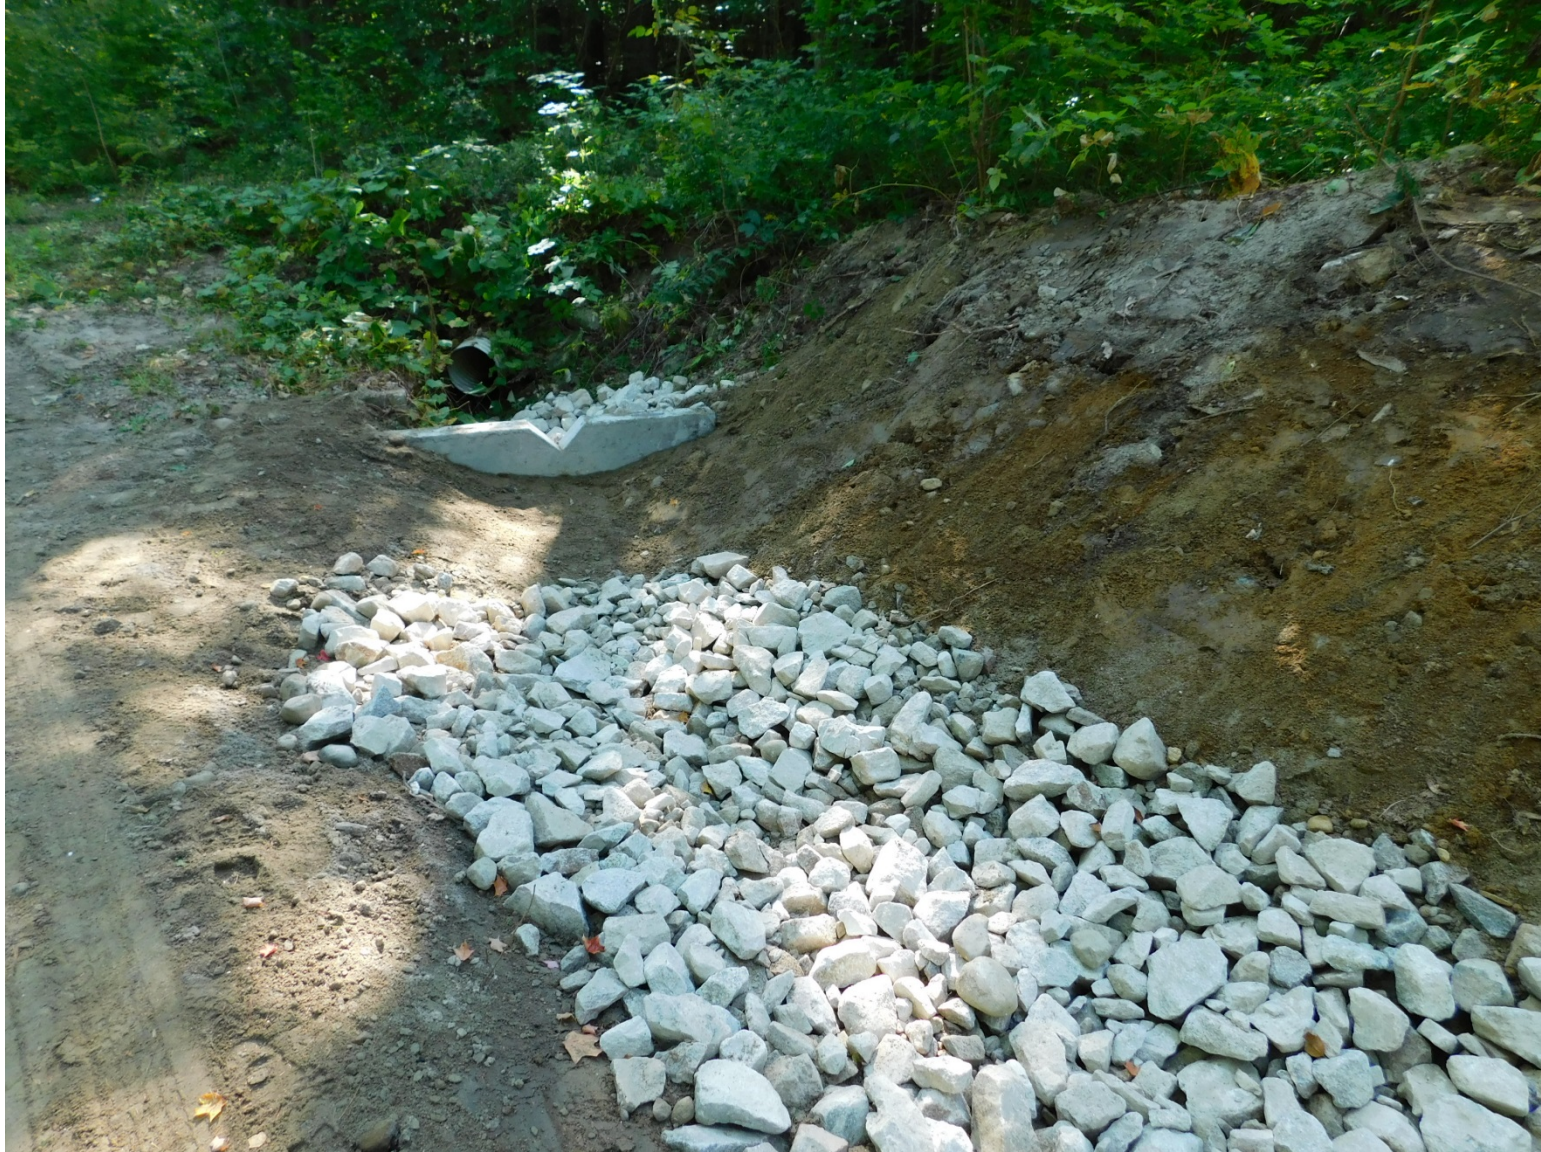
Weir walls in front of culverts?
